CINCINNATI

Enhanced Line of Duty Death Report

**Fire Apparatus Operator
Daryl Gordon**

March 26, 2015

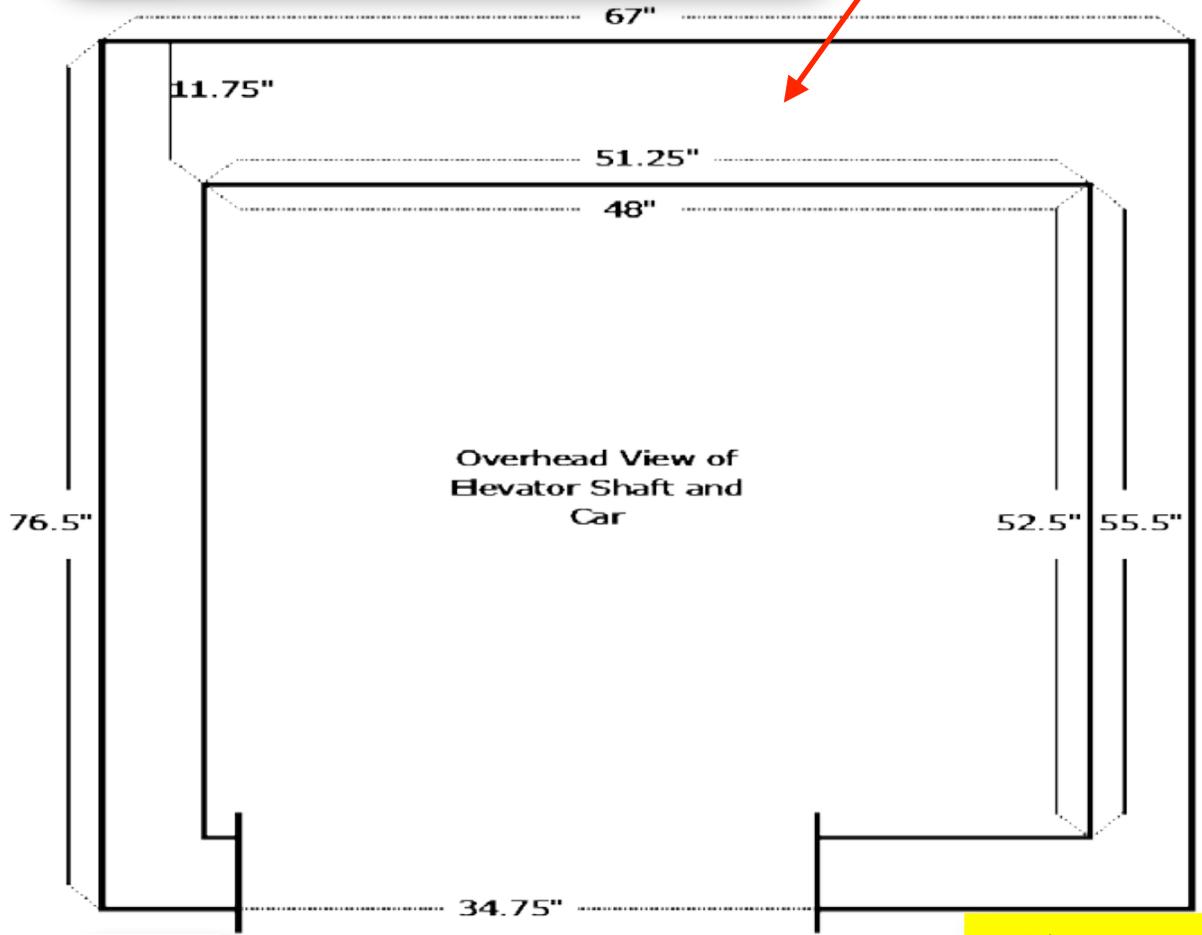
Diagram #38

Elevator Dimensions

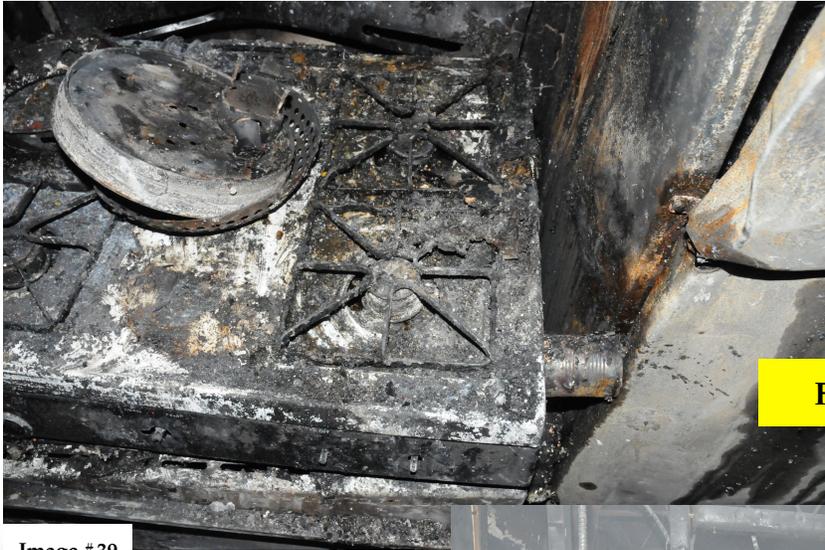
Image #39

The cause of the fire was ruled accidental as "Food Left Unattended on the Stove" by the Cincinnati Fire Investigation Unit. *(Note: See CFD Fire Investigation Report in Appendix #3.)*

Fire Origin

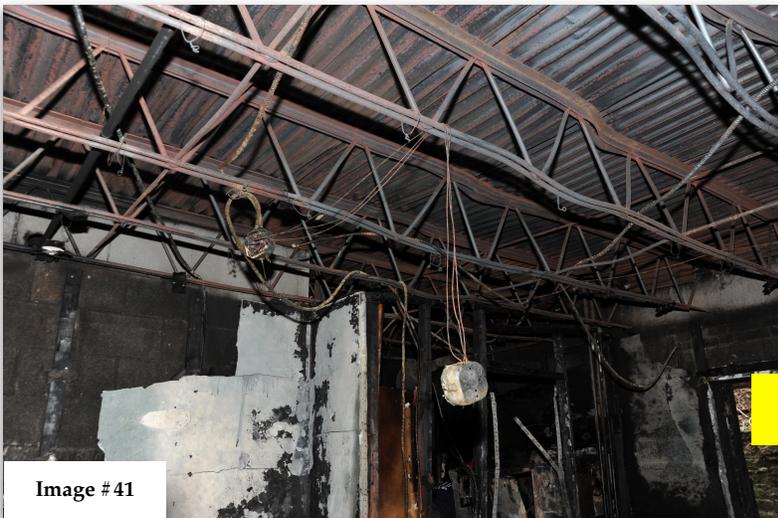
Image #41

Fire Damage

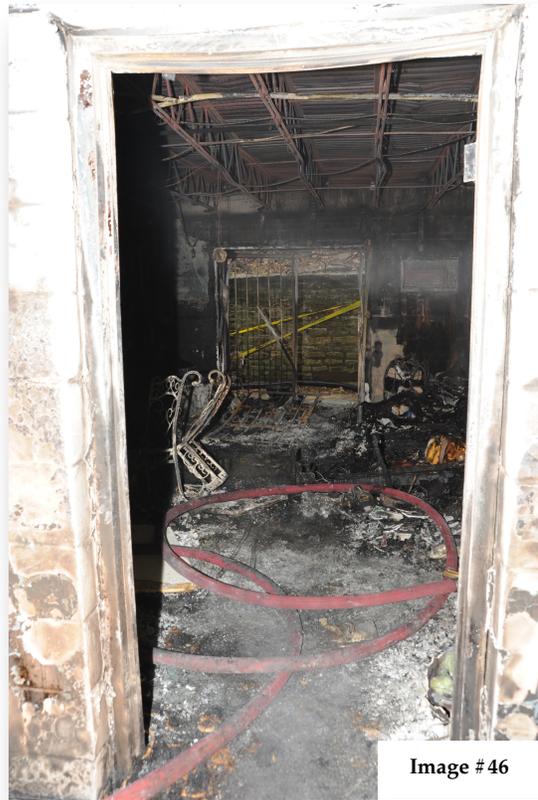
Image #46

**Fire Damage
Apartment 27**

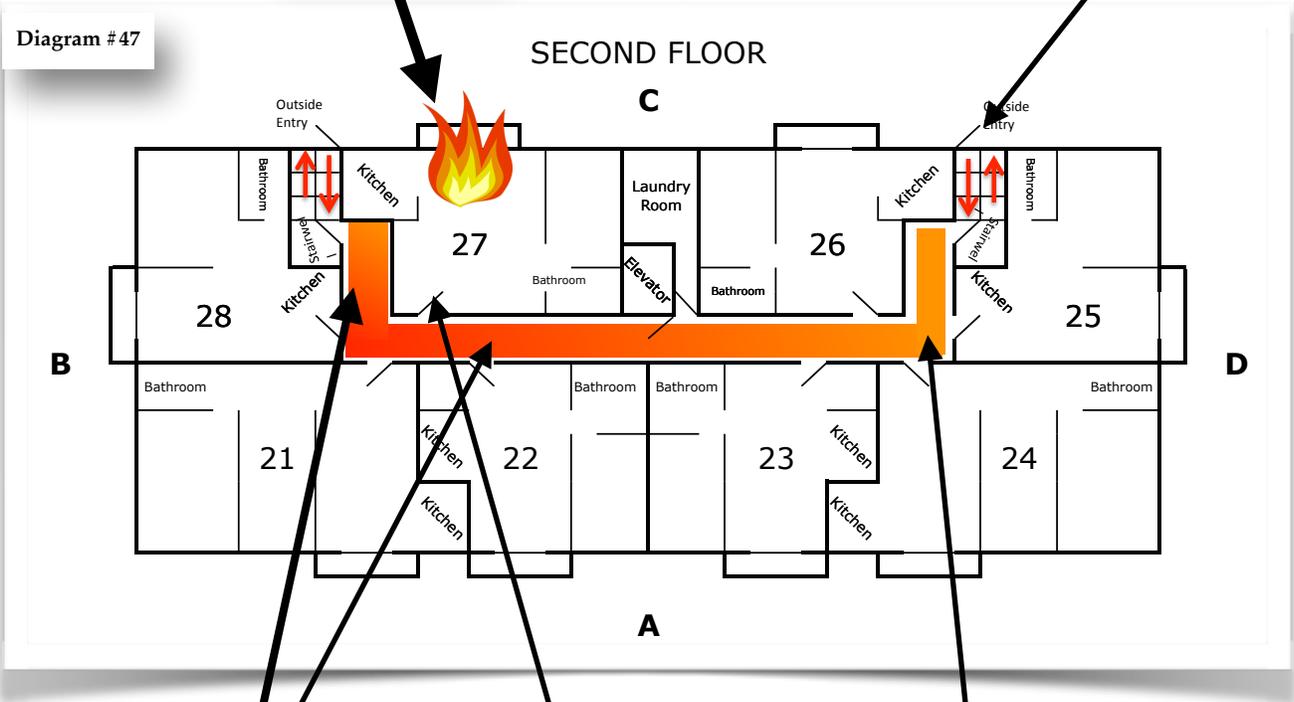
Diagram #47

Fire
Damage
In Hallway
MOST Severe

Fire
Damage
In Hallway
LEAST Severe

Door to Fire
Apartment Burned
Away

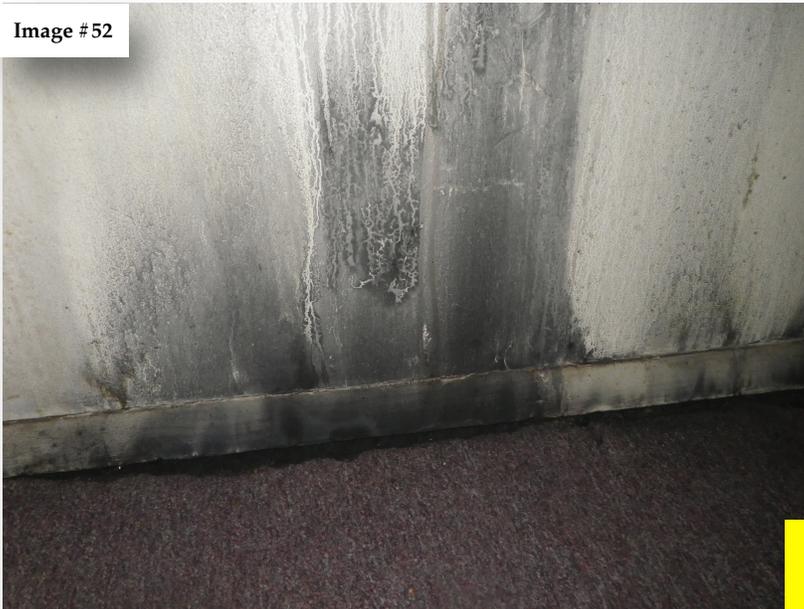
**Smoke Damage
Directly Above Fire
Apartment
on the 3rd Floor**

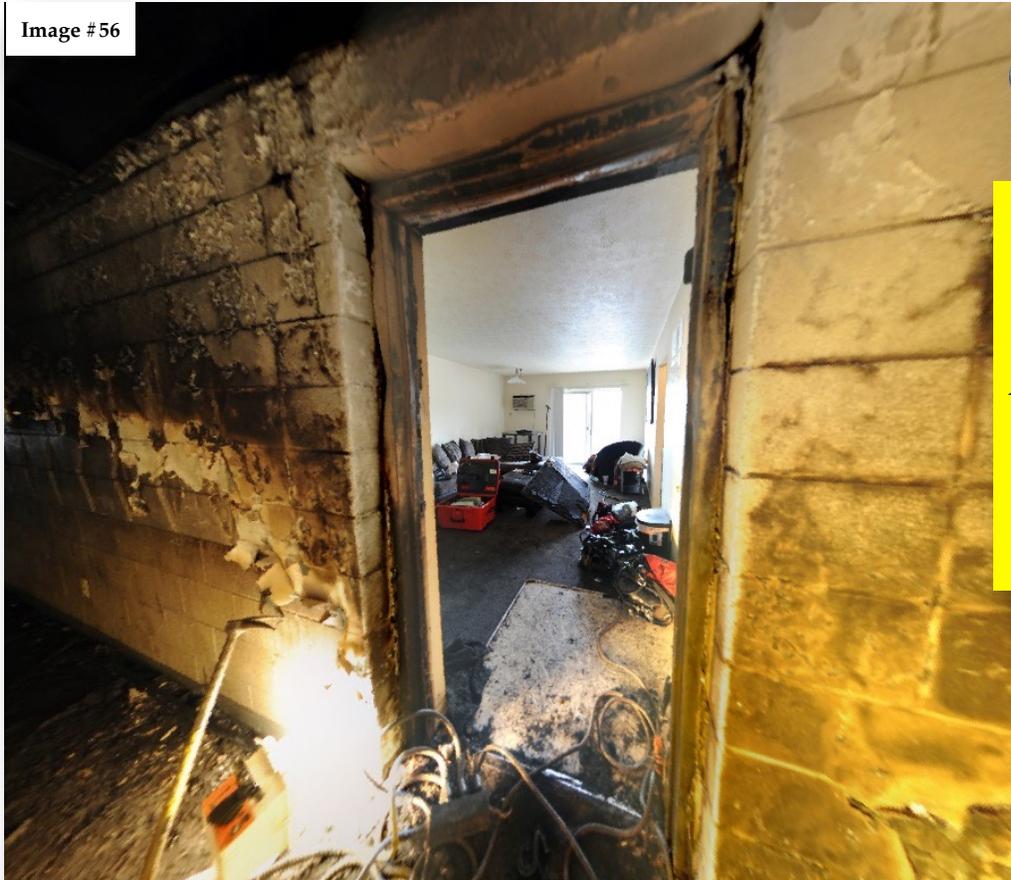
Image #56

**2nd Floor
Hallway
Looking Into
Apartment
Across The Hall
From Fire
Apartment
*Note: No Fire
Damage***

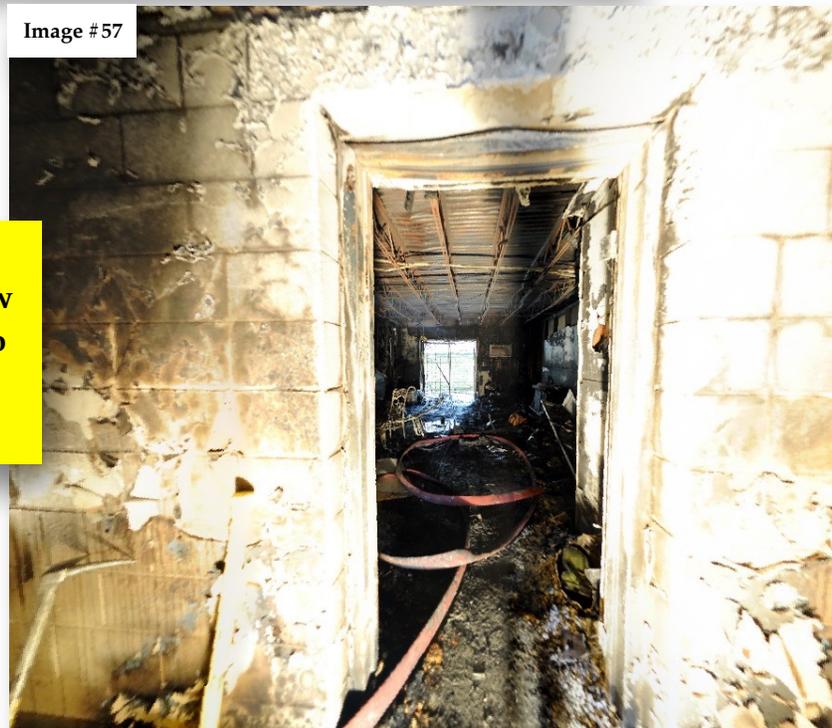
Image #57

**2nd Floor
Hallway View
Looking Into
The Fire
Apartment**

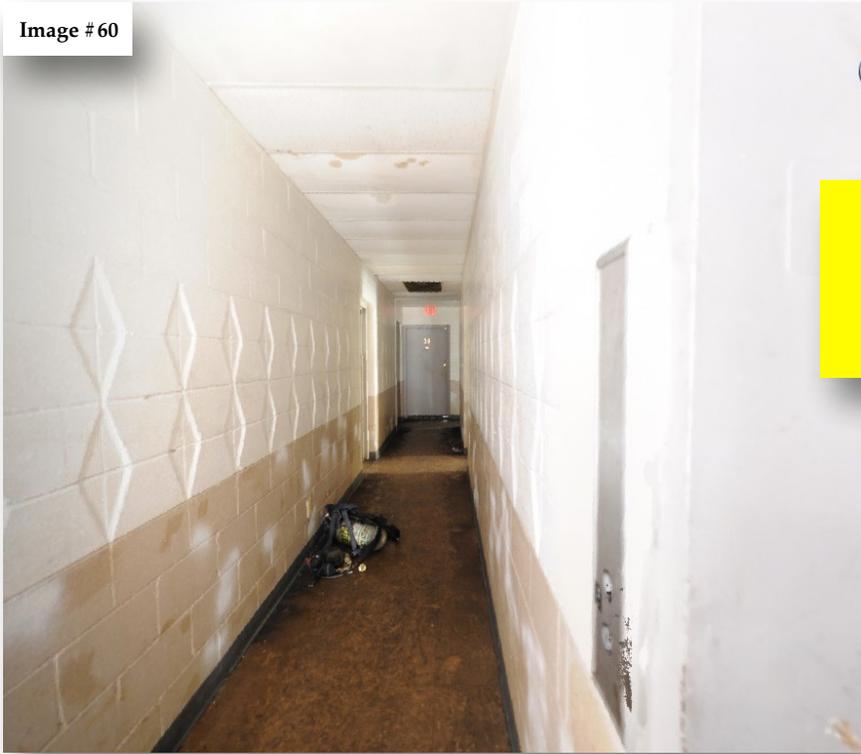
Image #60

**3rd Floor
Hallway
No Damage
from Smoke**

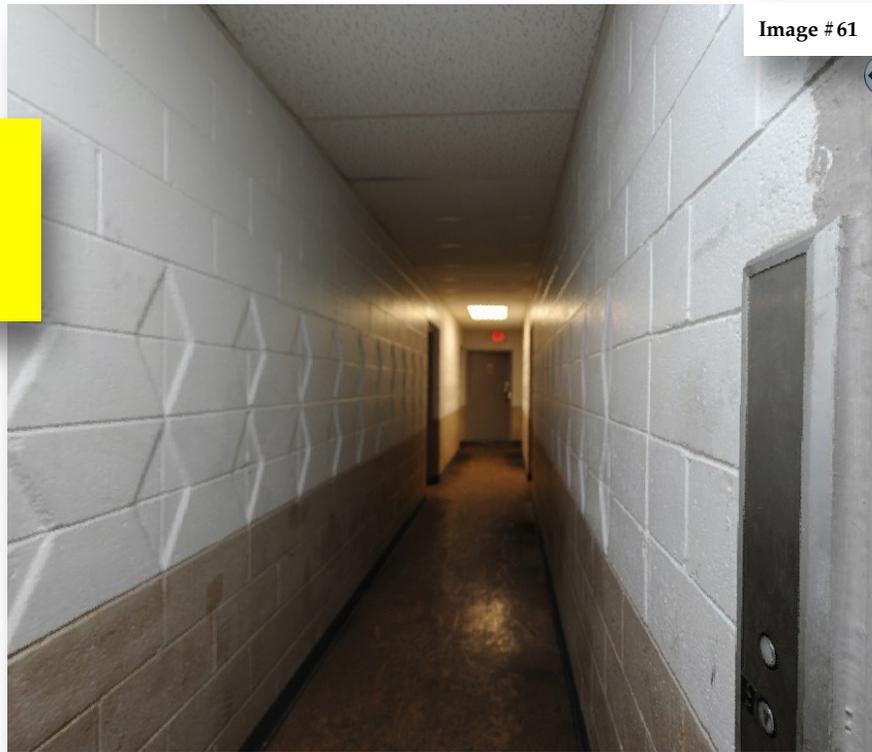
Image #61

**4th Floor
Hallway
No Damage
from Smoke**

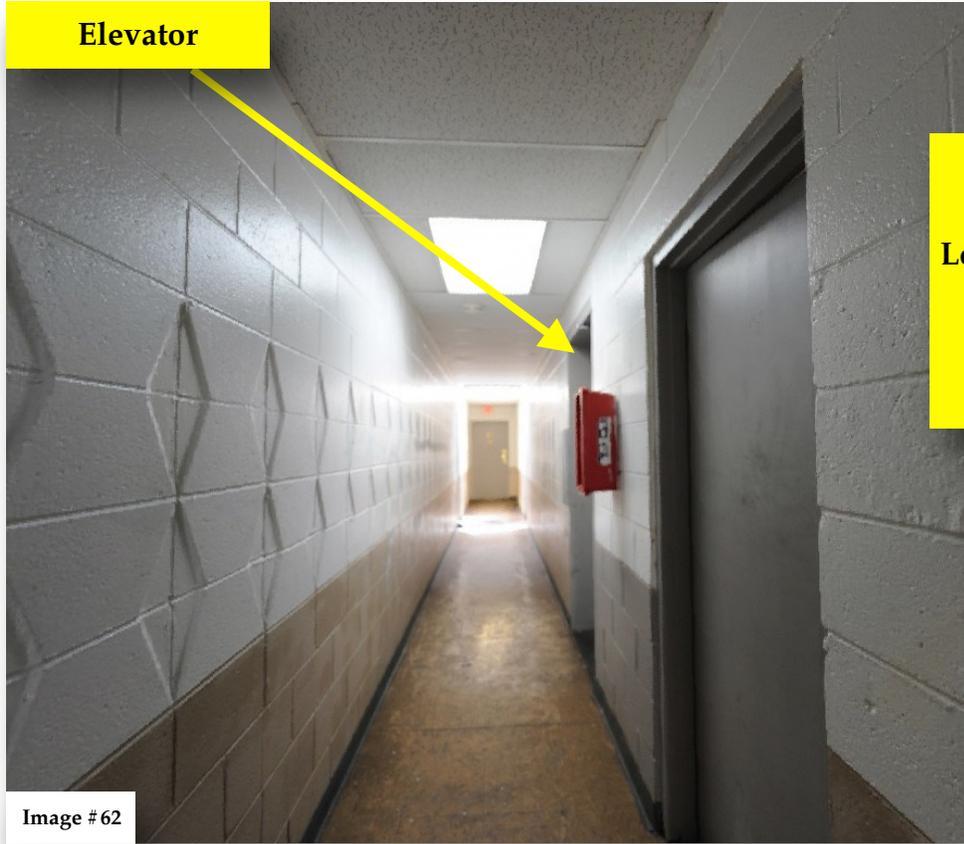
Image # 62

**5th Floor
Hallway
Looking Toward
"B" Side
No Damage
from Smoke**

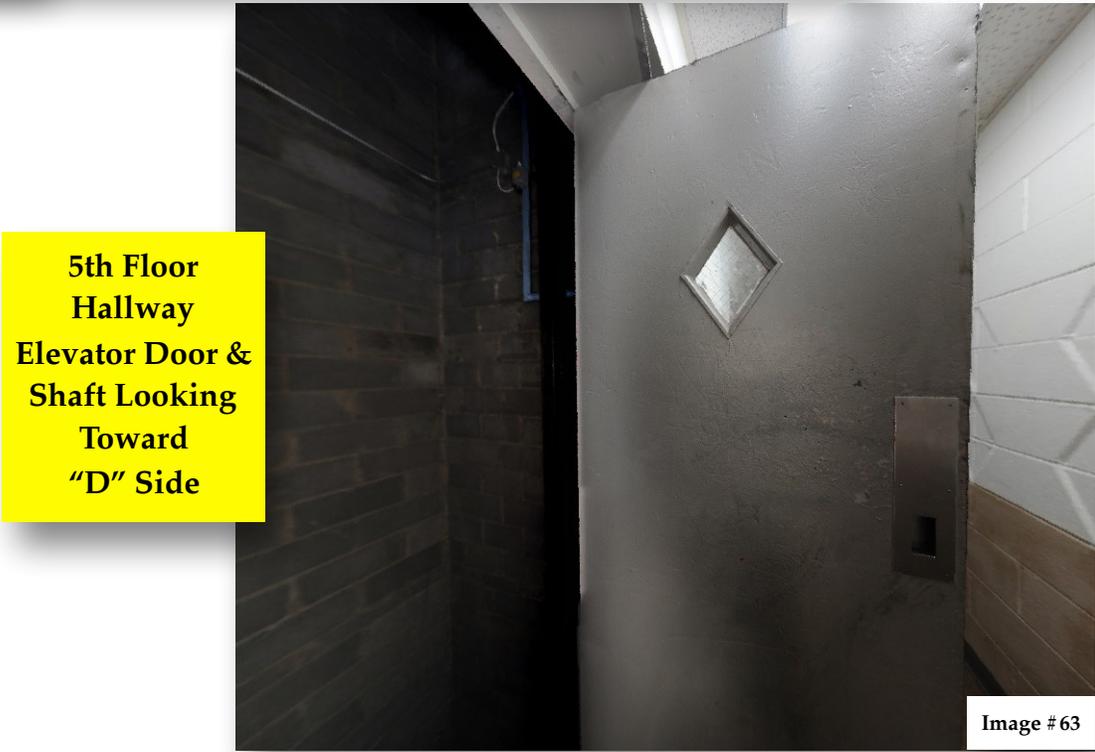
Image # 63

**5th Floor
Hallway
Elevator Door &
Shaft Looking
Toward
"D" Side**

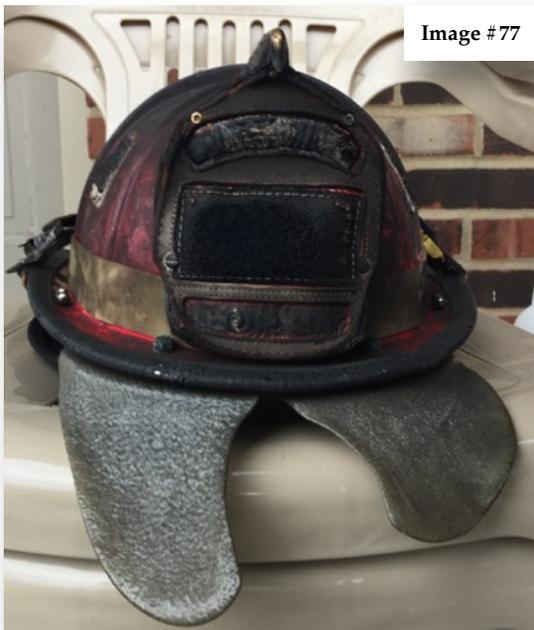
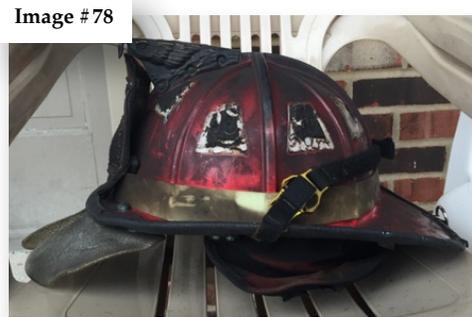
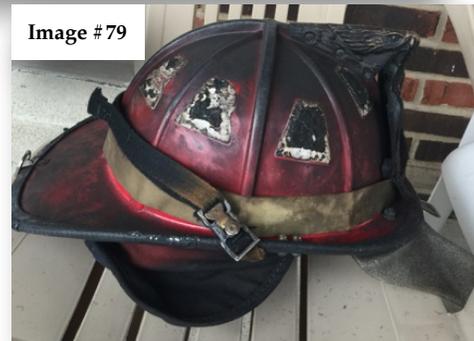
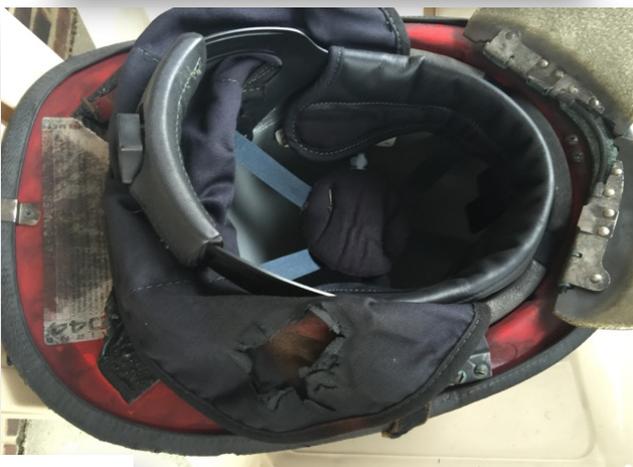
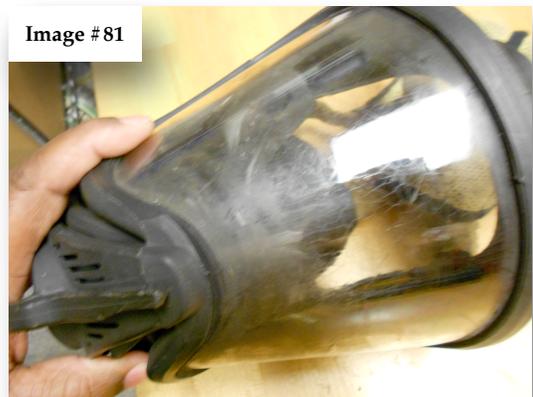
The attached photos show damage to the face piece and helmet of Truck 31 Officer who was initially in the hallway near the fire apartment. No other PPE (with the exception of FAO Gordon's) was inspected or damaged as a result of this fire. Other firefighters received minor burns, but their PPE was not a factor. PPE performed as designed at this incident, limiting injuries to firefighters exposed to high heat on the 2nd Floor hallway.

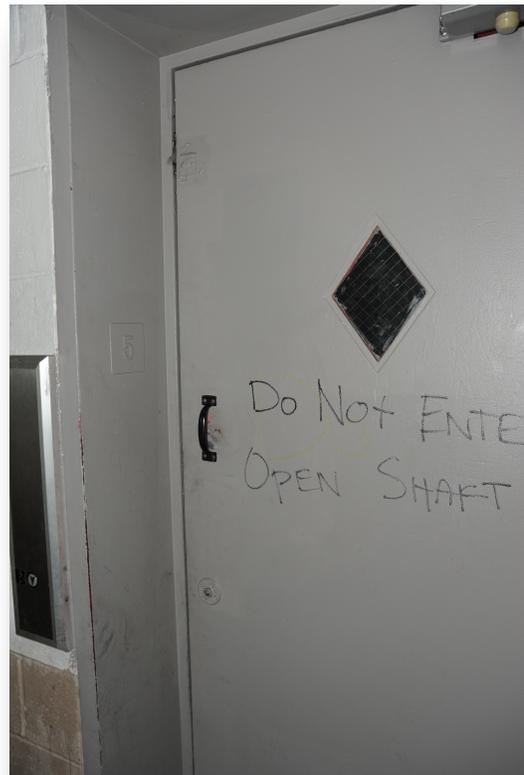
1. Rescue 14 FF #2 opened an outward-swinging door with a diamond-shaped window and “D” handle on the 5th floor. Rescue 14 FF #2 realized this door was different than the other doors, so he sounded the floor ahead with his tool after opening the door, finding NO floor. The door led to an open elevator shaft; the interlocking mechanism was not working correctly. The fire fighter notified his Acting Officer face-to-face and, collectively, they notified District 3 (Search & Rescue Branch) face-to-face. Members were concerned about the danger of the open shaft and marked on the door “DO NOT ENTER OPEN SHAFT.” There was never an “Emergency” radio transmission to Command about the hazard (or any radio transmission). (see image to right)

- a. Command should have been notified of the dangerous condition, and “Emergency” traffic should have been broadcast notifying all personnel on the scene of the hazardous condition.

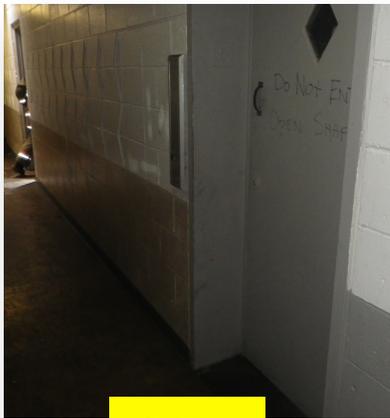
5th Floor
Elevator

3. At this incident, the smoke conditions were reported to be moderate on Floor 5, with visibility of a few feet. Firefighters from Heavy Rescue 14, Engine 8 and Truck 32 were on air as they operated on the 5th floor. It may have been difficult to read the warning marked on the elevator door. When dangerous conditions are found in a limited visibility environment, it is imperative to communicate these hazards to the Incident Commander, post a guard if conditions allow, attempt to render the hazard safe, and await further orders from the Incident Commander.

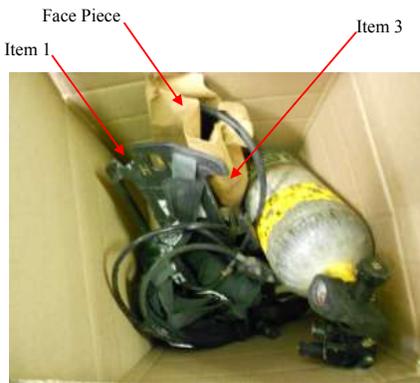
Figure 1

9. Retaining ring from the retaining strap connection was found resting in the bottom of the box (Secured in evidence bag).
10. Control Module Inspection
11. On inspection the control module appears to have no power (installed (4) new batteries for the purpose of retrieving data).
12. There is an abrasion to the Telemetry/Battery Pack Cap.
13. After installing new batteries MSU made multiple attempts to retrieve any and all data contained within the Control Module to no avail, with that result the new batteries were remove from the Telemetry/Battery Pack (the original batteries remained in the sealed evidence bag). There is a visible twist in the Control Module cable which appears to be un-characteristic in comparison with other SCBA's which may indicate a possible fault or failure

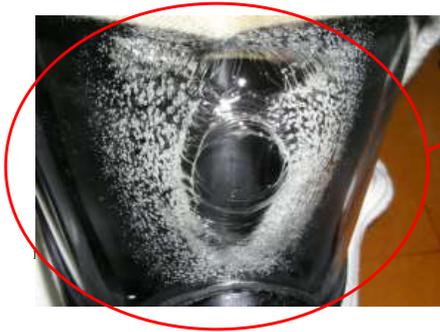
Typical fire-fighter breathing apparatus damaged in NIST tests shows facepiece warping under high heats.
Credit: NIST
