# 2019 RETAINING WALL AND LANDSLIDE REPORT

Department of Transportation and Engineering  
Division of Engineering  
Structures and Geotechnical Section

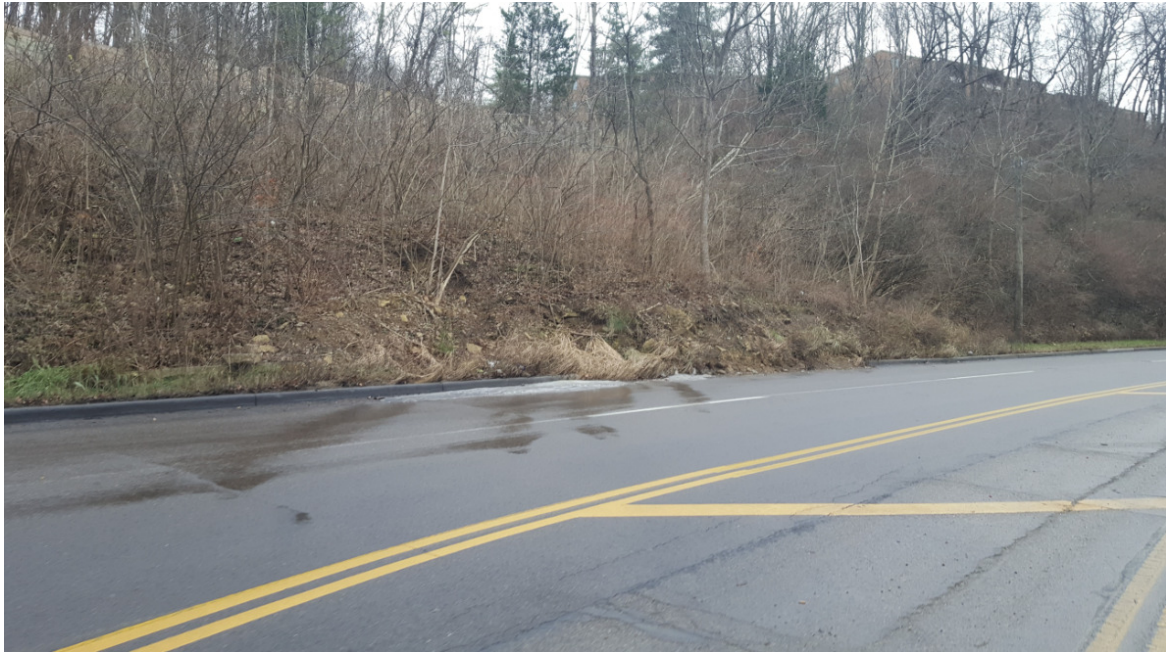
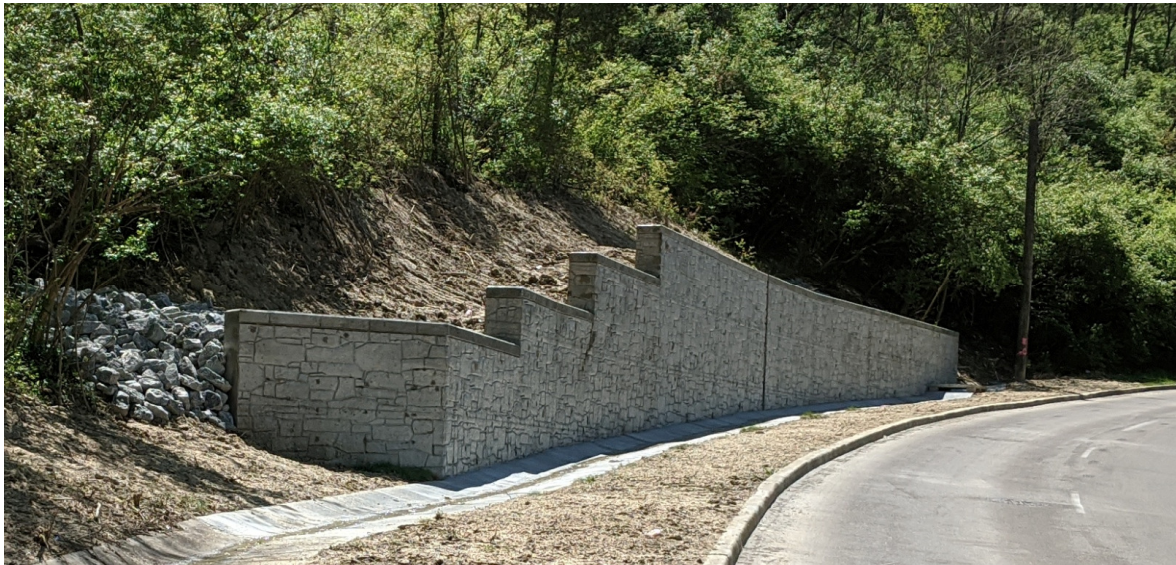
The toe of a landslide occurring in and below the private driveway accessing the Eagle Watch Apartments slid into the roadway along Sunset Avenue and caused drainage issues in the area. A "soldier pile" wall was constructed, then faced with a permanent concrete facing. The wall was completed in April 2020 using Wall Stabilization and Landslide funds.

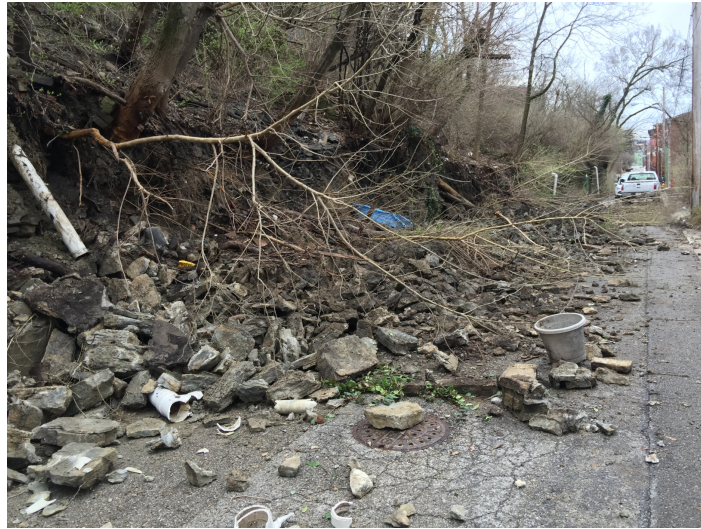
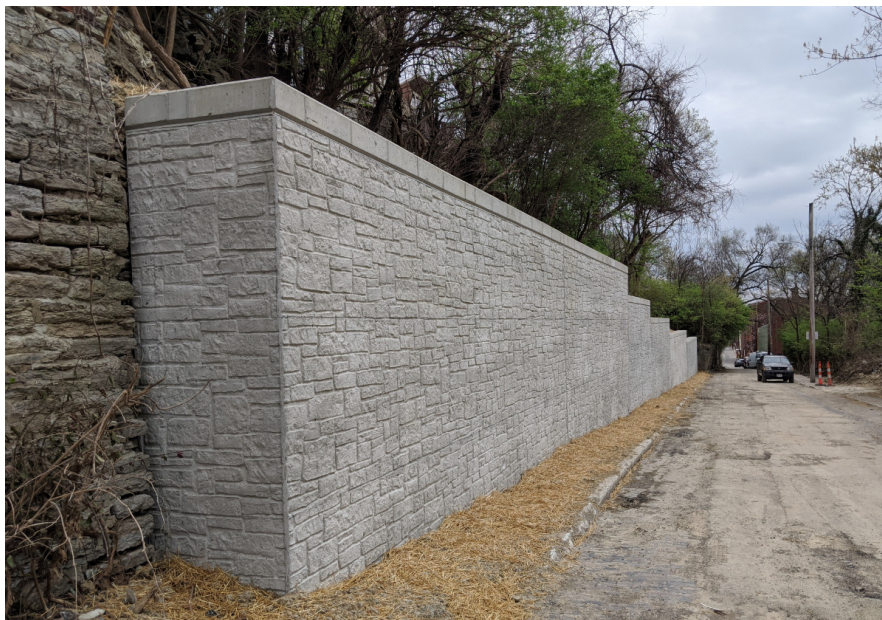
**Peete Street Retaining Wall Reconstruction** - Project contract price – \$280,148

A series of privately-owned mortared limestone retaining walls along Peete Street failed or were failing, resulting Dept. of Buildings and Inspections to issue orders to the Property Owners. At the request of the Homeowners, City Council passed a motion requesting that the City Administration begin the process of designing and constructing a public retaining wall to maintain the right-of-way and assess the Homeowners the project cost. Project funding was established by Ordinance No. 109-2019. This project was bid multiple times due to various circumstances and an acceptable bid was finally executed in November 2019. The wall was completed in April 2020.

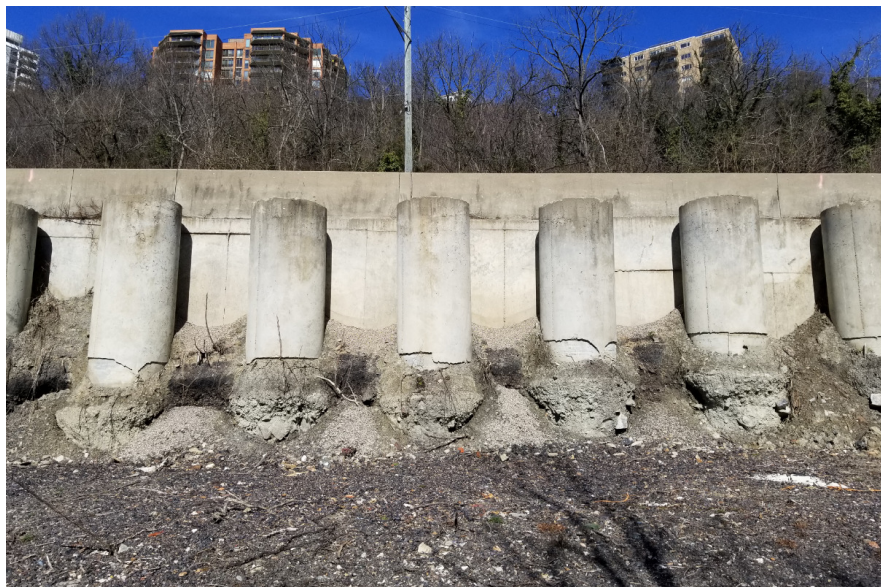
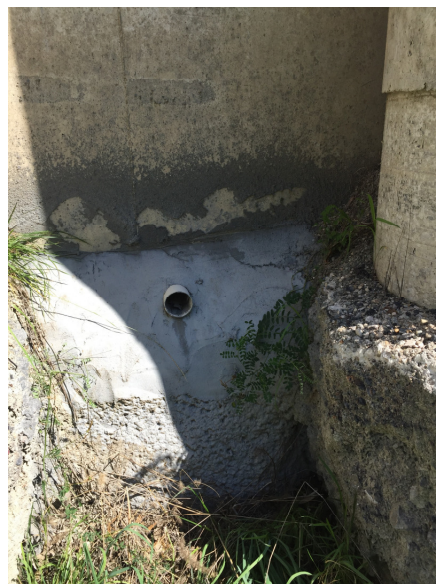
**Columbia Parkway Pier Wall Remediation** - Project cost – \$497,055

The Riverside Drive Landslide (2016-2018) resulted in exposure of soils between the piers along the south side of Columbia Parkway. Concrete lagging between the piers extended to eight feet below the top of the piers, but the ground in front of the wall dropped below the panels which would have caused the loss of ground between the piers. DOTE designed a system of soil nails and shotcrete panels that were constructed below the existing lagging panels to remediate the damage cause by landslide. This work was completed in September 2019. The project was funded by a combination of State of Ohio Capital Improvement Program (SCIP) funding, Municipal Road Funds from Hamilton County and DOTE Wall Stabilization and Landslide funds.

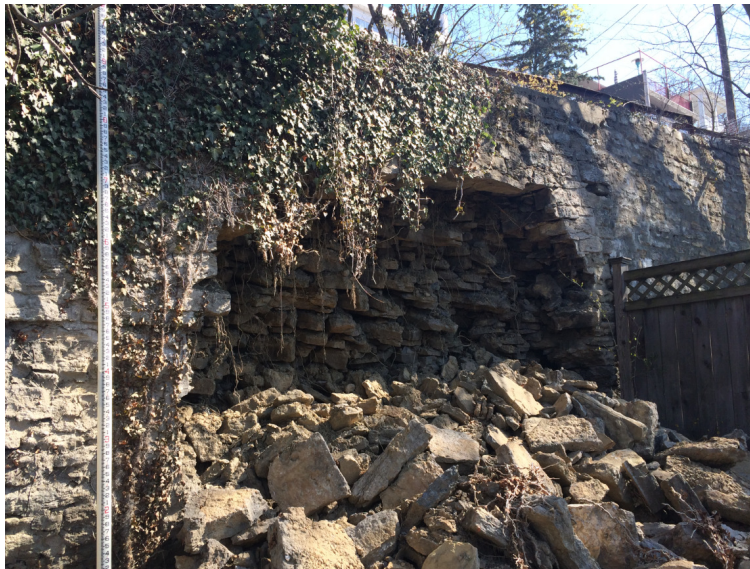
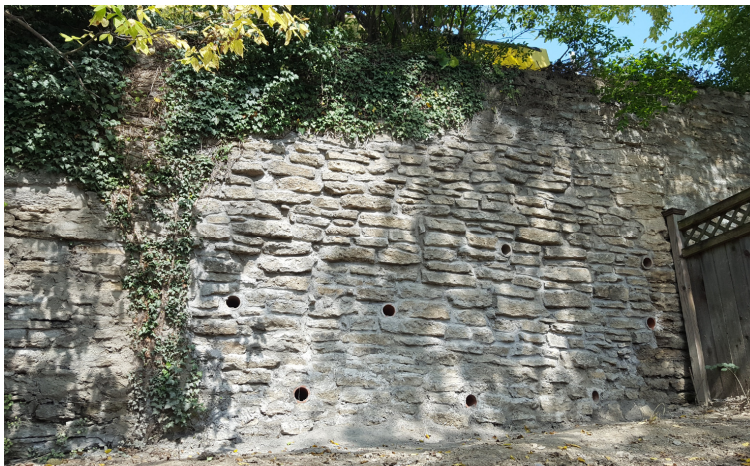
**Boal Street Retaining Wall Reconstruction** - Project cost – \$23,750

A City-owned stone retaining wall on the south side of Boal Street collapsed behind the property at 440 Milton Street. DOTE coordinated and contracted for the repair of the masonry wall and the filling of a void created along the curb. This work was completed in October 2018. This project is an excellent example of the varying scope of retaining wall projects, but of the necessity of repair.

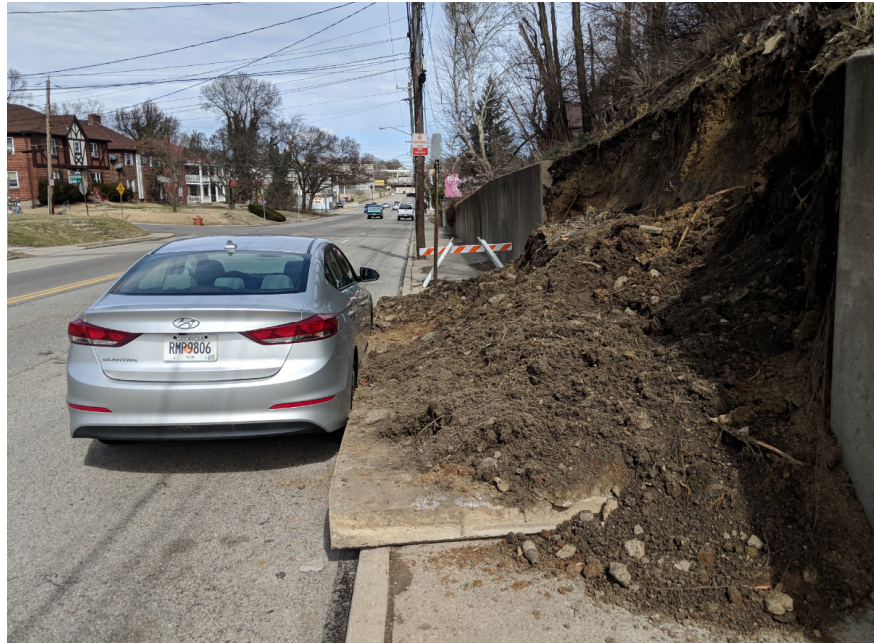
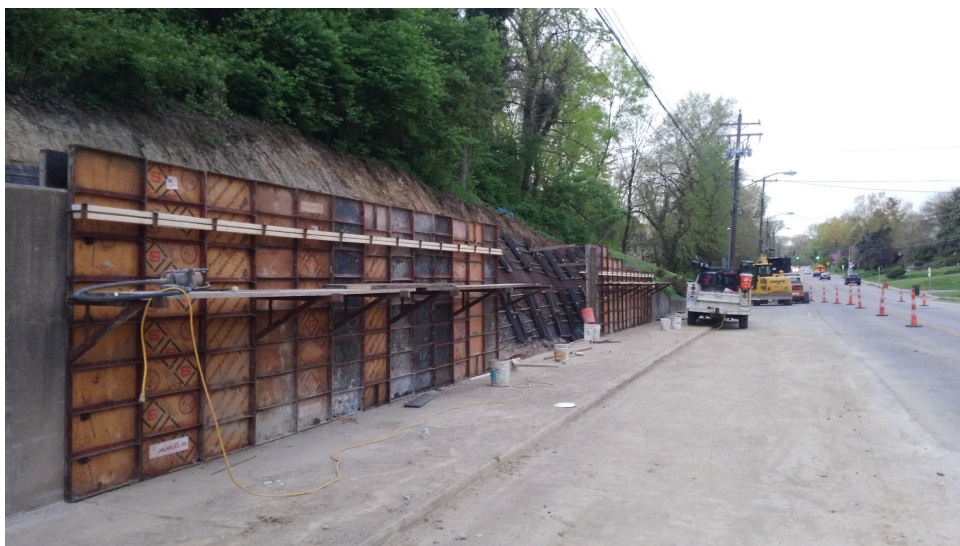
**Paddock Road Wall Repair** - Project cost – \$145,000

The wall stem of a 25-foot long section of a concrete retaining wall built in 1949 collapsed in March 2019, nearly damaging a parked car. The collapse was due to the corrosion of the steel which connects the stem of the wall to the footing. This is a common failure for walls of constructed in this time period. DOTE coordinated and contracted for the emergency replacement of the failed section and additional 25-foot sections on each side of the failed. This work was completed in April 2019.

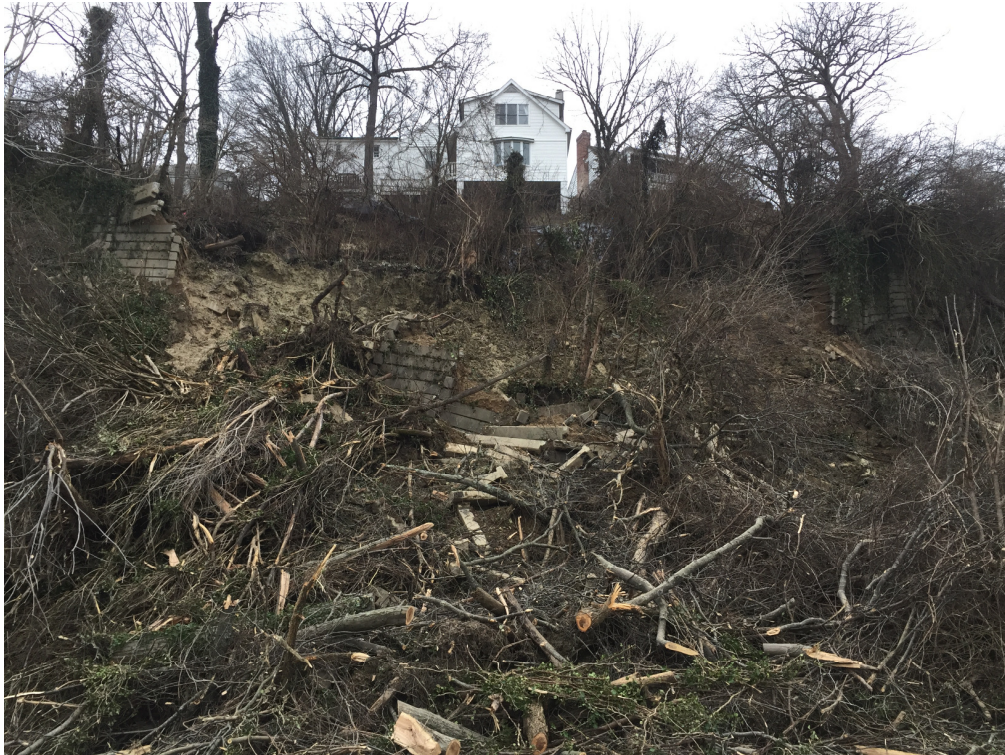
**Ham 50.29 Retaining Wall No. 4 (Columbia Parkway East of Beechmont Avenue Below (Richwood Avenue) - Project cost – \$929,653**

Rainfall in February caused a landslide to develop in the rear yard of 1002 Richwood Circle located on the hillside above Columbia Parkway east of Beechmont Avenue (SR 125). This landslide was located above a retaining wall constructed for the extension of the Parkway by the Ohio Department of Transportation (ODOT) in 1962. Sliding below the wall also occurred. The sliding above and below the retaining wall caused a hundred-foot section of the retaining wall to fail. Immediate action was taken due to the potential for additional wall failure and further slope movement, which could affect Columbia Parkway and residential properties located above the slope on Richwood Circle.

- Installation of soil nails and reinforced shotcrete to stabilize the upper slope face
- Installation of horizontal underdrains
- Stabilization of the existing retaining wall on both sides of the failed section
- Installation of soil nails and steel mesh to stabilize the lower slope.

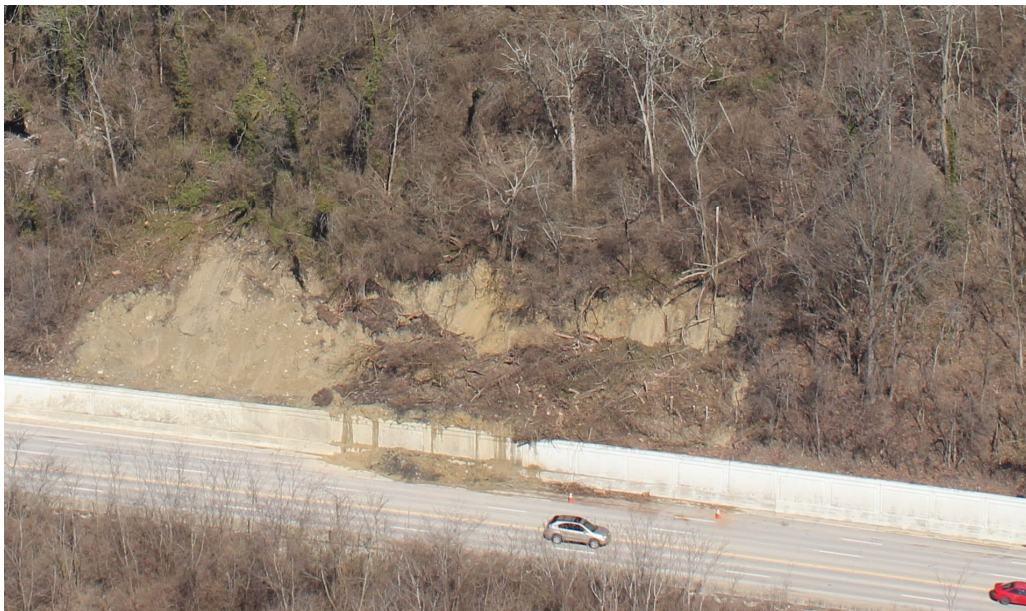
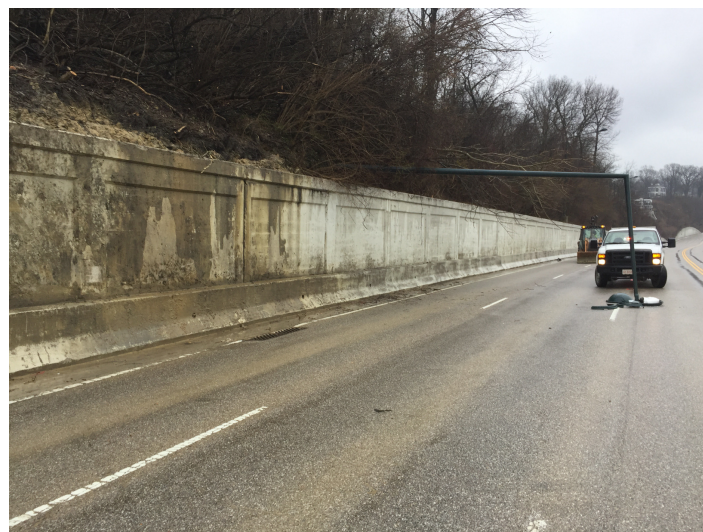
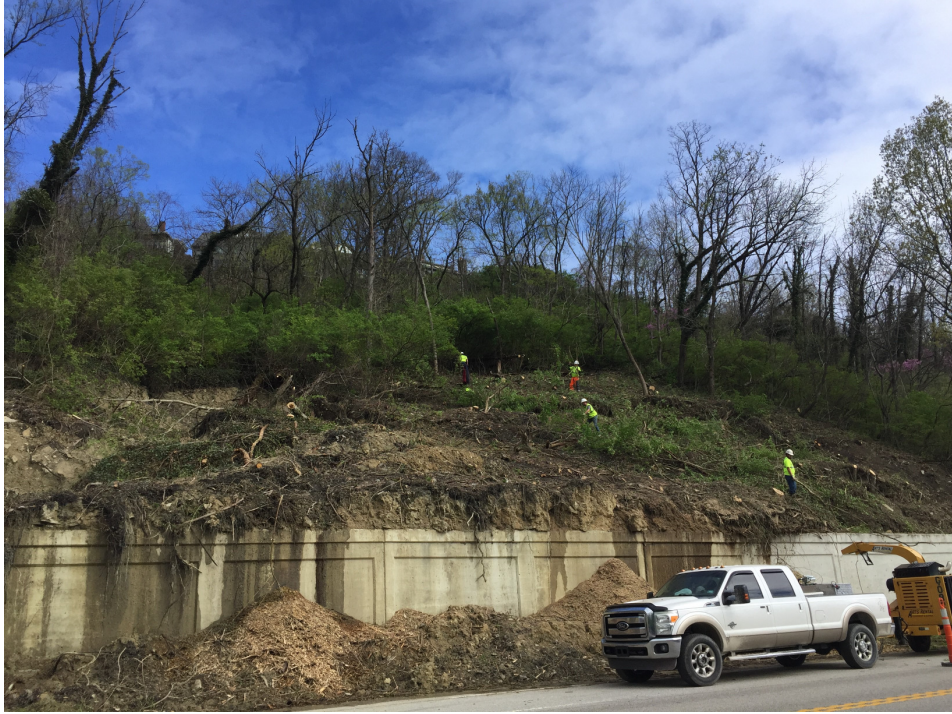
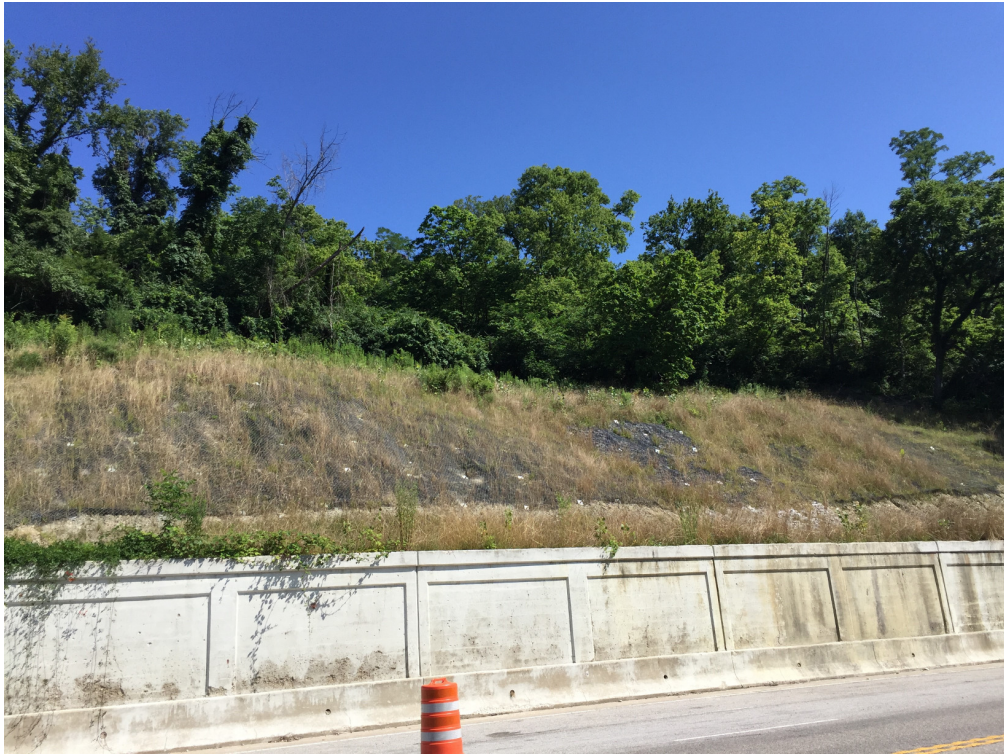
**2100 Columbia Parkway** - Project cost – \$715,308

The 2100 Columbia Parkway Landslide Project mitigated a landslide that occurred between Kemper Lane and Torrence Parkway on March 25, 2019. Landslide activity cracked a light pole in half which then fell across three lanes of the roadway. The project was an emergency repair of the landslide identified as Area 9 DOTE's Columbia Parkway Landslide Evaluation and Report dated March 27, 2019. The mitigation of this area required immediate action through emergency procurement. Three contractors submitted proposals for the emergency repair. The selected method of stabilization for the site consisted of soil nails and a turf reinforcing mat placed under the steel mesh.

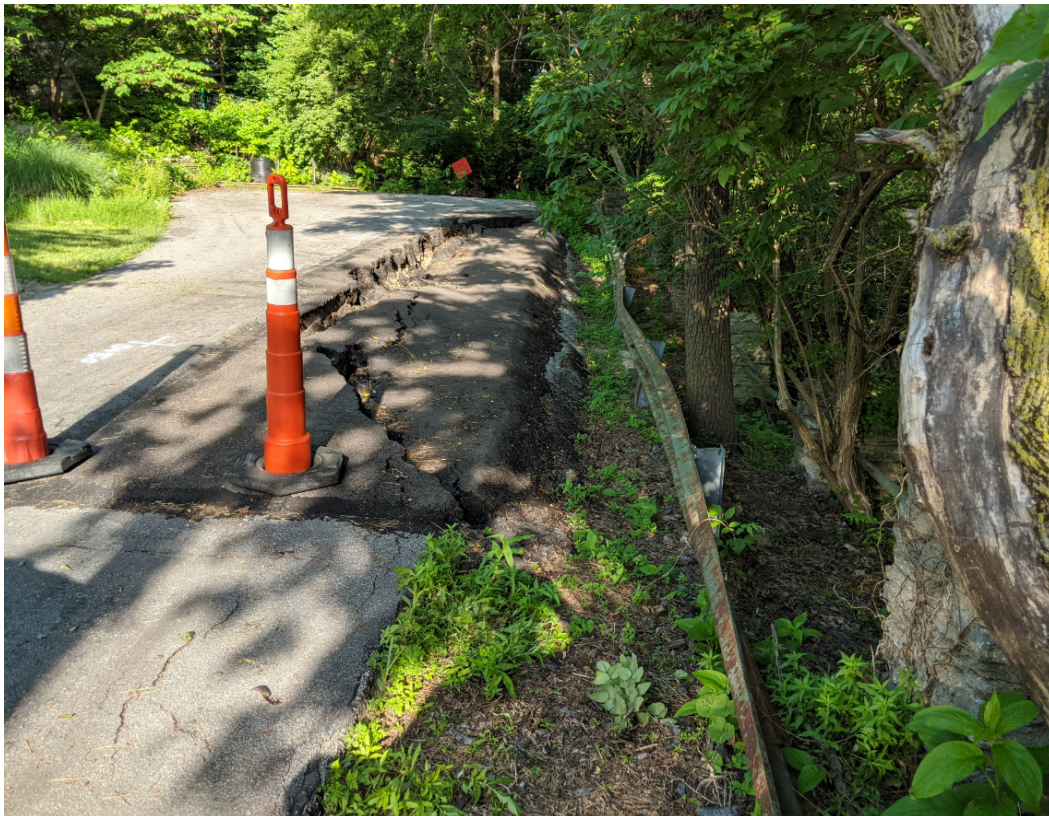
A landslide has been causing a significant set-down (scarp) in the pavement at the west terminus of Old McMillan Street. DOTE has been maintaining the pavement via various patches over the years, but the movement has accelerated to the point that patching is no longer a viable solution. DOTE is designing a “soldier-pile” retaining wall with concrete lagging between steel beams to be constructed along the north side of the roadway. The project is anticipated to be bid in the summer of 2020.

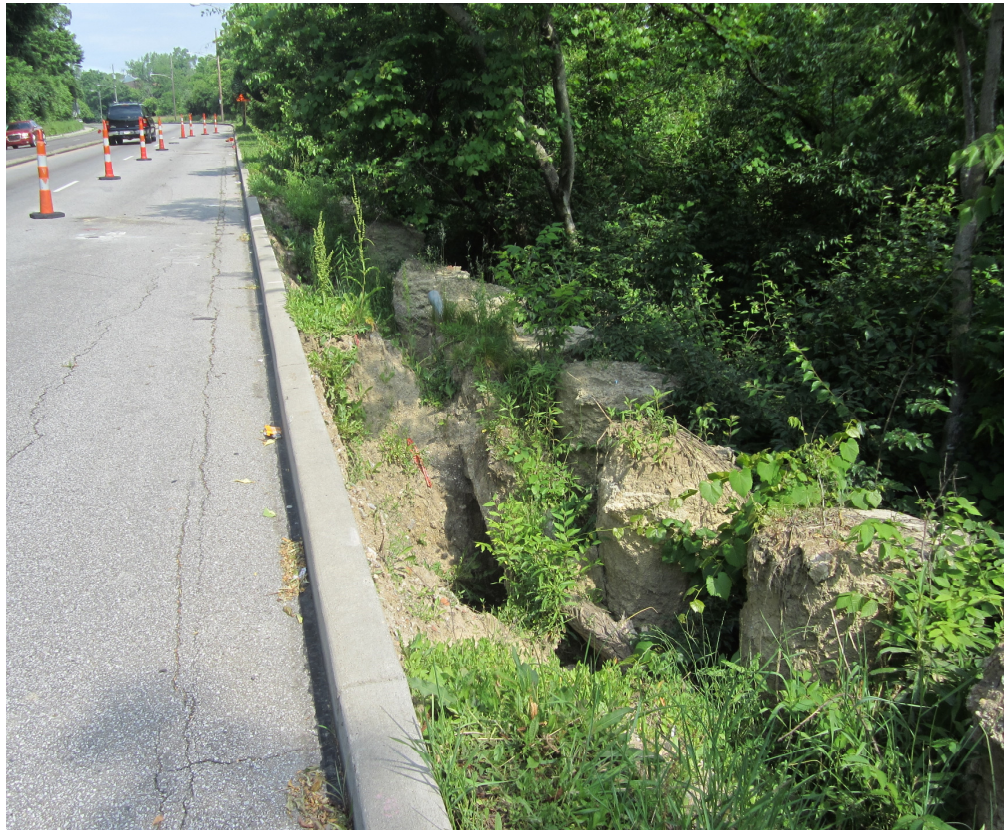
**Westwood Northern Boulevard** – Project cost – \$365,060

A large active landslide exists on the north side of Westwood Northern Boulevard (WNB) between Beekman and Sutter Avenues. The landslide caused the hillside to drop ten to fifteen feet below the height of the road over a length of 325 feet. An existing privately constructed pier retaining wall is ineffective in supporting the roadway. The loss of soil between the piers of the existing wall has impacted the pavement and continued erosion and movement of the hillside will result in the loss of pavement, use of the roadway and damage to public and private utilities.

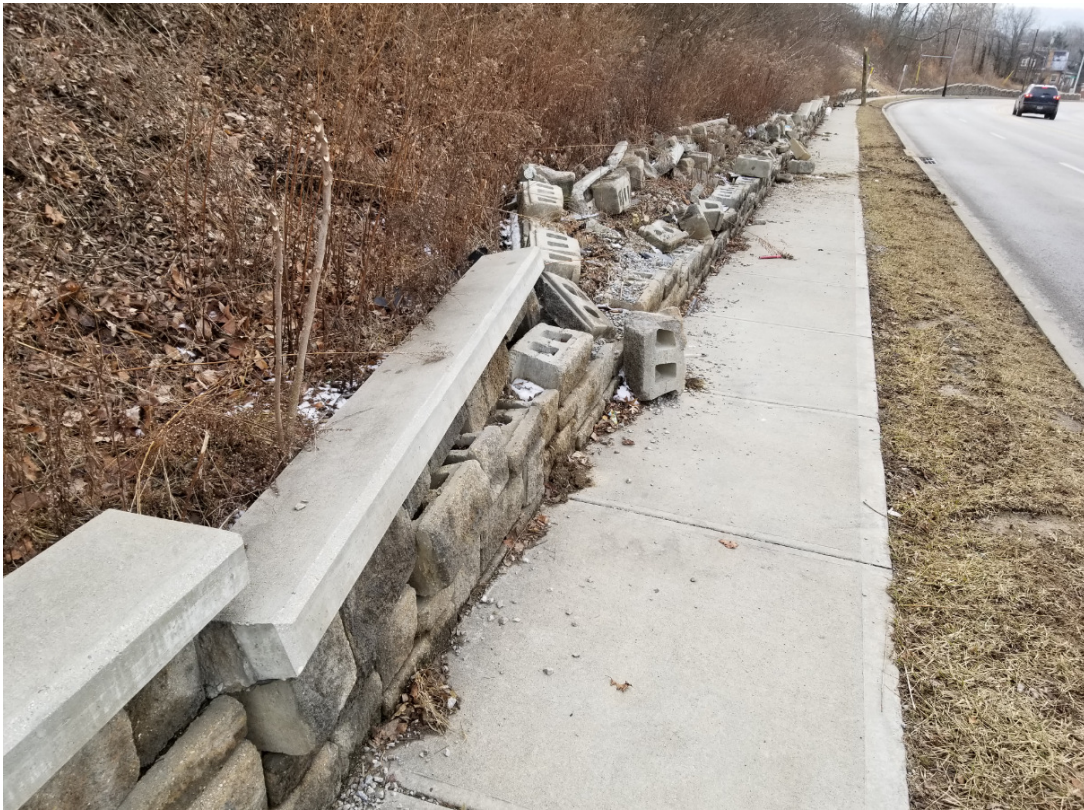
**Hamilton Avenue Segmental Wall Repair** - Anticipated project cost –\$50,000 - \$75,000

A segmental retaining wall constructed in 2009 as part of a roadway improvement project has been repeatedly struck in vehicle crashes. DOTE received State of Ohio funding for safety upgrades to the roadway, but the matching costs associated with the bids received for the proposed wall repairs and improvements were beyond available funding. The roadway safety improvements have been completed and DOTE plans to reconstruct the wall, possibly removing the most damaged portions of the wall where grades behind the sidewalk allow.

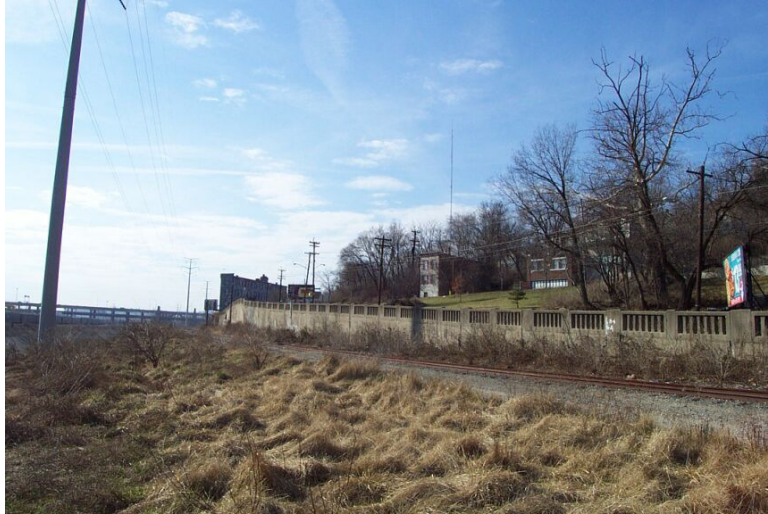
The existing wall is in fair condition, the coping which is attached to the wall and the concrete railing which is attached to the coping is in a failed to critical condition. Sections of the railing have deteriorated, exposing reinforcing steel. Sections of the railing which appear visually sound crumble within a grasp of the hand. Guardrail sections have been bolted to the pilasters throughout the years to temporarily repair the railing.

Southern portion of Cummins Street retaining wall from below.

The project requires removal of disintegrated concrete down to sound concrete and replacement of concrete removed. Soundings revealed approximately 2,000 square feet of unsound concrete. Joints between the panels need to be reconstructed and the entire wall will need to be sealed. The repairs to the retaining wall are essential in order to avoid complete replacement of the retaining structure. The existing concrete railing and coping needs to be replaced with a Texas Style railing by doweling into the existing retaining wall. The installation of the new concrete railing will require the removal and replacement of the curb.

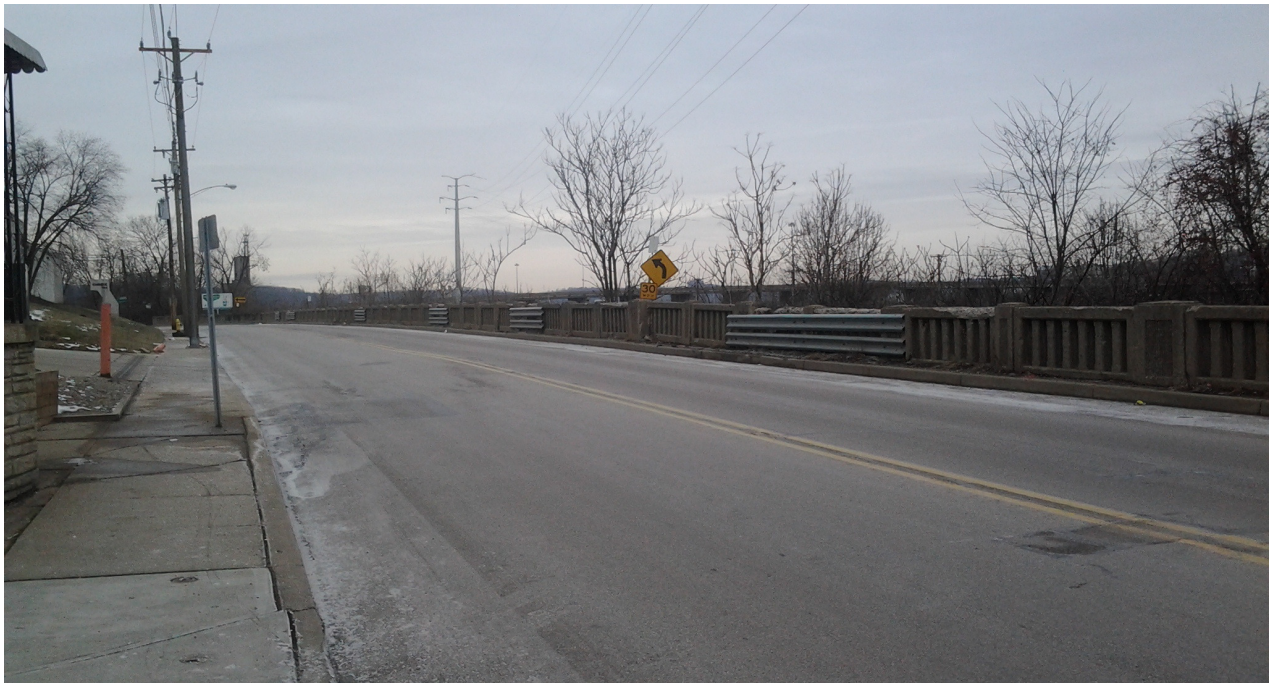
Sections of concrete railing replaced with guardrail sections bolted to pilasters on Cummins Street.

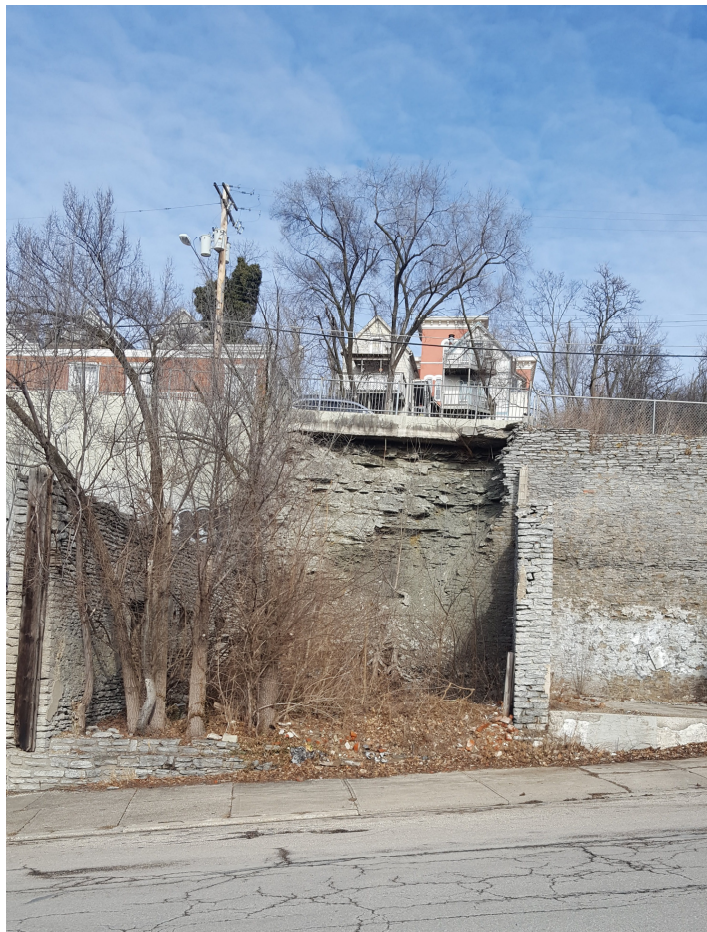
**Dorchester Avenue Wall Repair** (Mt. Auburn) – Estimated construction cost – \$100,000 - \$150,000

The sidewalk on Dorchester Avenue remains closed due to the collapsed wall. The collapsed wall served as the foundation wall of a private building on Sycamore and was a privately owned wall. DOTE has prepared plans to permanently repair the wall. The repair will be included in the Auburn Avenue Phase II Project scheduled for construction in 2021.

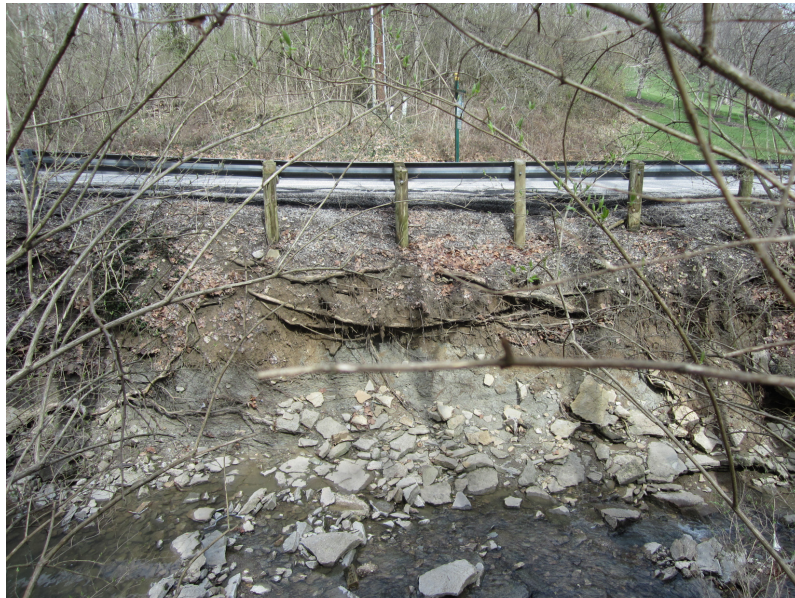
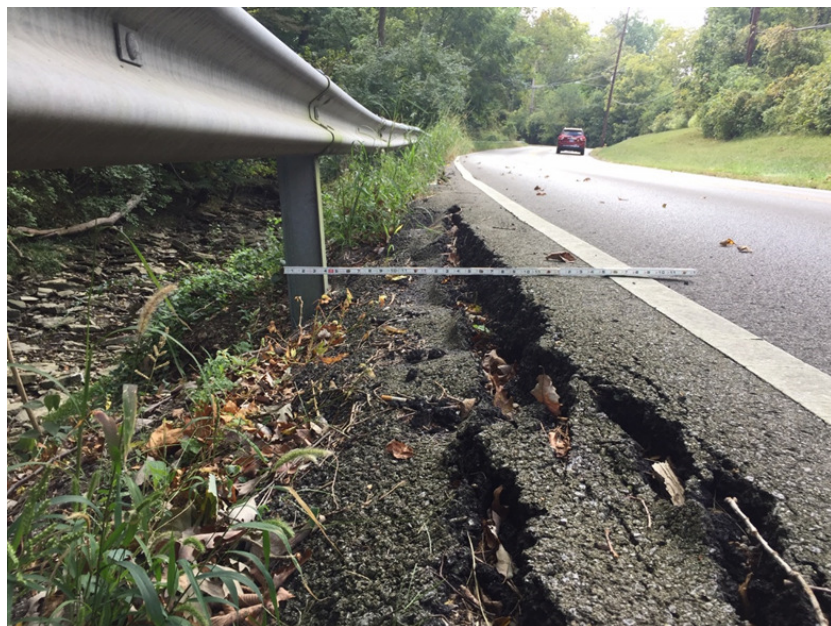
**Berkshire Road Stabilization Project** – Estimated construction cost – \$690,000

The existing creek bank which supports Berkshire Lane is being severely eroded. The erosion is causing settlement of the guardrail and is undermining the pavement resulting in the loss of pavement. Continued erosion will result in the continued loss of pavement into the travel lane. An OPWC application was submitted for permanent repair. The project did not make the list of projects for funding. The proposed repair is the construction of 420 feet long pier wall. TROD is scheduled to install temporary repairs measures to support the roadway until permanent repairs can be constructed.

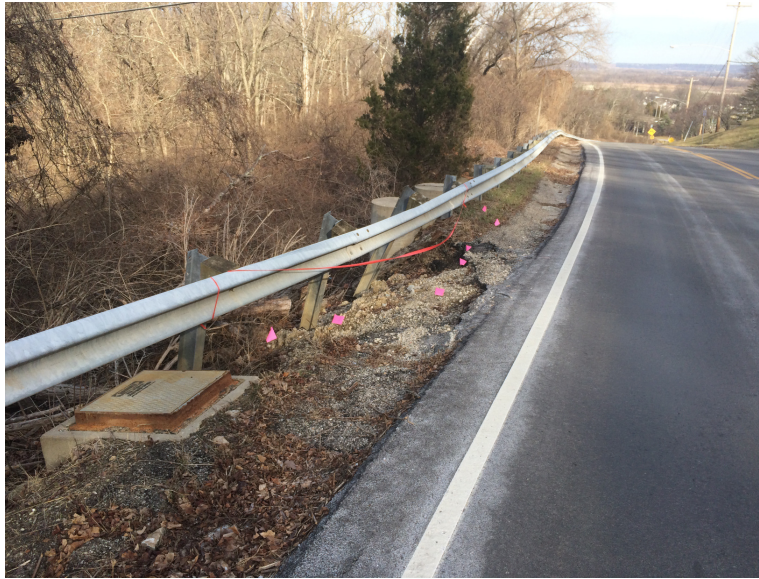
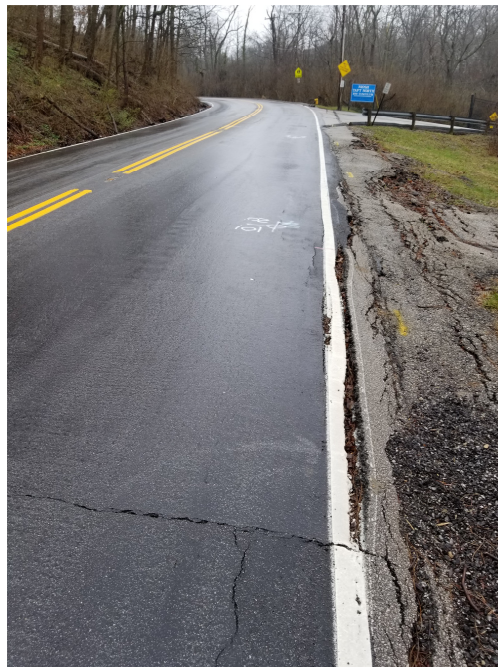
**Grandin Road Wall Extension** (Mt. Lookout) – Estimated construction cost – \$350,000 - \$400,000

A portion of Grandin Road between the driveways for the NIOSH facilities is being subjected to slope movement. The most significant movement has undermined guardrail and has damaged a paved drainage channel in the roadway shoulder. The movement begins at the west end of a pier wall that was constructed in 1995 and continues for 230 feet. DOTE is completing plans and intends to bid this work as funding allows.

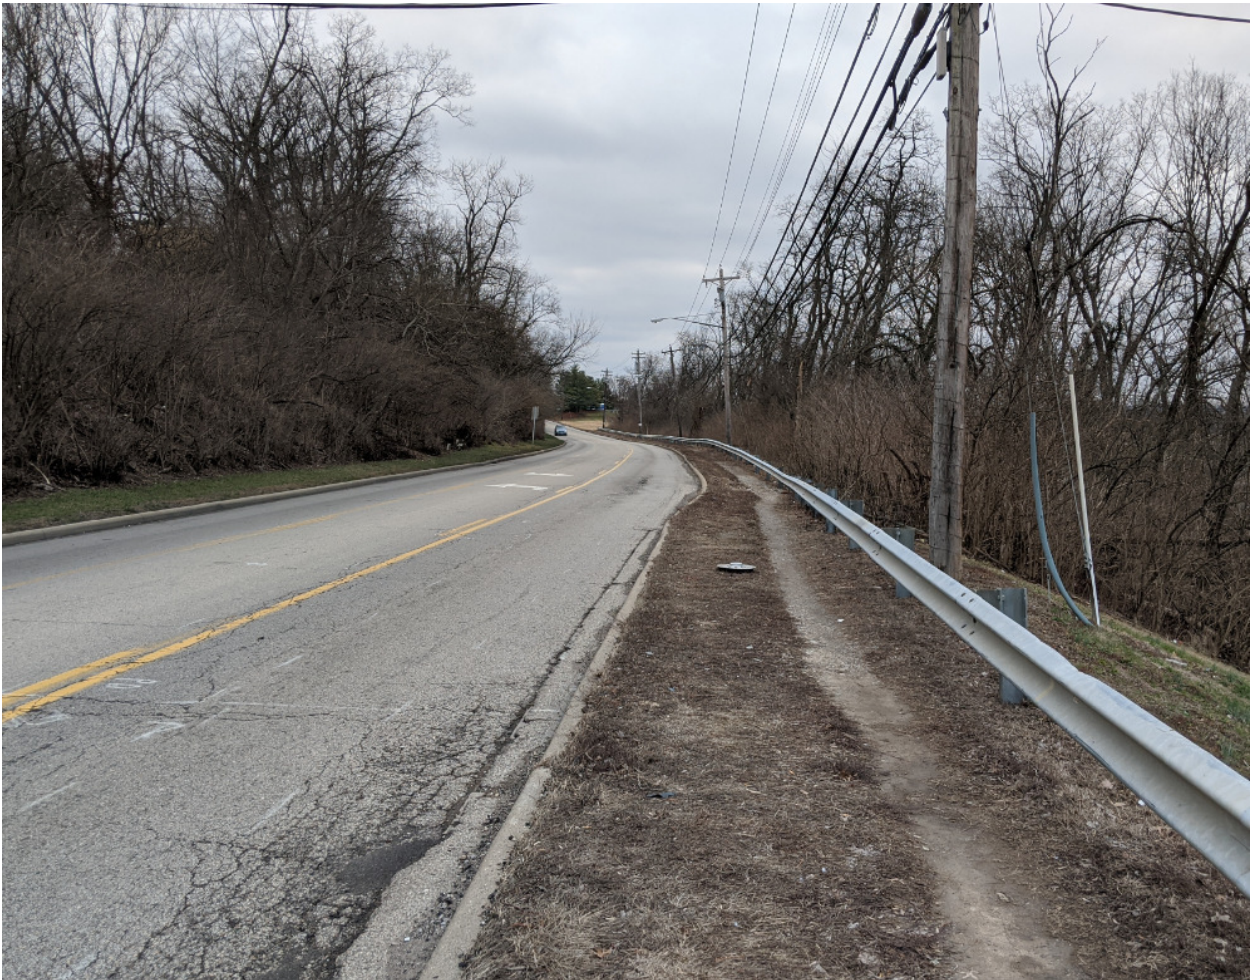
**West Galbraith Road (@ 341)** – Anticipated project cost –\$200,000

A landslide is occurring along the eastbound lane of West Galbraith Road, near 341. The slide has moved the curb and guardrail significantly and created a dip in the pavement. DOTE has applied (and was approved) for OPWC funding for a street improvement project that includes this stretch of roadway, however, the project funding has been placed on hold due to the COVID 19 crisis. The site has been investigated and plans are being produced to remediate the landslide when the street improvement project proceeds. The repair is anticipated to consist of earthwork benched into the underlying bedrock. In the meantime, DOTE will be monitoring the condition of the roadway and TROD will make spot repairs as needed.

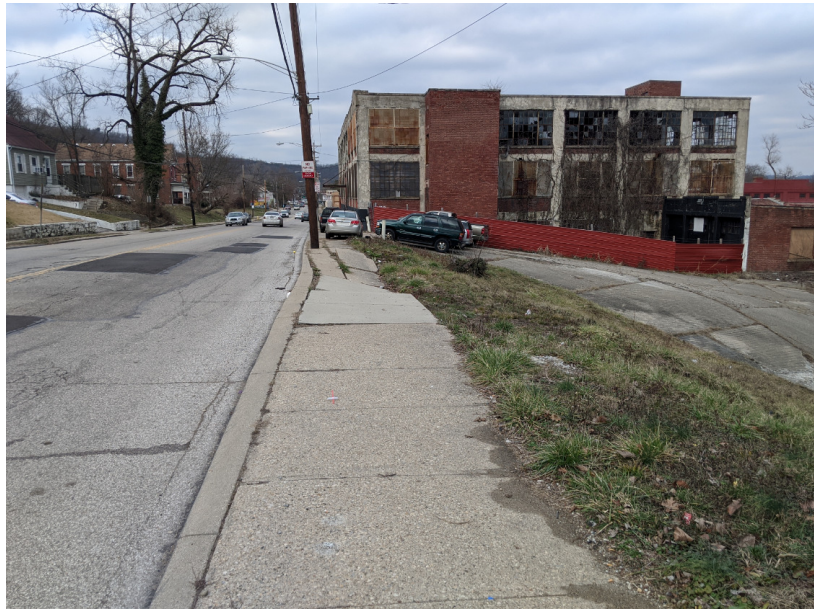
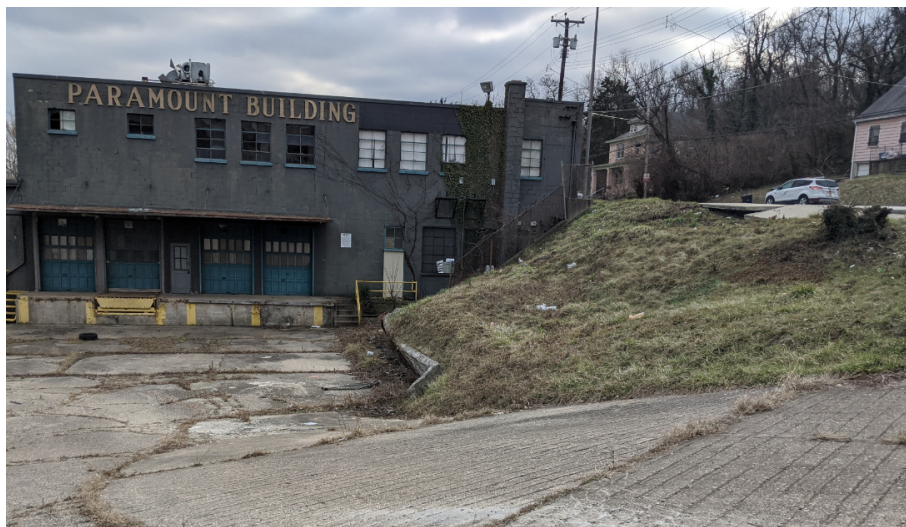
**Beekman Street (@ 3138)** - Anticipated project cost –\$300,000

A private retaining collapse on the property at 3138 Beekman Street has caused a landslide to occur along the roadway that has resulted in the destruction of the sidewalk along Beekman Street, curb and pavement distress which threatens the stability of water and sewers within the roadway. The property has been abandoned, such that there is no Owner to provide the wall or slope remediation. DOTE has initiated an investigation of the subsurface, including installation of an inclinometer to provide slope monitoring. The repair is anticipated to consist of a pier wall or earthwork embankment, coupled with replacement of the wall on the private property. DOTE will continue monitoring the condition of the roadway and begin preparing plans for remediation.

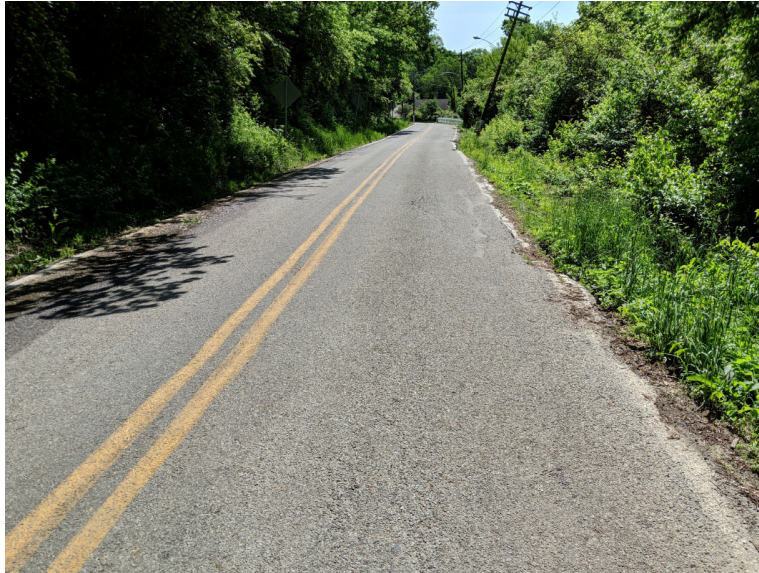
4355 Hillside Avenue

Hillside Avenue from the City limits, near Anderson Ferry Road to the east terminus at River Road has numerous areas of instability. Many areas have been repaired over the years, but areas between those sections continue to require pavement work to remain safe. DOTE monitors these areas and intends to remediate the worst areas as funding allows. A few of the most problematic areas are shown below.

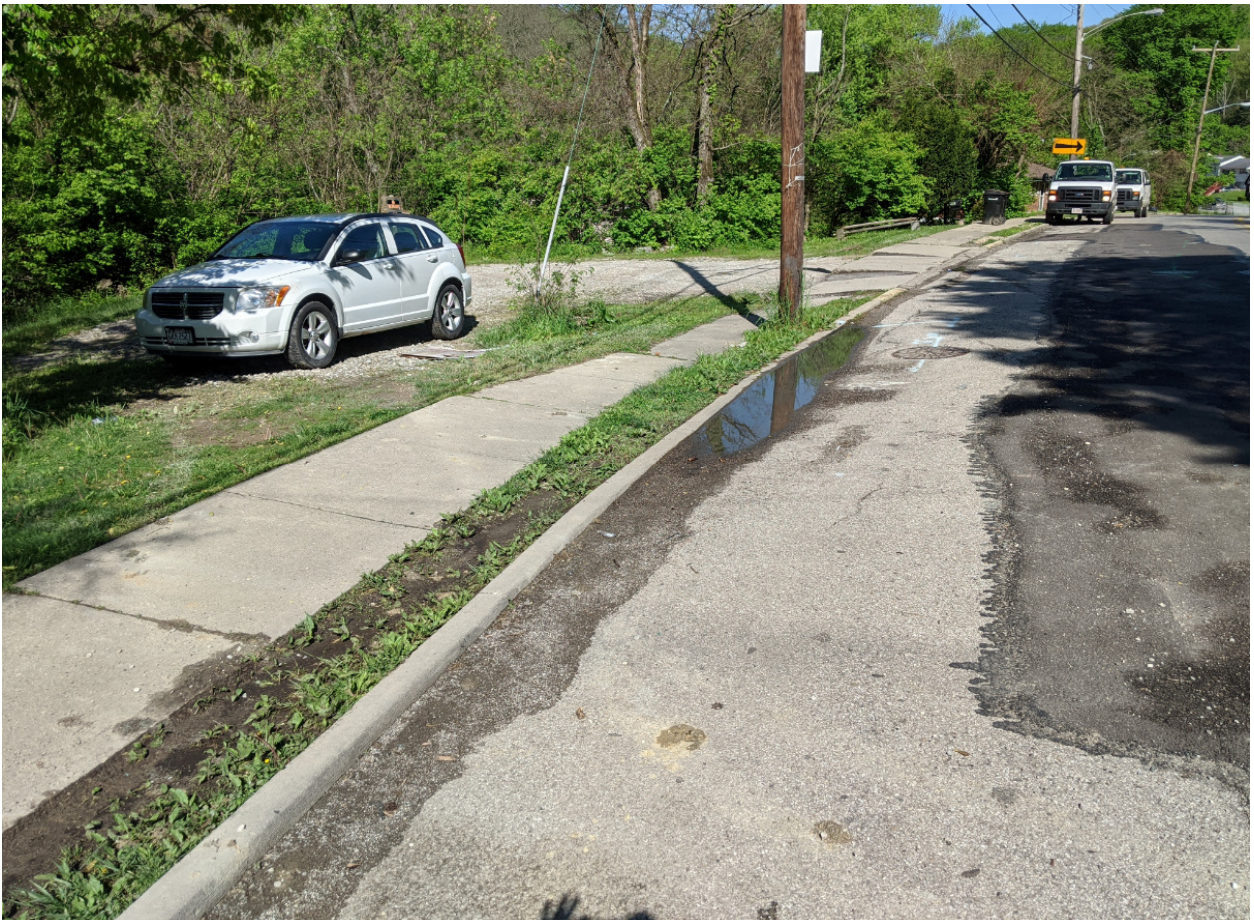
A slow-moving landslide has been causing Delhi Avenue and the south sidewalk to settle. The area also ponds water as a result of the movement. DOTE has applied for state funding of a safety enhancement for Delhi Avenue and intends to apply for Ohio Department of Public Works (OPWC) State Capital Improvement Program (SCIP) funding when the program is reinstated after the COVID 19 pandemic. DOTE has initiated an investigation of the subsurface, including installation of an inclinometer to provide slope monitoring. The repair is anticipated to consist of a pier wall. DOTE will continue monitoring the condition of the roadway and begin preparing plans for remediation.

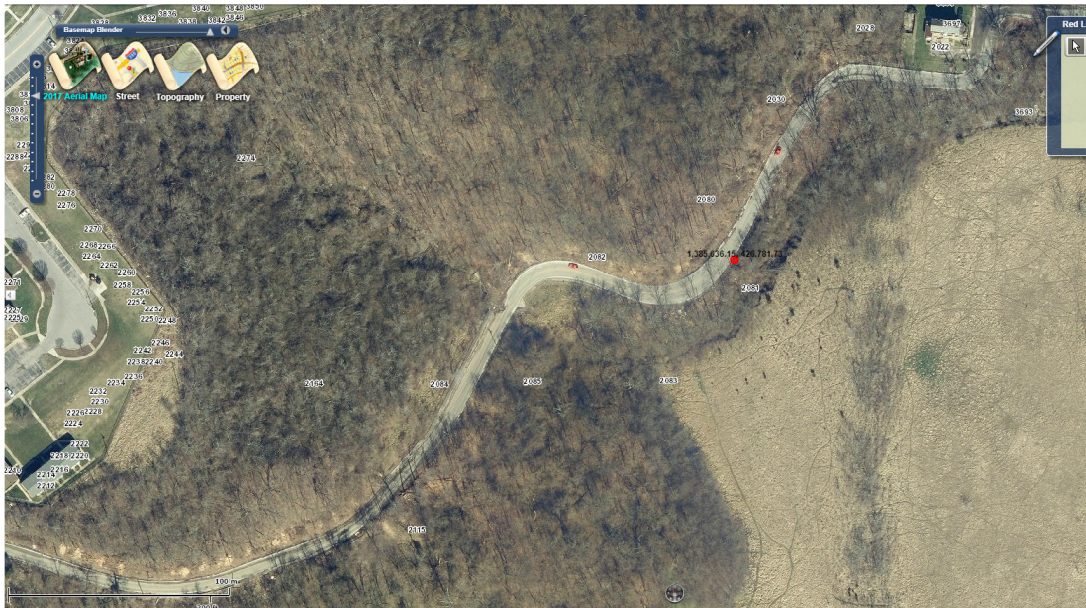
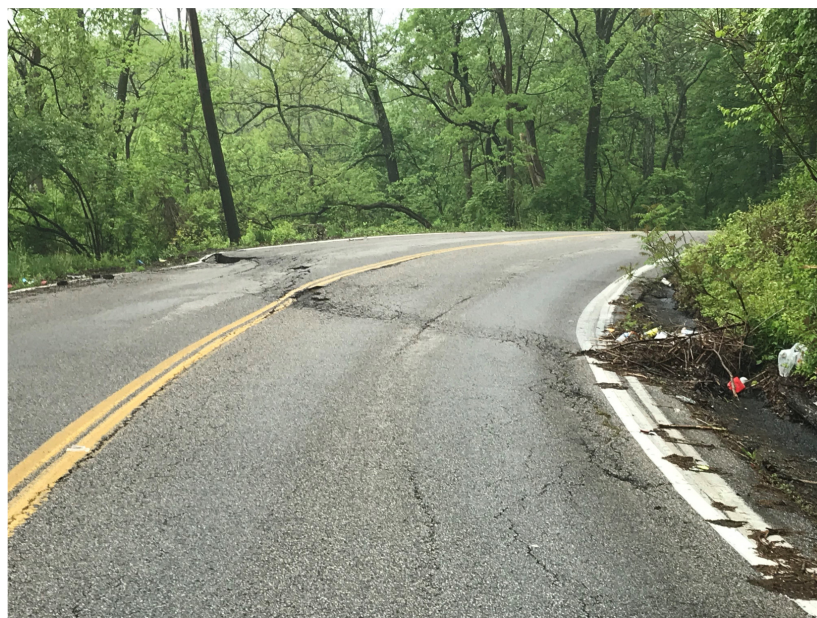
**Faraday Road** - Anticipated project cost –\$600,000

A landslide has been causing Faraday Road to slip toward an adjacent creek. The total length of the movement is difficult to discern but appears to be 300 feet +/- and the upper limits of the slide (scarp) has resulted in a significant set-down in a sharp bend. DOTE plans to apply for state funding of a safety enhancement as well as SCIP funding for an overall street improvement project for Faraday Road. DOTE has initiated an investigation of the subsurface, including installation of an inclinometer to provide slope monitoring. The repair type is not currently known and may consist of a pier wall or earthwork buttressing. The buttress approach may require piping the adjacent creek.
