# 2019 RETAINING WALL AND LANDSLIDE REPORT

Department of Transportation and Engineering  
Division of Engineering  
Structures and Geotechnical Section

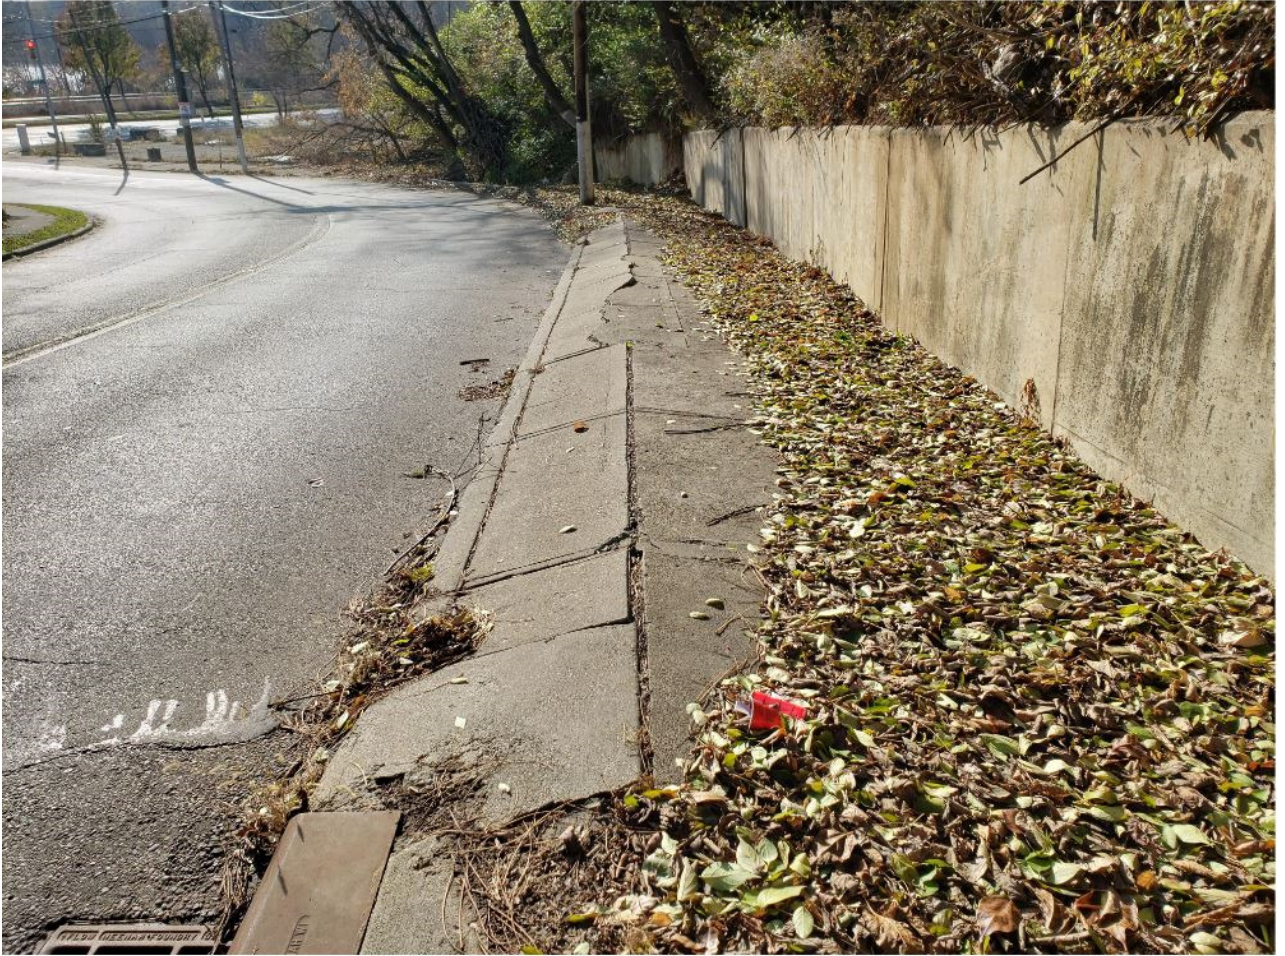
**Anderson Ferry Retaining Wall** – Anticipated Project cost – \$300,000

Hillside movement is causing the sidewalk on the west side of Anderson Ferry Road to buckle. The sidewalk was closed in February of 2020. The road is not affected, and pedestrian traffic is detoured the sidewalk on the east side of Anderson Ferry.

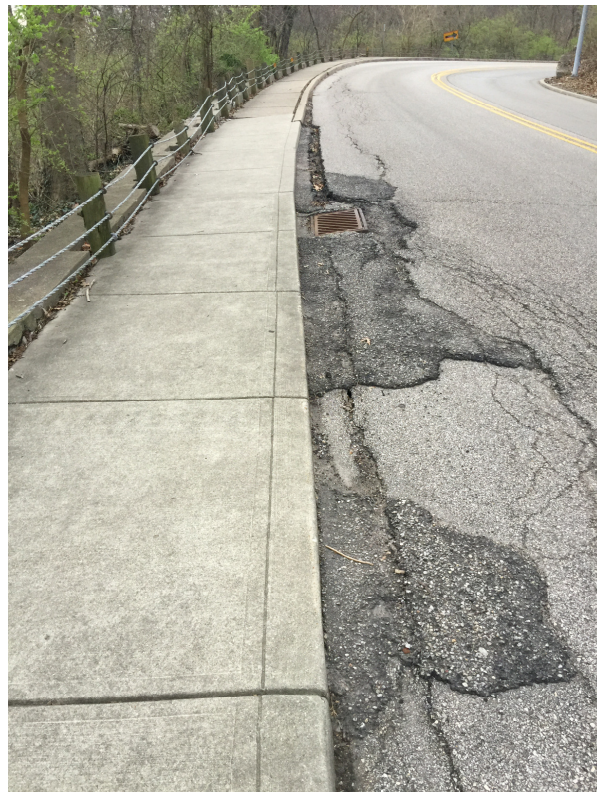
Hillside movement affects Art Museum Drive for approximately 500 feet from its intersection with Eden Park Drive. Separation of the sidewalk from the curb, separation of the curb from the roadway and tension cracks within the pavement continues to occur. Sections of the cable guardrail system need repair.

Patchwork to fill gaps due to hillside movement between curb and pavement.

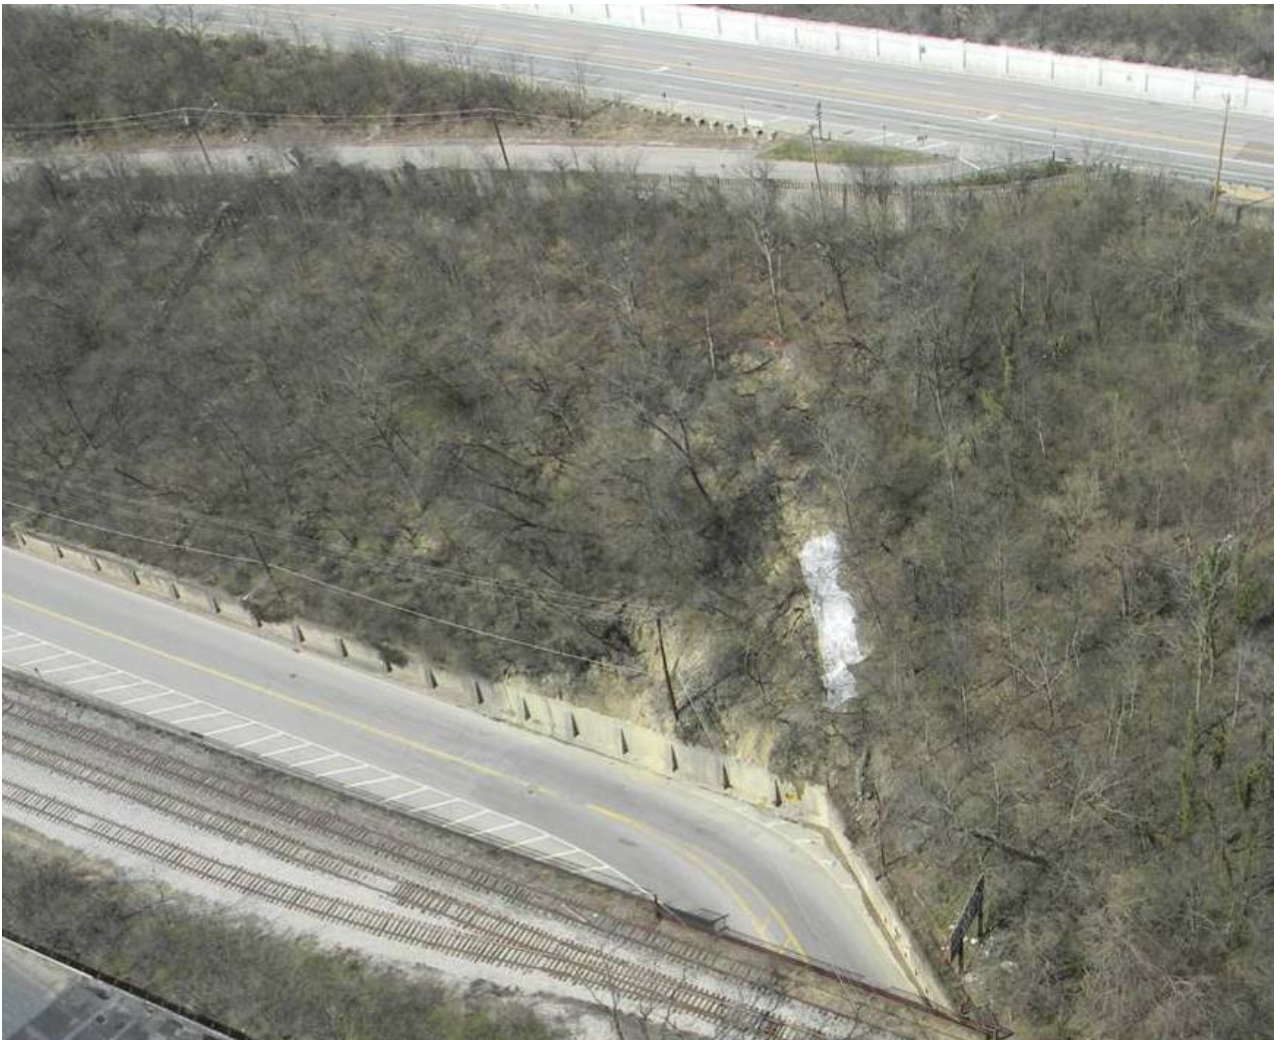
*As previously described in the 2015 and the 2016 – 2017 Wall Reports.* A landslide occurs above the existing retaining wall on the north side of Riverside Drive, US Truck Route 50, immediately west of the Rookwood Railroad Overpass. It extends up the hillside to immediately below Kemper Lane and Columbia Parkway US Route 50. The slide area covers nearly 1.5 acres of hillside. Riverside Drive, US Truck Rt. 50 is one lane in each direction through the Rookwood Overpass. The road curves as it goes under the overpass. Significant movement has not occurred since the spring seasonal rains of 2011. Riverside Drive is routinely inspected following periods of heavy rainfall.

Aerial view of landslide on Riverside Drive west of the Rookwood Overpass. The property above the wall is owned by the Park Board. Note extent of headscarp. Plastic sheet left behind after test pits were dug in 2011 to prevent water from seeping along scarp line into the slide mass. Plastic has since deteriorated and no longer exists.
