# 2020-2021 RETAINING WALL AND LANDSLIDE REPORT

Department of Transportation and Engineering  
Division of Engineering  
Structures and Geotechnical Section

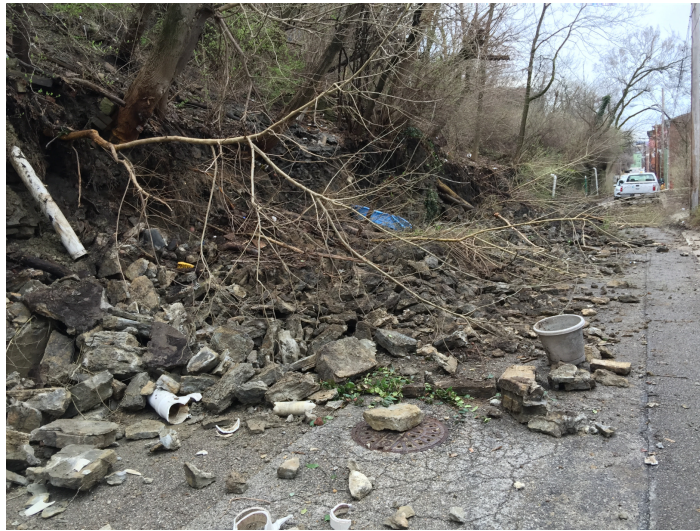
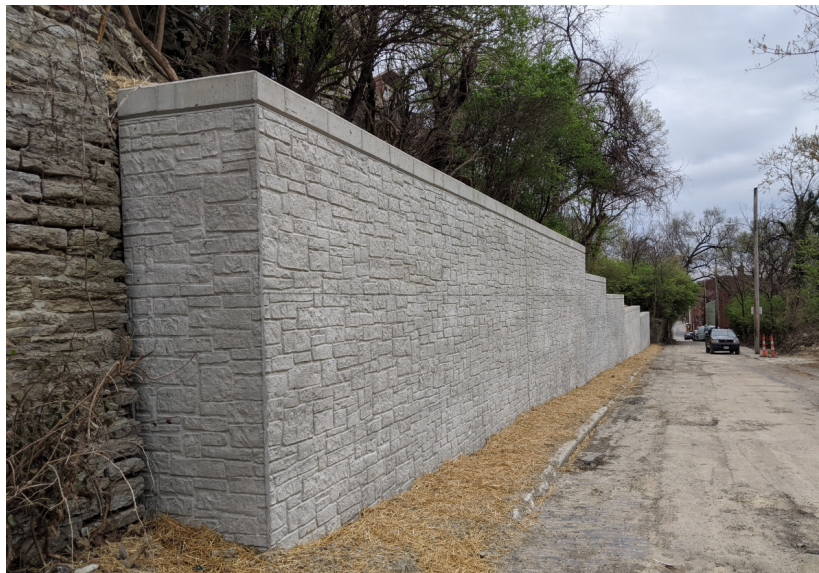
**Peete Street Retaining Wall Reconstruction** - Project contract price – \$292,550

A series of privately-owned mortared limestone retaining walls along Peete Street failed or were failing, resulting Dept. of Buildings and Inspections to issue orders to the Property Owners. At the request of the Homeowners, City Council passed a motion requesting that the City Administration begin the process of designing and constructing a public retaining wall to maintain the right-of-way and assess the Homeowners the project cost. Project funding was established by Ordinance No. 109-2019. This project was bid multiple times due to various circumstances and an acceptable bid was finally executed in November 2019. The wall was completed in April 2020.

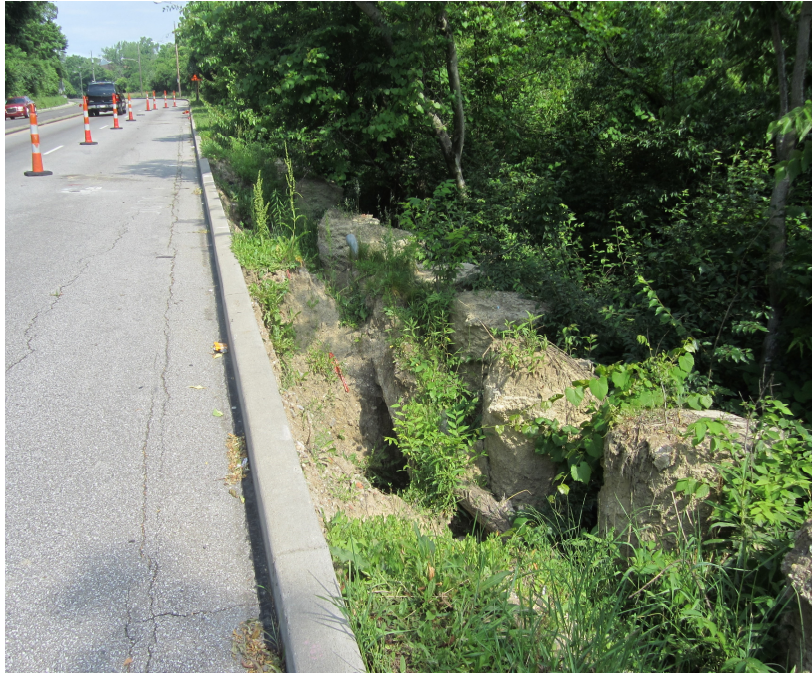
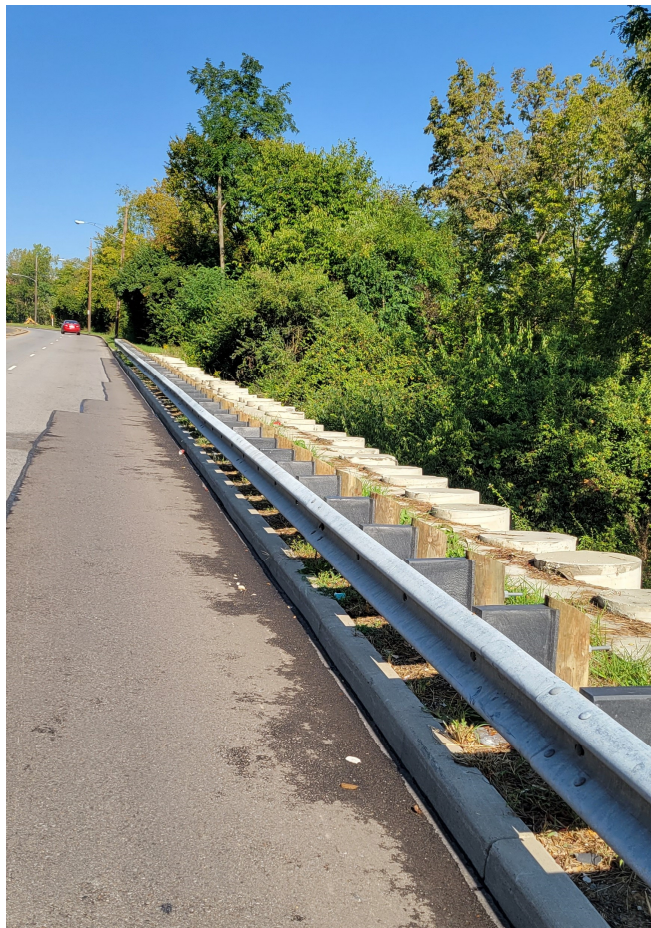
**Westwood Northern Boulevard** (Continued)

A large active landslide exists on the north side of Westwood Northern Boulevard (WNB) between Beekman and Sutter Avenues. The landslide caused the hillside to drop ten to fifteen feet below the height of the road over a length of 325 feet. A pier retaining wall constructed by Cincinnati Metropolitan Housing Authority (CMHA) in 1981 was compromised ineffective in supporting the roadway. The loss of soil between the piers of the existing wall impacted the pavement and continued erosion and movement of the hillside would result in the loss of pavement, use of the roadway and damage to public and private utilities.

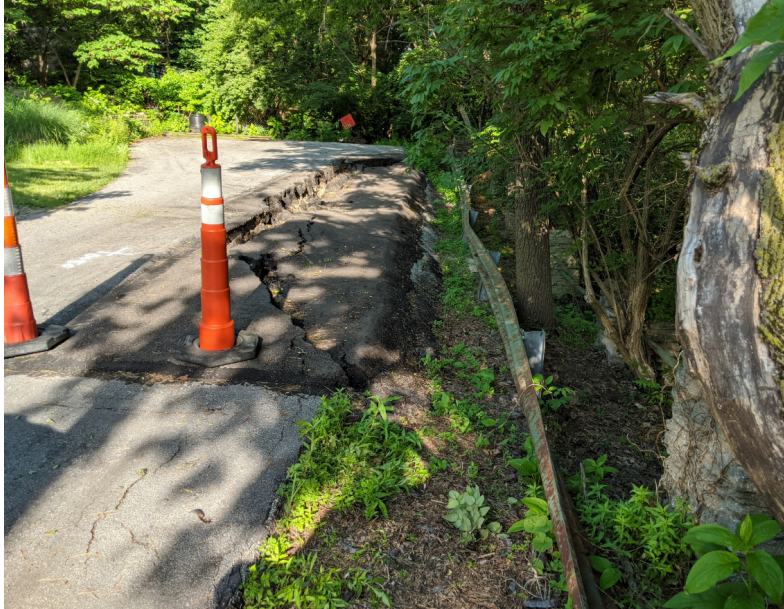
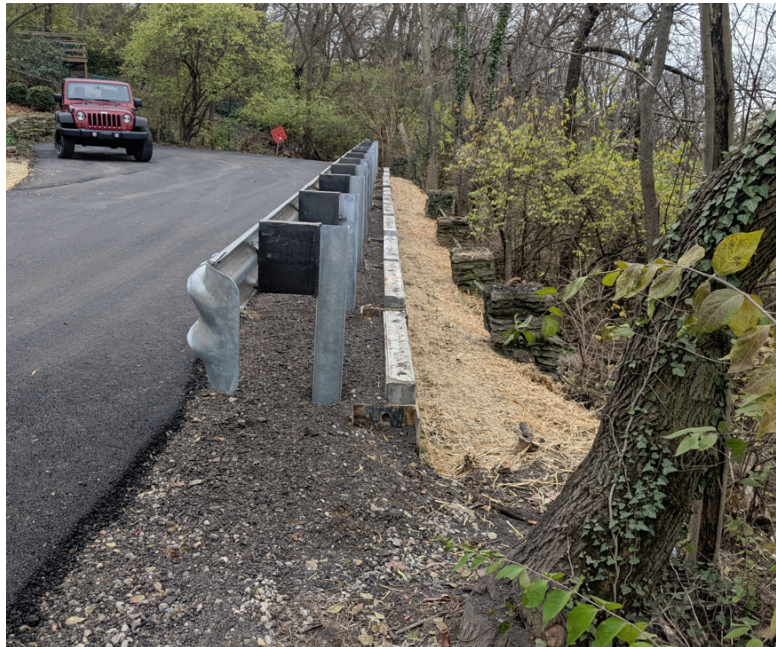
**Old McMillan Street** – Project contract price -\$109,439

A landslide caused a significant set-down (scarp) in the pavement at the west terminus of Old McMillan Street. DOTE had been maintaining the pavement via various patches over the years, but the movement accelerated to the point that patching was no longer a viable solution. DOTE designed a 66 ft. long “soldier-pile” retaining wall consisting of 12 piers with concrete lagging between steel beams along the north side of the roadway. The project was completed in January of 2021.

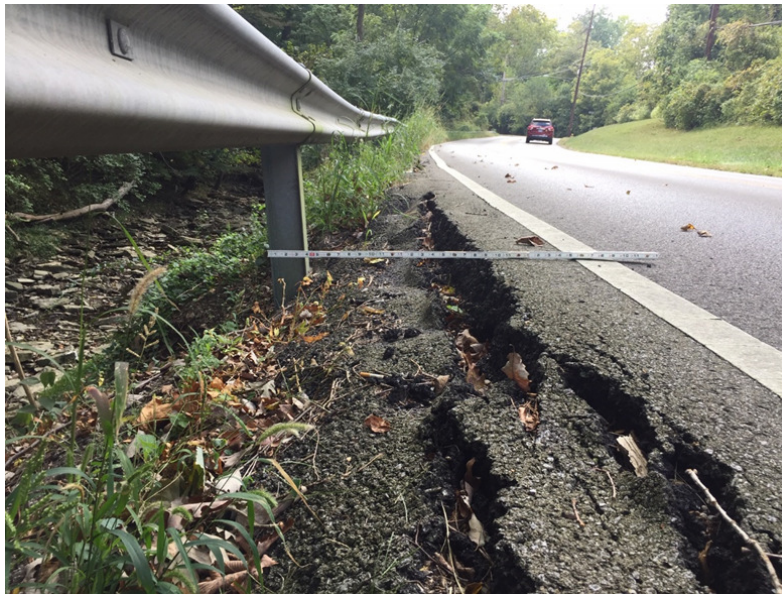
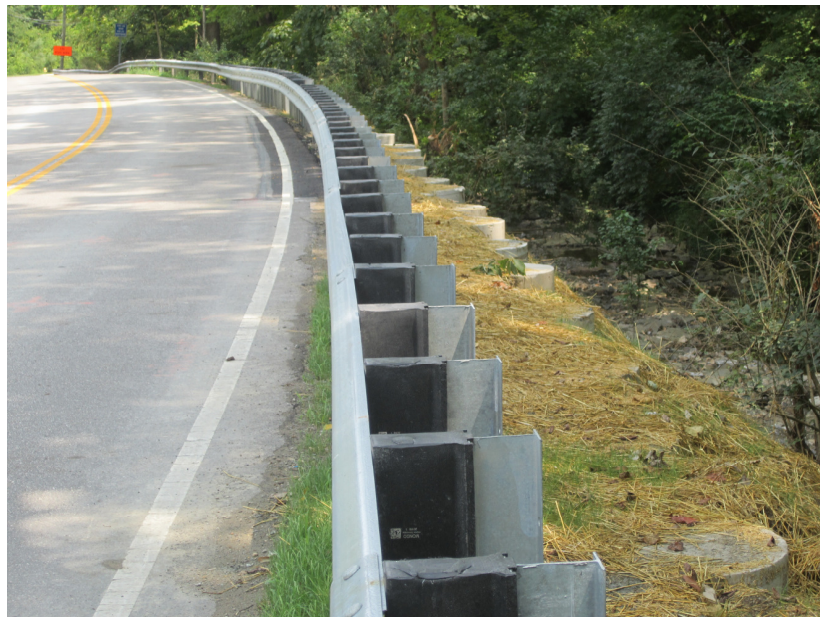
**Berkshire Lane Pier Wall Project** –construction cost – \$143,206.48

The existing creek bank which supports Berkshire Lane was being severely eroded. The erosion caused settlement of the guardrail and undermined the pavement resulting in the loss of pavement. The repair consisted of the installation of a 166 ft. long pier wall consisting of twenty-eight 30-inch diameter piers and fifty-six 24-inch diameter plug piers. Guardrail upgrades and pavement repair were also included in the project. The project was completed in August of 2021.

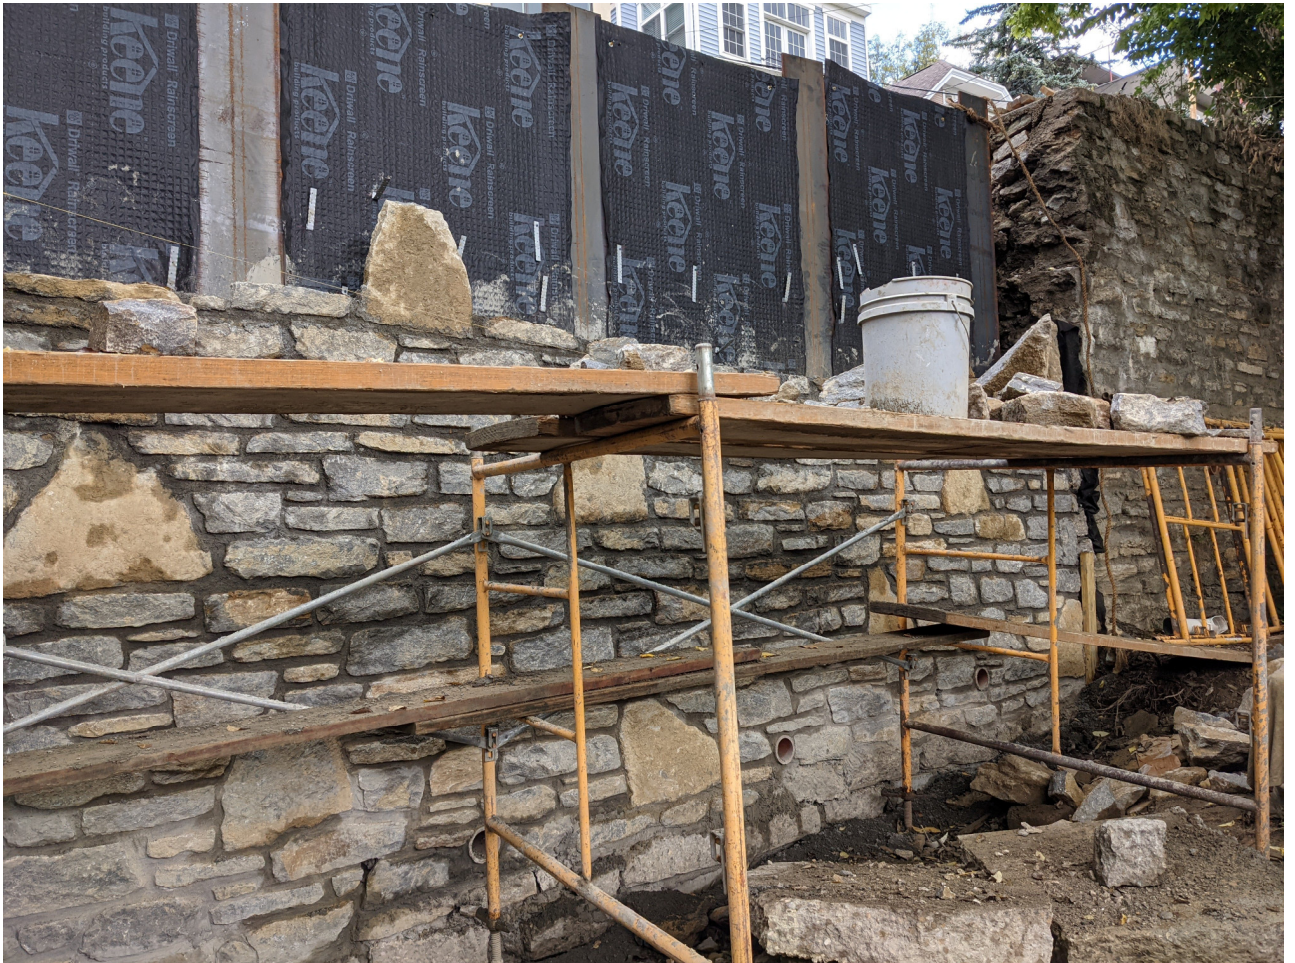
### **Boal Street Partial Retaining Wall Replacement** – Contract amount - \$148,994

The retaining wall behind 440 Milton Street which supports Boal Street was repaired in 2018. The repair consisted of a masonry reconstruction of the stone wall. This same section of wall failed again in 2020. The current project replaced the stone wall with drilled piers and concrete lagging with a stone facing. The project also improved drainage by changing the grades and replacement of the sidewalk to direct water away from the wall. A wall cap and new, upgraded railing are included in the project which is expected to be completed in November of 2021.

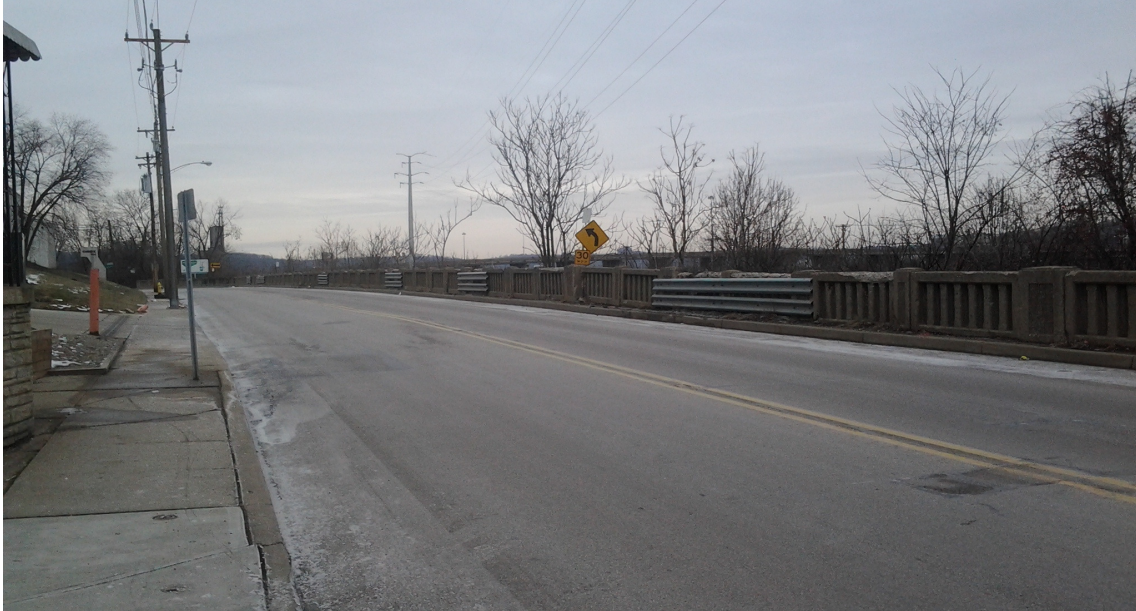
The existing wall is in fair condition, the coping which is attached to the wall and the concrete railing which is attached to the coping is in a failed to critical condition. Sections of the railing have deteriorated, exposing reinforcing steel. Sections of the railing which appear visually sound crumble with a grasp of the hand. Guardrail sections have been bolted to the pilasters throughout the years to temporarily repair the railing.

Sections of concrete railing replaced with guardrail sections bolted to pilasters on Cummins Street.

The project requires removal of disintegrated concrete down to sound concrete and replacement of concrete removed. Soundings revealed approximately 2,000 square feet of unsound concrete. Joints between the panels will be reconstructed and the entire wall will be sealed. The repairs to the retaining wall are essential to avoid complete replacement of the retaining structure. The existing concrete railing and coping will be replaced with a Texas Style rail mounted on a concrete moment slab which rests on top the existing retaining wall.

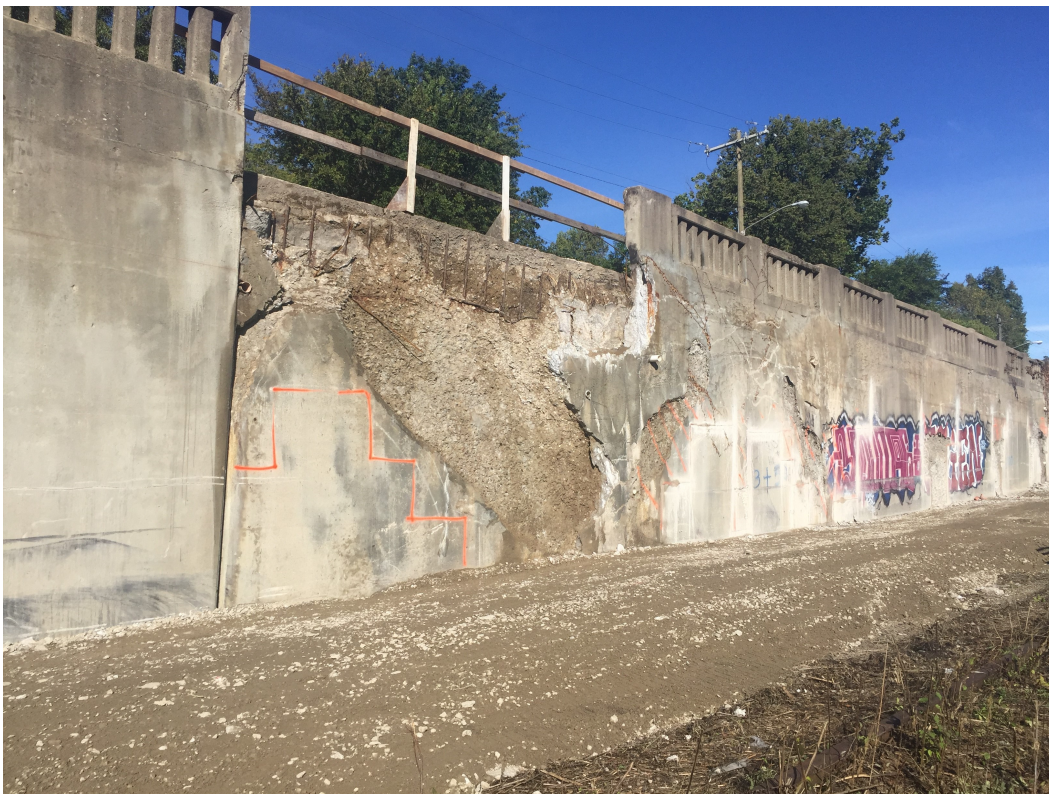
Retaining wall panel after chipping and prior to patching.

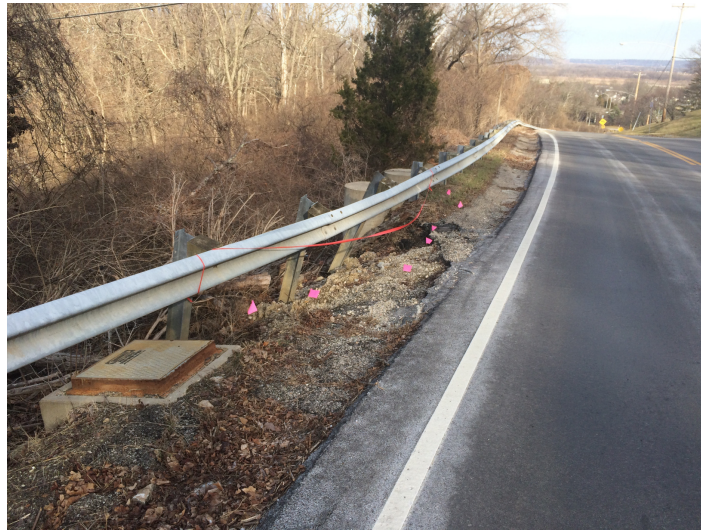
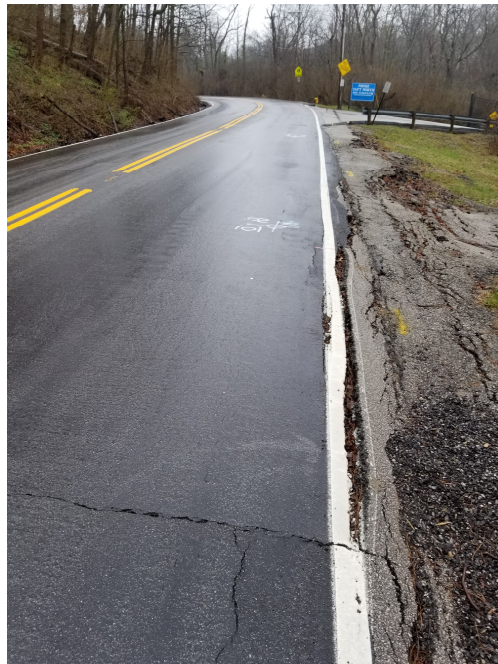
**Grandin Road Retaining Wall Extension** -Contract bid amount of \$205,317.31

The western end of the existing drilled pier retaining wall built in 1995 needs to be extended to stabilize Grandin Road from continued slope movement. The movement has undermined the guardrail and has damaged a paved drainage channel and the roadway shoulder.

The project consists of the construction of a 230-foot drilled pier wall, consisting of 35 reinforced piers with plug piers between the majority of the reinforced piers.

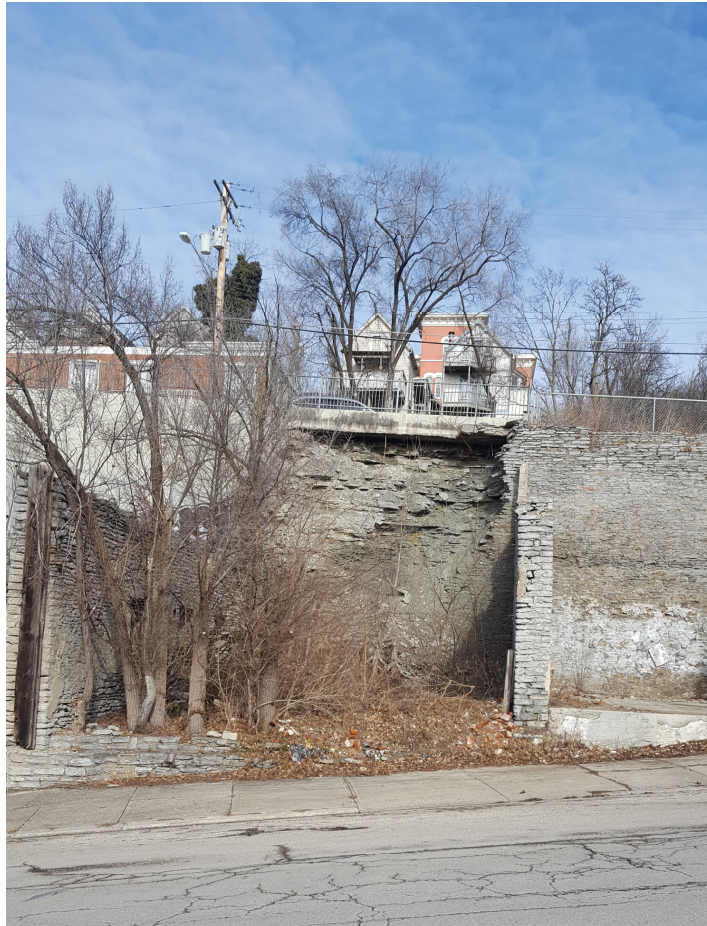
**Dorchester Avenue Wall Repair** (Mt. Auburn) – Estimated construction cost – \$100,000 - \$150,000

The sidewalk on Dorchester Avenue remains closed due to the collapsed wall. The collapsed wall served as the foundation wall of a private building on Sycamore and was a privately owned wall. DOTE has prepared plans to permanently repair the wall. The repair is included as an alternate in the Auburn Avenue Phase II Project which will be bid in October of in 2021.

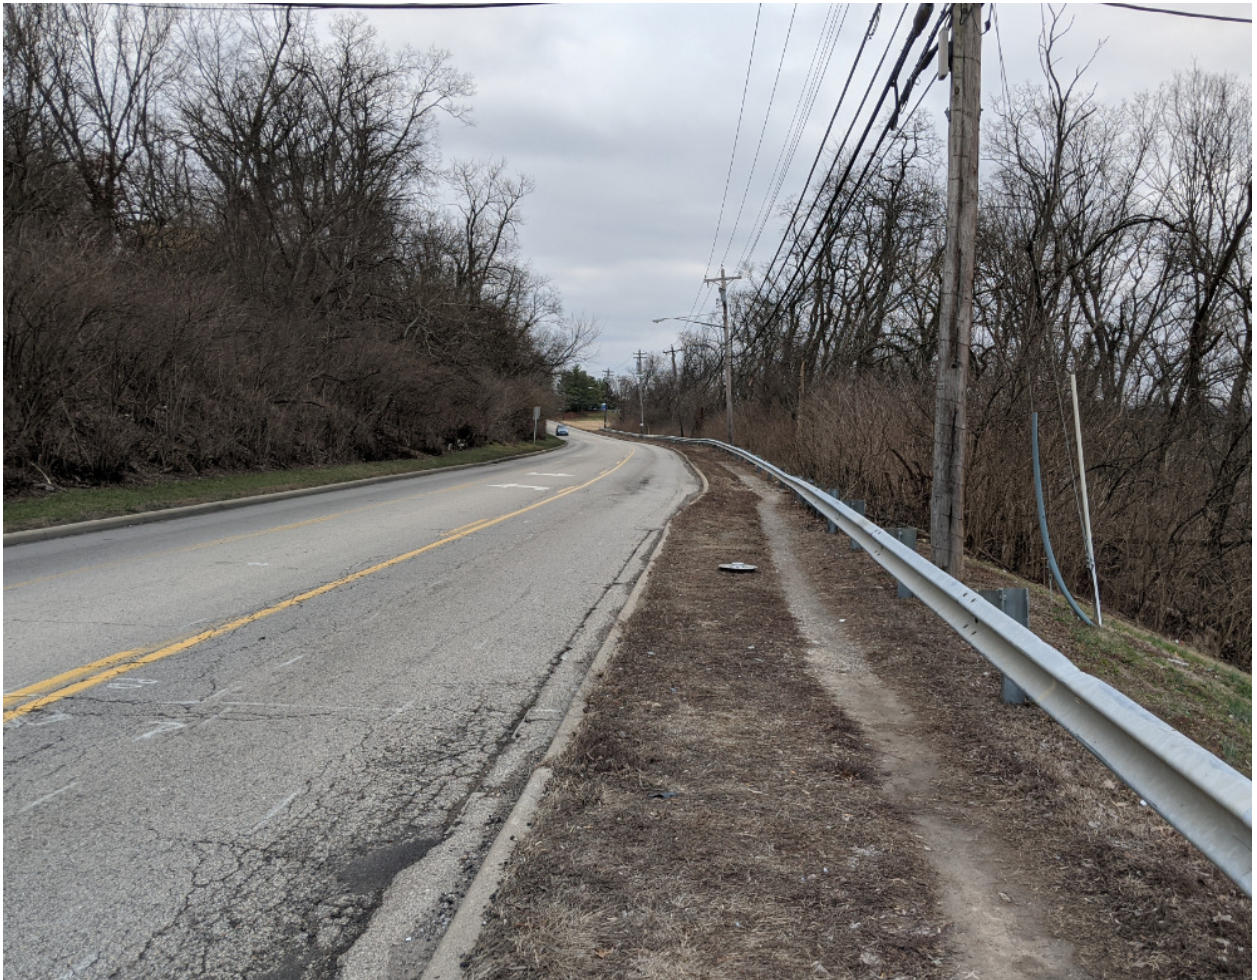
**West Galbraith Road (@ 341)** – Anticipated project cost –\$200,000

A landslide is occurring along the eastbound lane of West Galbraith Road, near 341 W. Galbraith Rd. The slide has moved the curb and guardrail significantly and created a dip in the pavement. DOTE was awarded OPWC funding for the street improvement project that includes this section of roadway. The site has been investigated and plans to remediate the landslide have been completed and will be included with the street improvement project. The repair consists of excavation and compaction of the soil on benches cut into the underlying bedrock. Underdrains are to be installed on the bedrock benches prior to the replacement of the excavated soil. TROD has recently patched the area to temporarily repair the dip in the road.

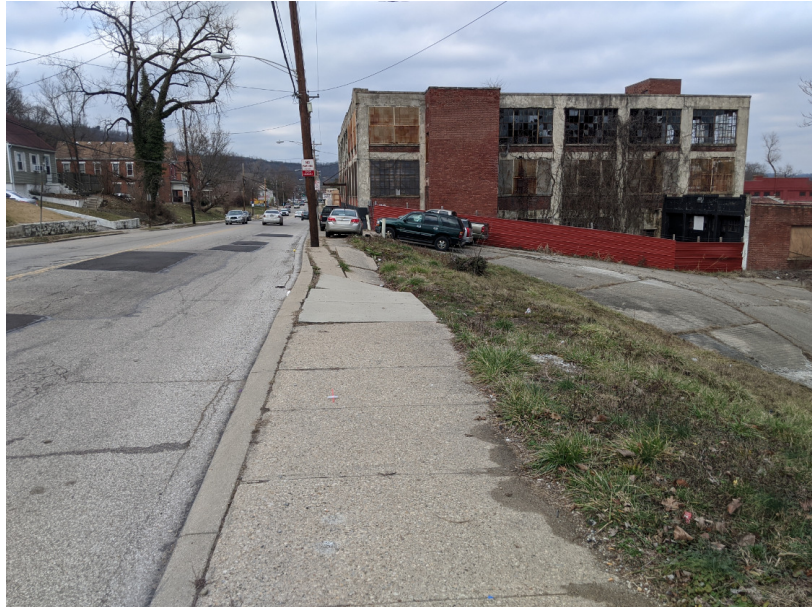
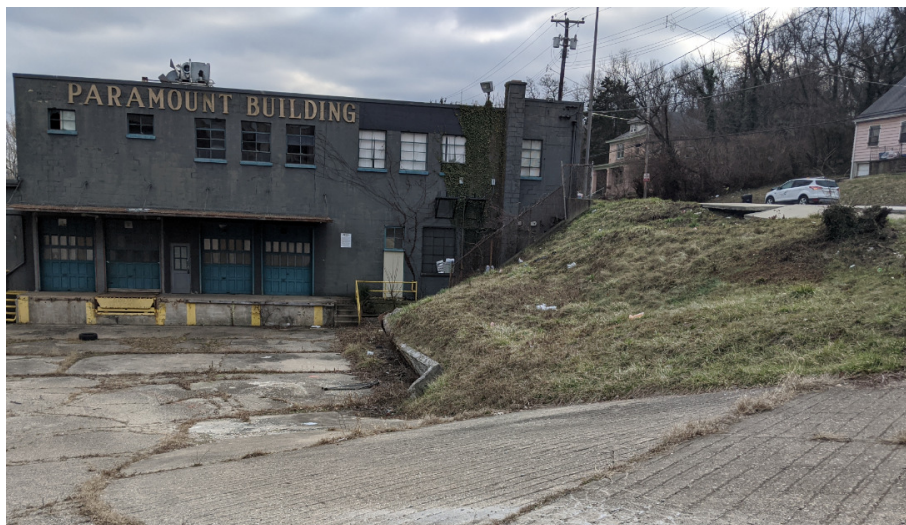
**Beekman Street (@ 3138)** - Anticipated project cost –\$200,000

A private retaining collapse on the property at 3090 Beekman Street has caused a landslide to occur along the roadway that has resulted in the destruction of the sidewalk and the initiation of curb and pavement distress. Department of Community and Economic Development (DCED) has taken control of the property from foreclosure and intends to make the repair before marketing the property. DOTE designed a soldier pile wall comprised of 12 piers with steel piles and pre-cast concrete lagging panels for DCED.

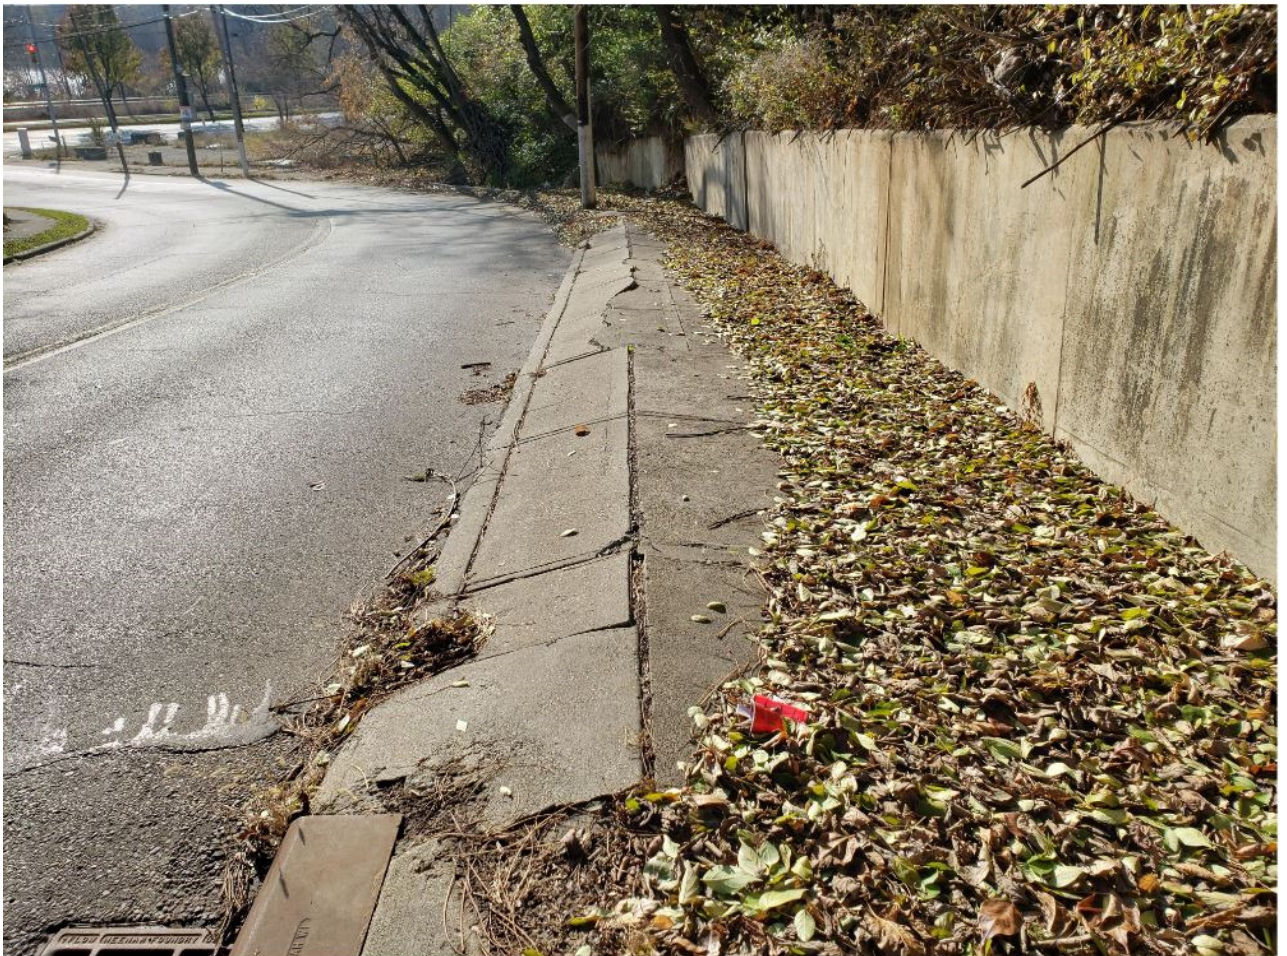
Hillside movement is causing the sidewalk on the west side of Anderson Ferry Road, between Hillside Avenue and River Road to buckle. The sidewalk was closed in February of 2020. The road is not affected, and pedestrian traffic is detoured to the sidewalk on the east side of Anderson Ferry. This project was requested by the Riverside Community and is funded as a Capital Improvement Project in the amount of \$300,000. Stormwater Maintenance Utility (SMU) is also a team member on the project. The team will apply for OPWC funds in 2021 to assist in funding both the stabilization and stormwater improvements

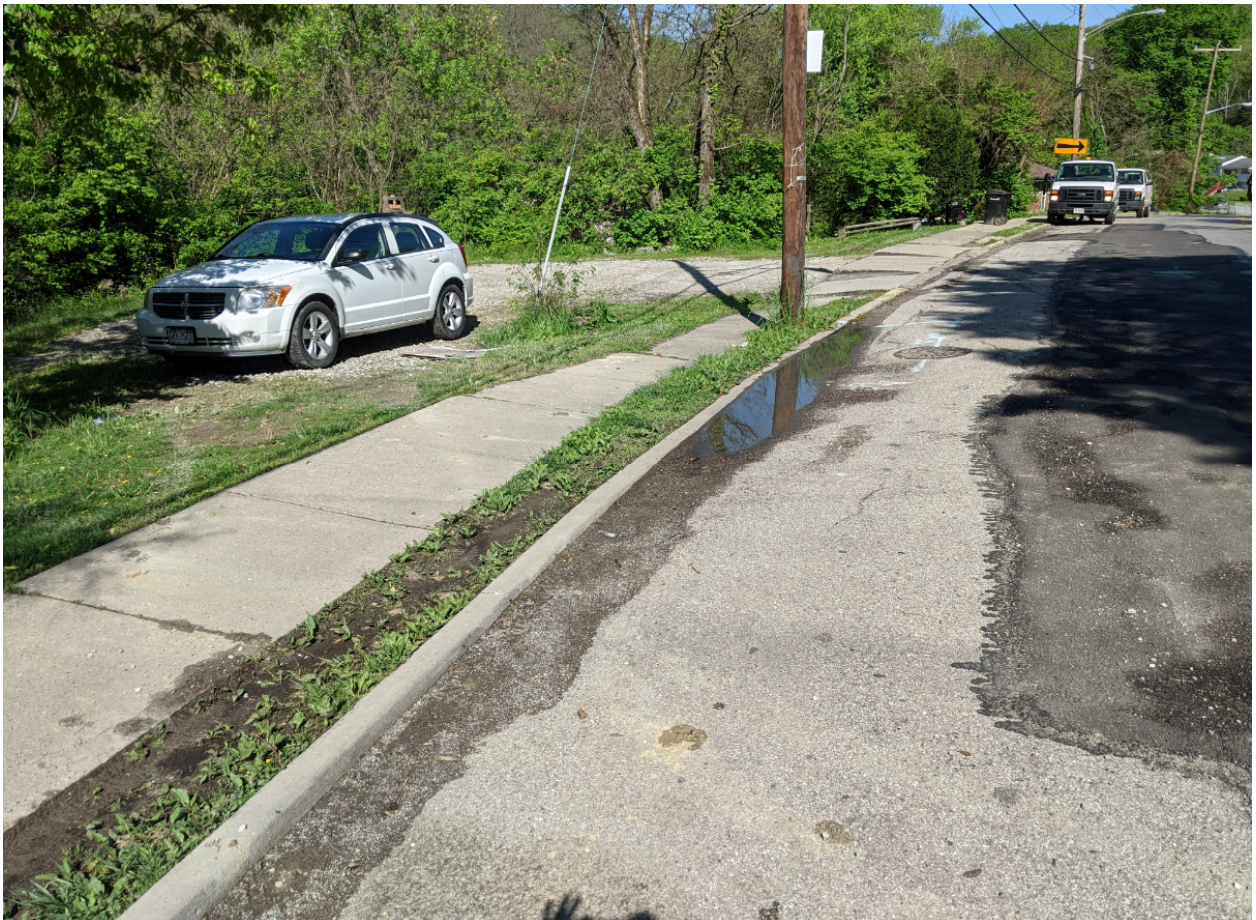
**Delhi Avenue (@ 999)** - Anticipated cost –\$400,000

A slow-moving landslide has been causing Delhi Avenue and the south sidewalk to settle. The area also ponds water because of the movement. The roadway requires regular patching, and the sidewalk is becoming hazardous. Utilities within the road are at risk. DOTE was awarded a state safety enhancement grant for Delhi Avenue and Ohio Department of Public Works (OPWC) State Capital Improvement Program (SCIP) funding. The stabilization of the landslide is included with the street improvements. DOTE has obtained a subsurface investigation, including the installation of an inclinometer to provide slope monitoring. A pier wall is being designed.

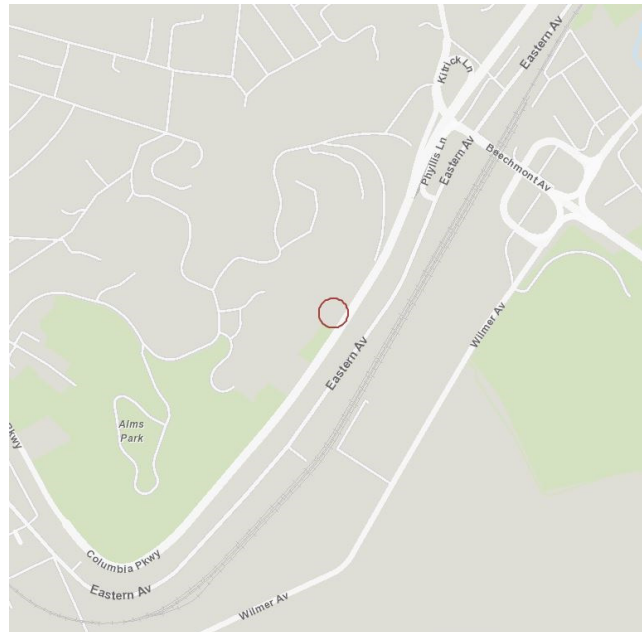
## **Columbia Parkway – South of Beechmont Avenue**

Public Services trimmed the vegetation along Columbia Parkway in the summer of 2020. The removal of the vegetation exposed the toe of a landslide on the hillside above the retaining wall between Beechmont Avenue and the curve in the parkway below Alms Park. Comparison of photographs of the area suggest that the slide has existed prior to 2018 with additional movement occurring prior to June of 2019.

A reconnaissance of the hillside revealed that the landslide extends more than halfway up the hillside and that there are at least two internal scarps within the slide mass in addition to the primary head scarp. Many of the trees within the slide mass, which are more than likely Ash trees are dead. The slide remains relatively stable on top of the wall. Removal of the toe can not take place until the slide is thoroughly investigated and more than likely not until the mass is stabilized. The slide mass is routinely observed and appears dormant for now.

A drone flight which includes LIDAR to produce a topographic survey of the landslide and surrounding area is the next step in the investigation of the landslide. The use of a drone with LIDAR proved very useful in obtaining topography and delineating slide features and boundaries on the Columbia Parkway Hillside Stabilization Project.

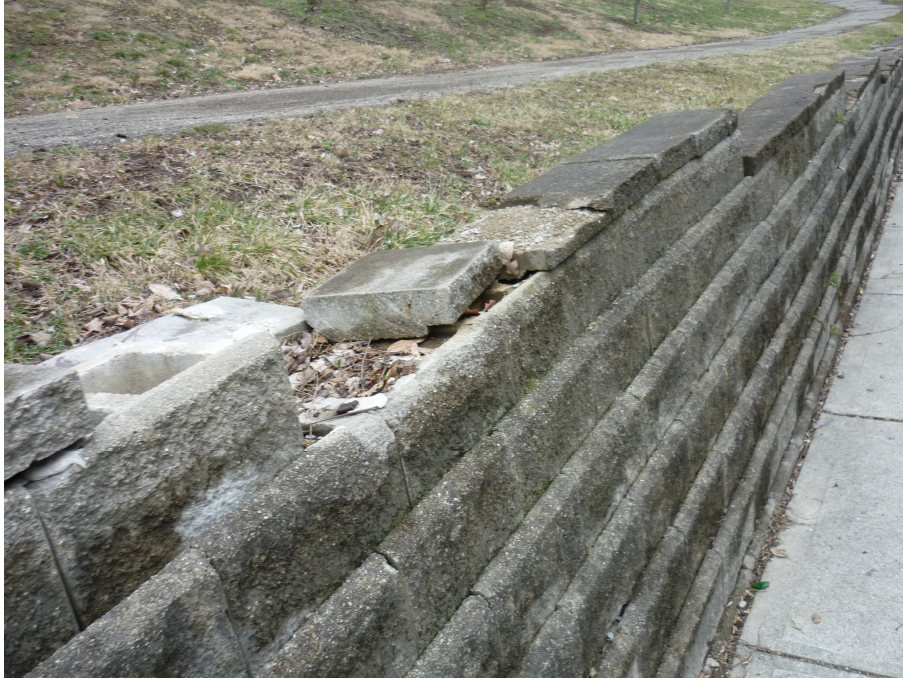
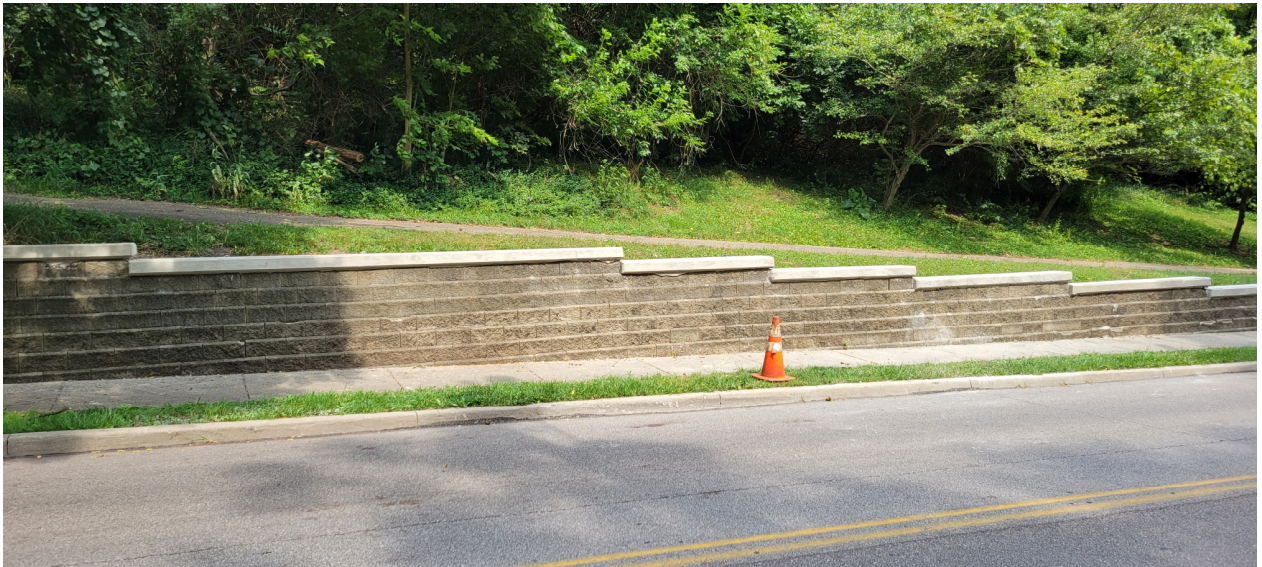
**Guerley Road Wall Cap** – Construction price \$9,116.83

Most of the caps on the wall were loose, broken, severely deteriorated or missing. The prefabricated modular caps were replaced with a cast-in-place wall cap. The cap was constructed by TROD and funded by DOTE Wall Program.

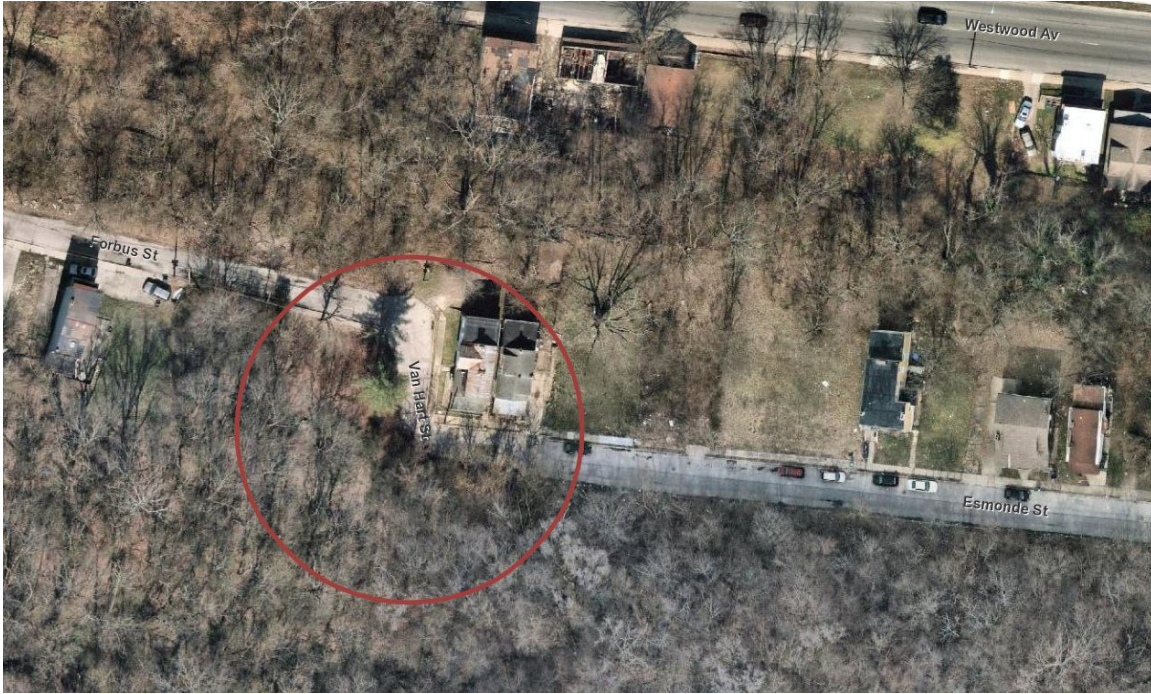
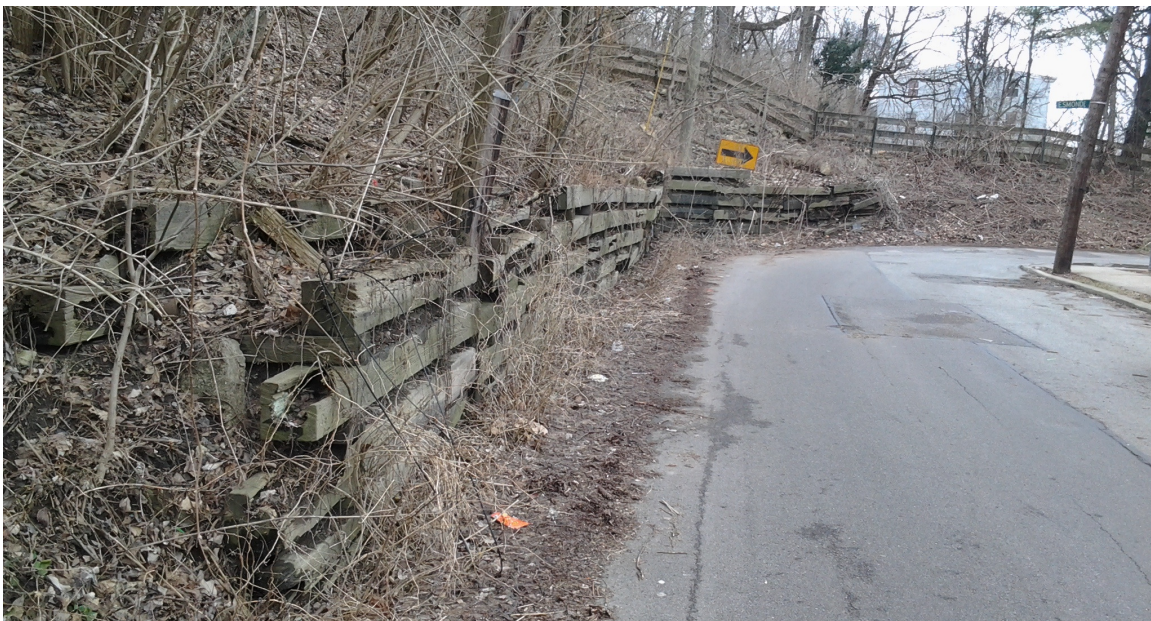
The timber crib wall at the bend in Esmonde Street and Van Hart Street has reached its useful life and needs to be replaced. A large block modular wall is the most likely type of wall to replace the wood crib wall.

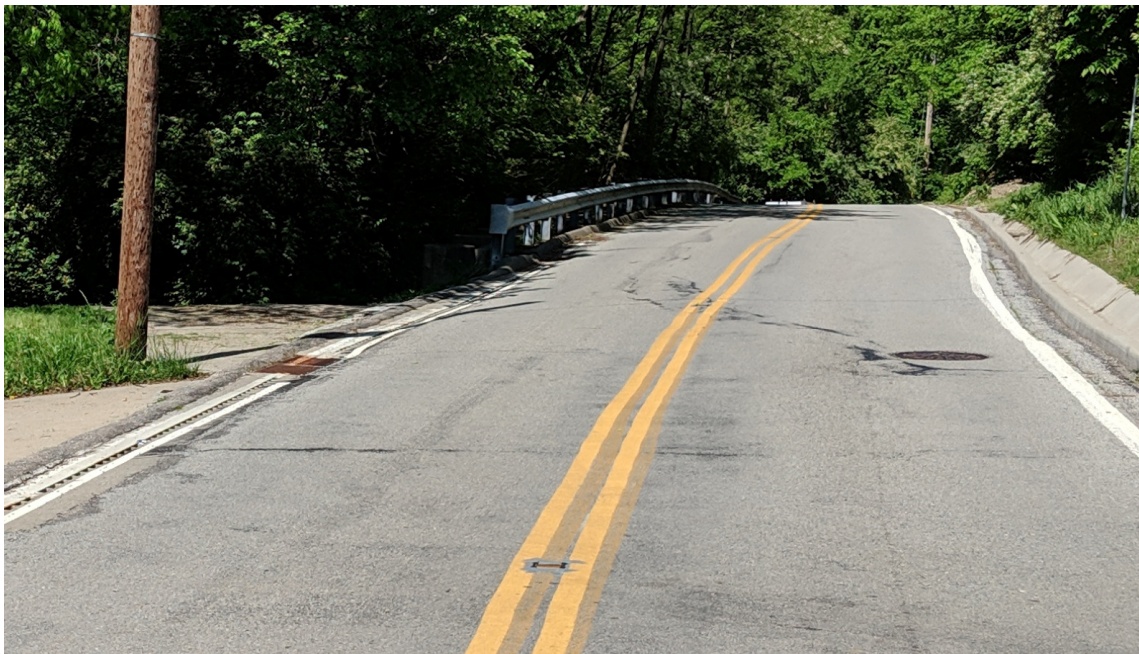
4291-4261 Hillside Avenue (Area 1)

**Condition:** Landslide scarp in pavement effecting both lanes. Wedge recently placed at west end.

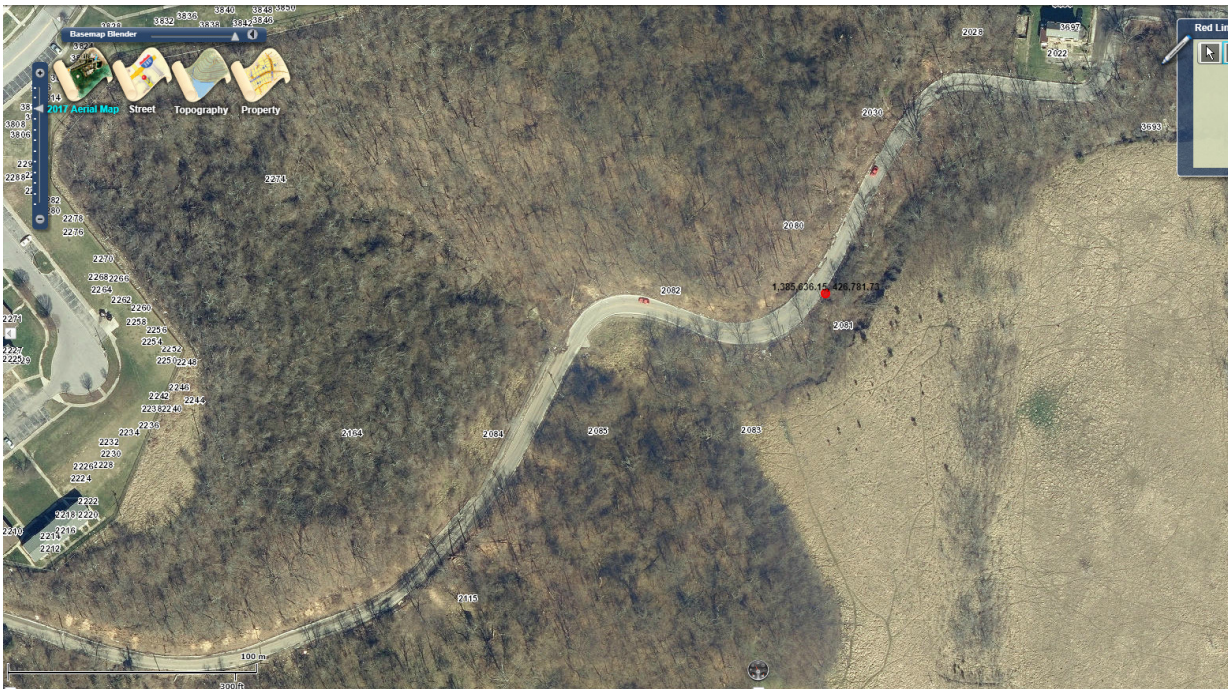
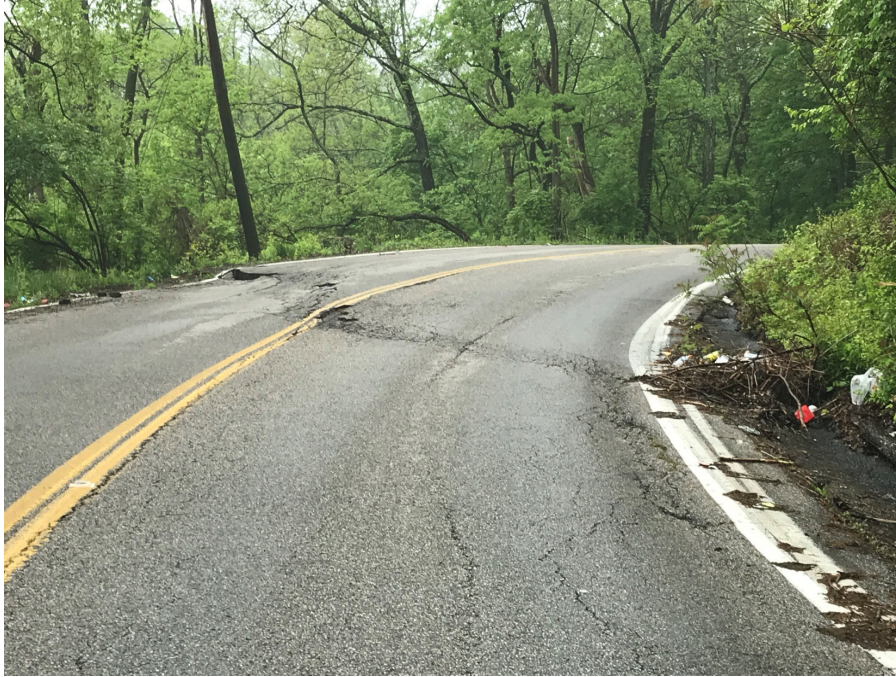
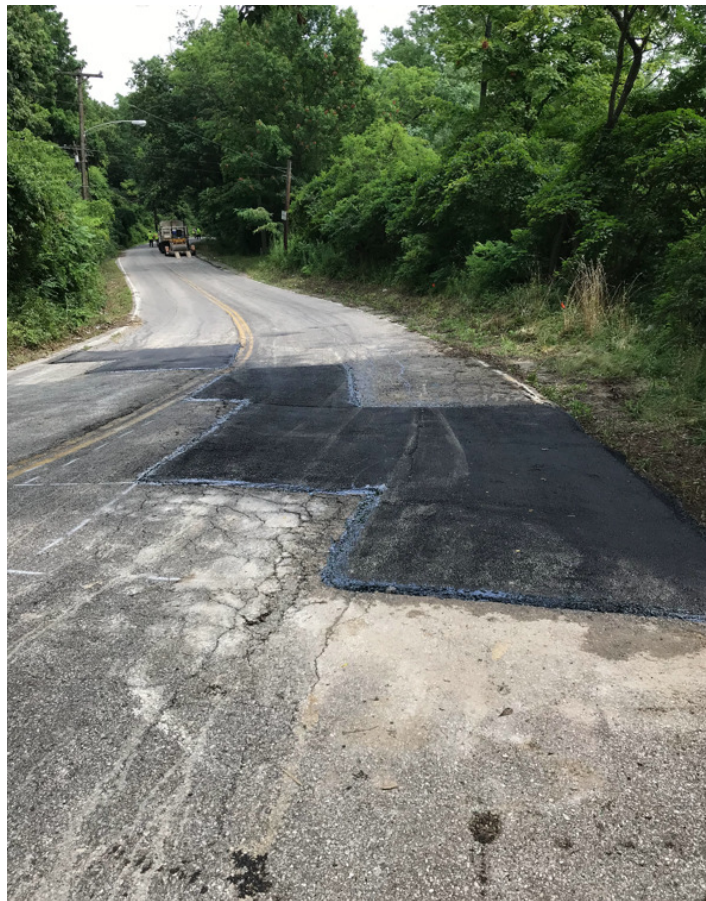
**Faraday Road** – (Continued)

A landslide is causing Faraday Road to slip toward an adjacent creek. The total length of the movement is difficult to discern but appears to be 300 feet +/- and the upper limits of the slide (scarp) has resulted in a significant set-down in a sharp bend. DOTE and Stormwater Maintenance Utility (SMU) plan to apply for state funding of a safety enhancement project as well as SCIP funding for an overall street improvement project for Faraday Road. DOTE has initiated an investigation of the subsurface, including installation of an inclinometer to provide slope monitoring. The repair type is not currently known and may consist of a pier wall or earthwork buttressing. The buttress approach may require piping the adjacent creek.

Completion of design and construction dates are dependent on funding. Temporary repairs to the pavement will continue to be made as needed.

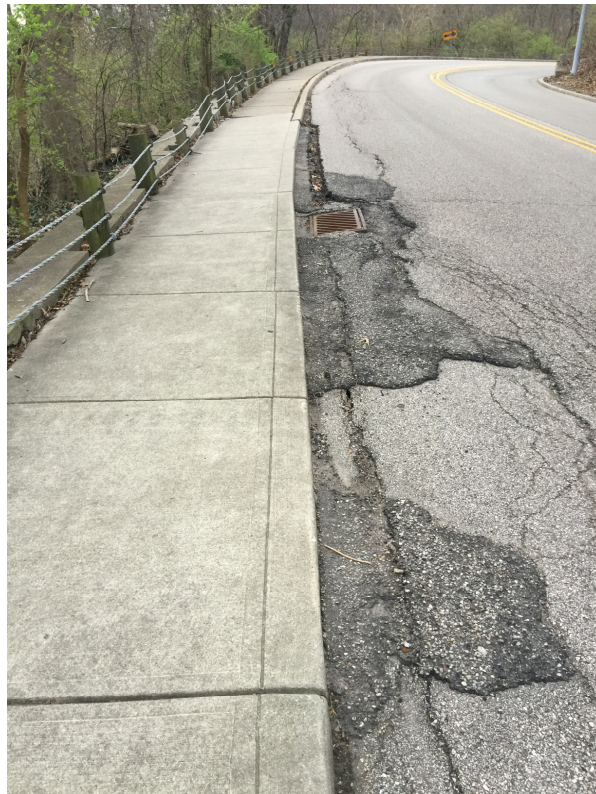
Hillside movement affects Art Museum Drive for approximately 500 feet from its intersection with Eden Park Drive. Separation of the sidewalk from the curb, separation of the curb from the roadway and tension cracks within the pavement continues to occur. Sections of the cable guardrail system need repair. DOTE will apply for a Transportation Infrastructure grant in 2022 and will also apply for SCIP funding in 2022.

Patchwork to fill gaps due to hillside movement between curb and pavement.
