# 2020-2021 RETAINING WALL AND LANDSLIDE REPORT

Department of Transportation and Engineering  
Division of Engineering  
Structures and Geotechnical Section

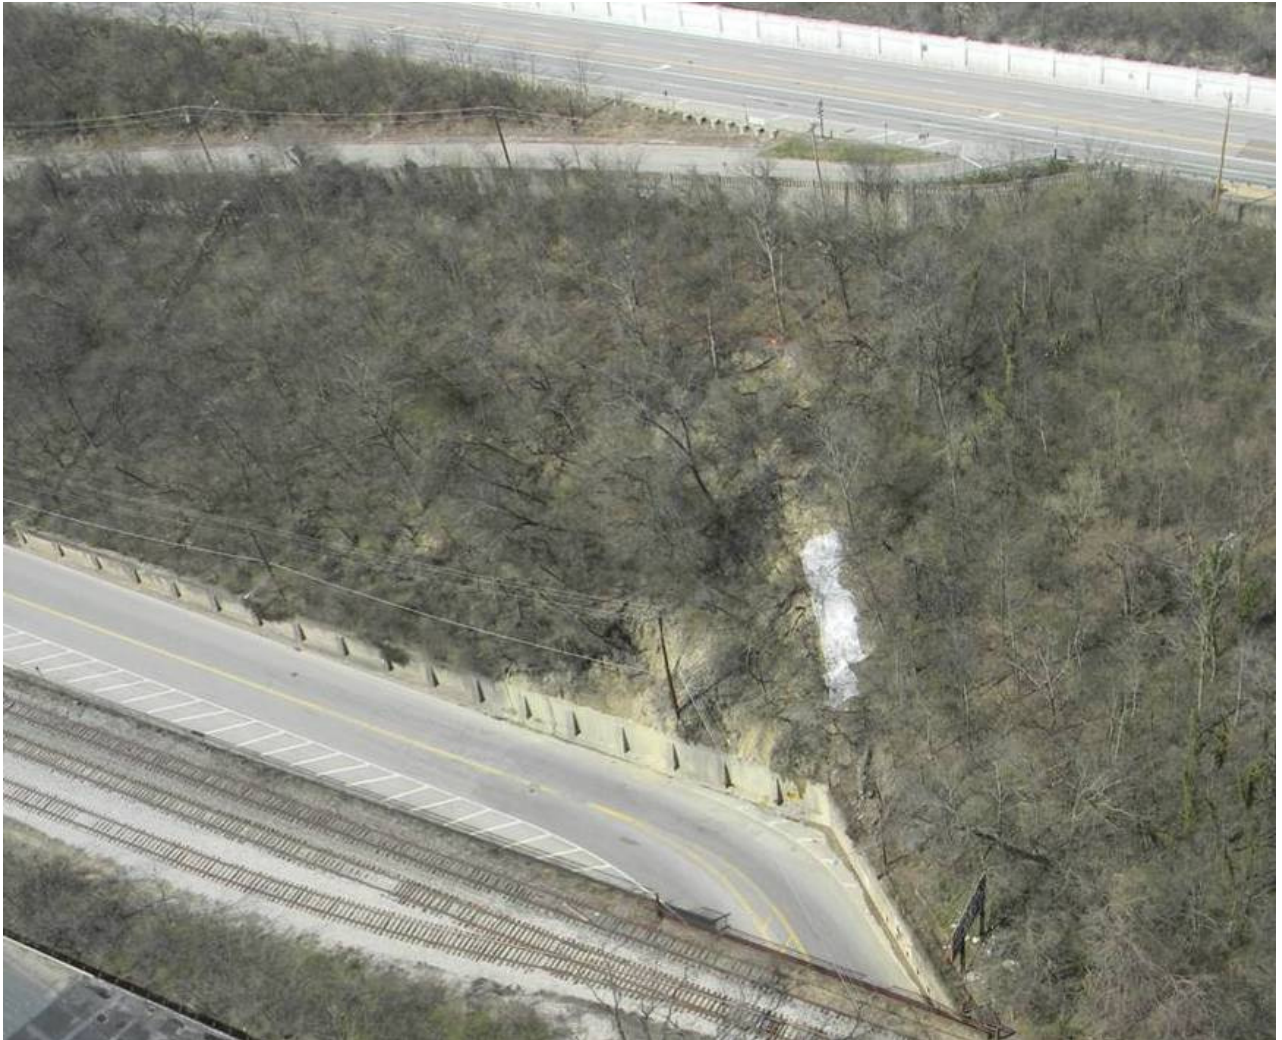
Aerial view of landslide on Riverside Drive west of the Rookwood Overpass. The property above the wall is owned by the Park Board. Note extent of headscarp. Plastic sheet left behind after test pits were dug in 2011 to prevent water from seeping along scarp line into the slide mass. Plastic has since deteriorated and no longer exists.

Replace 1,380 feet of wall cap and guardrail, wall repairs - \$775,000
