2019 COLUMBIA PARKWAY

Landslide Evaluation and Report

Bains Street to Torrence Parkway

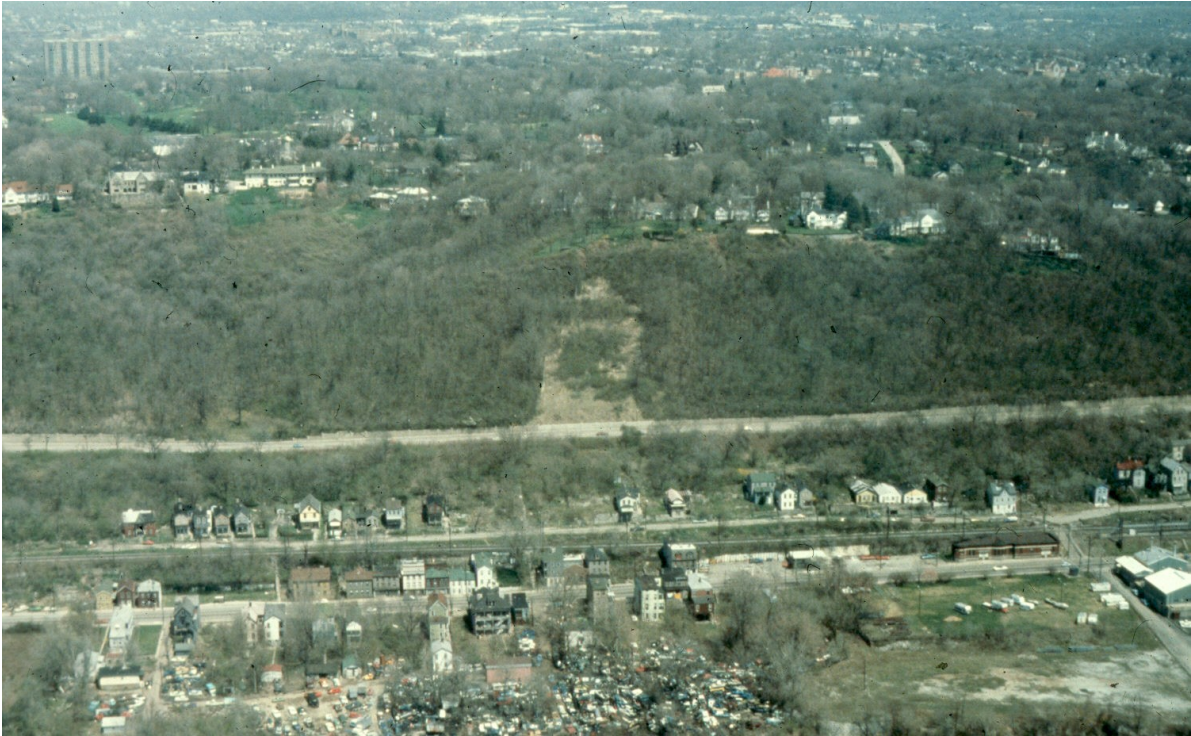
Although this report specifically addresses the slope stability issues along the Parkway between Bains and Torrence Parkway, the largest landslide to occur on the uphill side of the Parkway occurred East of Torrence and west of Delta Avenue, approximately 775 feet west of the Parkway’s intersection with Audubon St. The slide occurred on March 29, 1975. It had an average width of 150 feet and extended up the hillside approximately 150 feet in elevation. This large landslide reportedly involved as much as 10,000 cubic yards of soil. The weight and force of the moving slide mass caused about 160 feet of retaining wall to fail. It was concluded that most of the slide material was shale and clay dumped along the slope during 19th-century quarrying operations. The cost of the removal in 1975 was stated as \$31,000. The occurrence of this landslide as stated in a June 30, 1975 City memorandum “precipitated much public concern regarding such occurrences not only above Columbia Parkway, but at other locations throughout the City as well, and gave rise to many demands the City prevent such reoccurrences.”

Figure 3: 1975 landslide west of Audubon

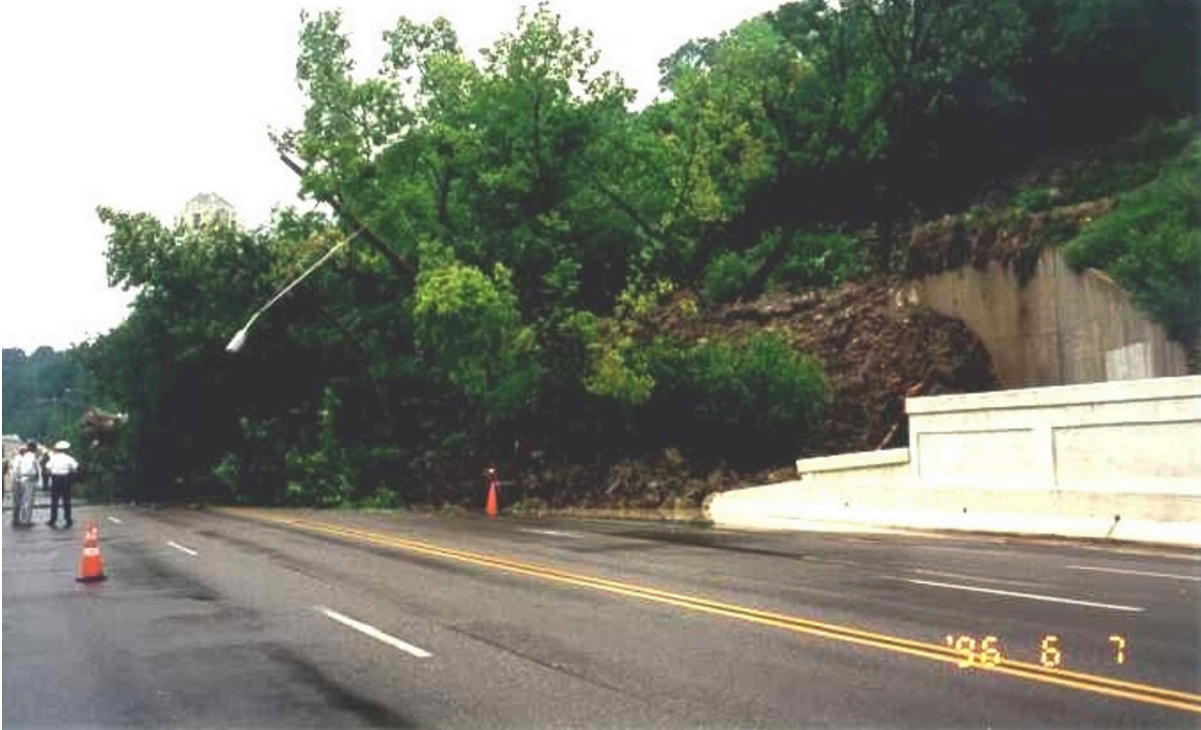
A second large landslide occurred above the Parkway on June 7 of 1996. The debris from this landslide rapidly overtopped the retaining wall immediately west of the driveway for 2110 Columbia Parkway. The landslide mass extended out into four of the five lanes of the Parkway. The major cause or trigger of this landslide was the extraordinary amount of rainfall that preceded the movement. Fill had been placed on the hillside in the upper reaches of the landslide. This landslide also occurred at the same location and most likely involved material that had previously slid in May of 1945.

Although the landslide had temporarily stabilized, additional movement was expected. Personnel from DOTE and PS visually monitored the slide. Traffic devices were left on site. Heavy rainfall was forecasted overnight for Thursday June 6 into Friday morning of June 7. Personnel from PS were stationed on site to monitor the location. Camera crews from WCPO were also on site overnight. Movement was not observed until approximately 4:00 am on Friday, June 7, 1996. Soil began slowly moving over the wall and accumulating in the inbound lane closest to the retaining wall. Personnel from PS closed the inbound lane adjacent to the wall. At approximately 6:00 am there was a surge in the rate of movement and the landslide mass rapidly came over the retaining wall.

Figure 5: 1996 landslide at 2110 Columbia Parkway

Crews from PS worked essentially around the clock removing the slide debris. Traffic was opened on Monday June 10, 1996. The total cost of the cleanup was approximately \$165,000.

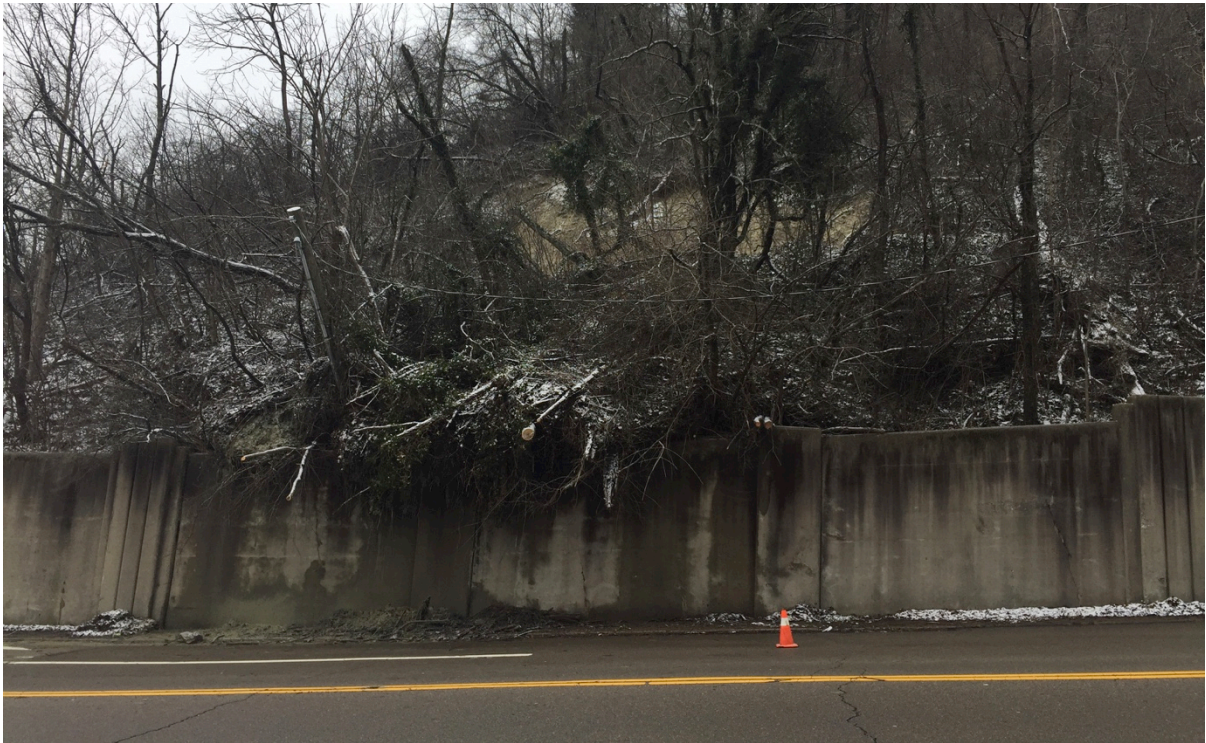
The first significant landslide that occurred in 2019 was not on the Parkway but on Kemper Lane just north of its intersection with Columbia Parkway. A 60 ft. wide section of hillside slid down to the top of the retaining wall on the west side of Kemper Lane on January 23, 2019. The walls on the west side of Kemper were constructed along with the original Columbia Parkway Wall. Trees within the slide mass that overhung the wall were cut back. Additional movement occurred on January 24th requiring the closure of Kemper Lane and the complete removal of trees from the slide mass. DPS removed the slide debris and opened Kemper Lane on January 25, 1

Figure 6: Jan. 24th 2019 landslide on Kemper Lane

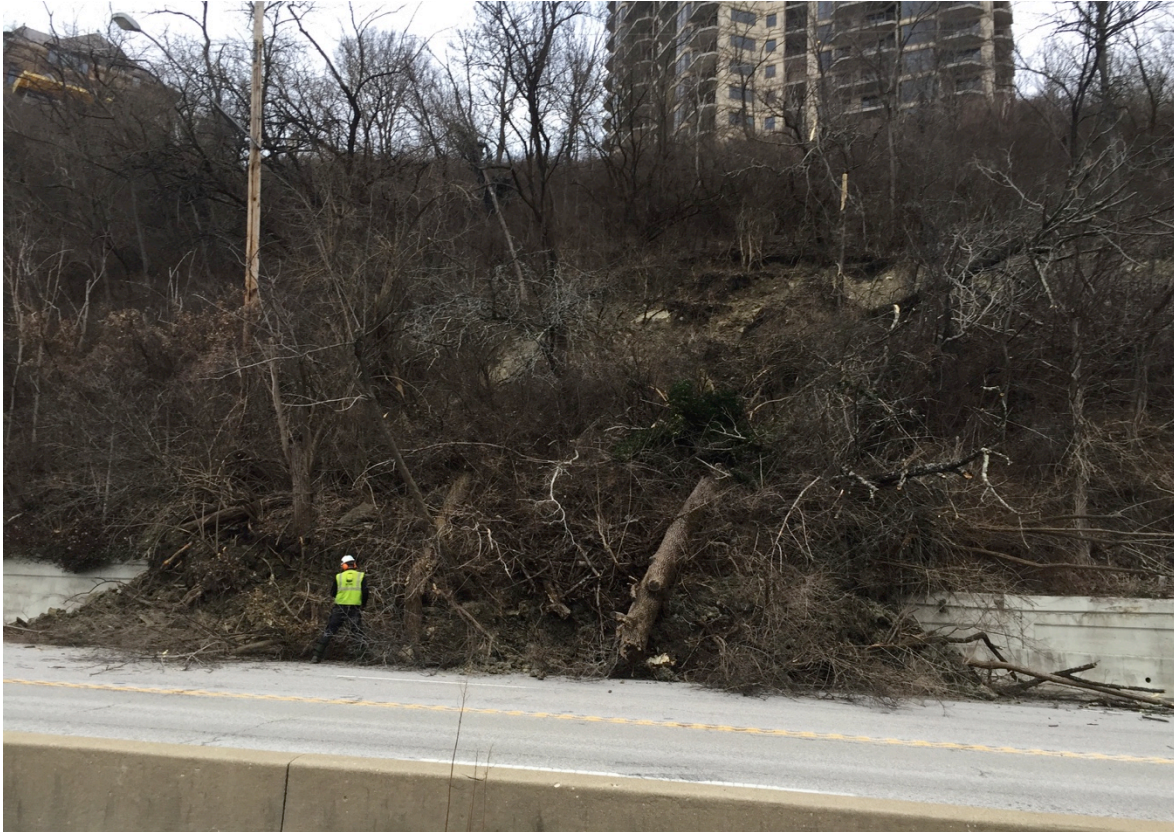
There were two locations where landslides on Columbia Parkway (between Bains and Torrence) that caused the closure of the Parkway in 2019 (see pages 26-27 for a third location). Sliding at the first location occurred on January 27, approximately 1,000 feet east of Kemper Lane. This landslide was the westward expansion of an area that slid in February and March of 2016, May of 2017 and again in February 25 of 2018. The most recent movement at this location was first noted by a DPS Emergency Service Response (ESR) person who notified DOTE personnel that the trees were leaning out onto the Parkway. DOTE and DPS personnel arrived on site and closed both lanes of the Parkway prior to any major movement. Slide debris came over the wall and onto the Parkway overnight while the Parkway was closed. Crews cleared trees and

Figure 7: Jan. 29th 2019 landslide on Columbia Parkway 1,000 ft. east of Kemper Lane

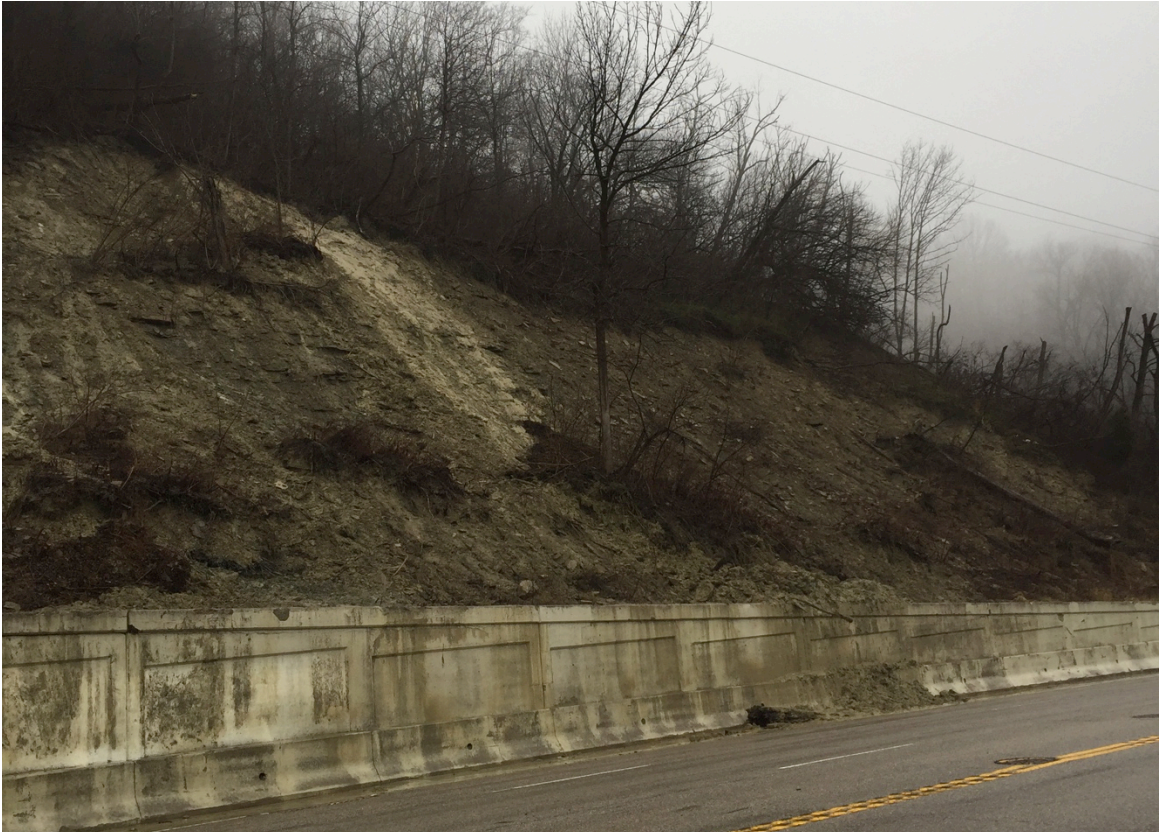
A small block of debris from higher up the slope broke loose at this location on February 11th, 2019. Although small, the removal of the debris required the temporary closure to remove it from the travel lane. Landslide activity was occurring at various locations on February 11, 2019. A significant landslide occurred on Hill Street in Mt. Adams approximately 200 feet west of Martin Drive and on Martin Drive 250 feet north of Hill Street. Hill Street was closed to through traffic.

Figure 8: Feb. 11th, 2019 debris coming over the wall 1,000 ft. east of Kemper Lane

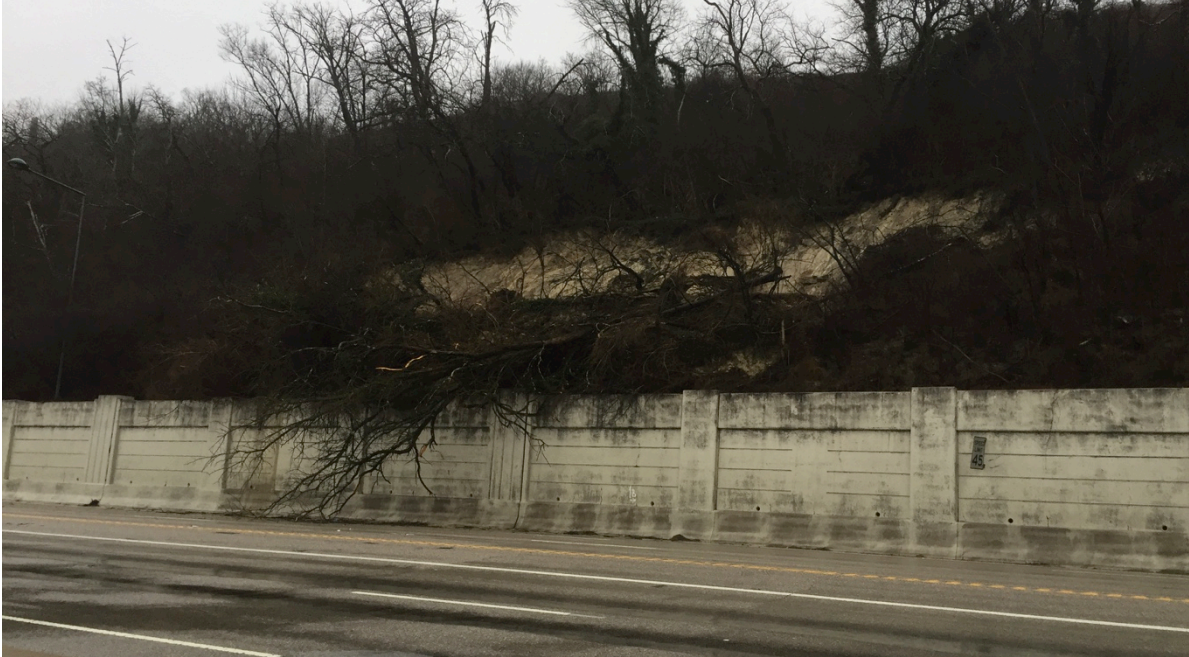
The second landslide on the Parkway occurred overnight and prior to the morning rush hour on February 12, 2019. This landslide is located 300 feet west of Kemper Lane. Cincinnati Police Department (CPD) closed the Parkway in both directions. Soil did not actually come over the wall however trees in the slide mass were hanging over the wall. DPS crews removed the slide mass after Davey Tree who is under contract with the City for emergency tree removal services removed the trees. The landslide debris was cleared from above the wall. The Parkway was opened that evening. In addition to clearing the landslide at this location, a small block of soil mass was also removed from the previous slide location east of Kemper Lane.

Figure 9: 300 ft. west of Kemper morning of February 12th, 2019

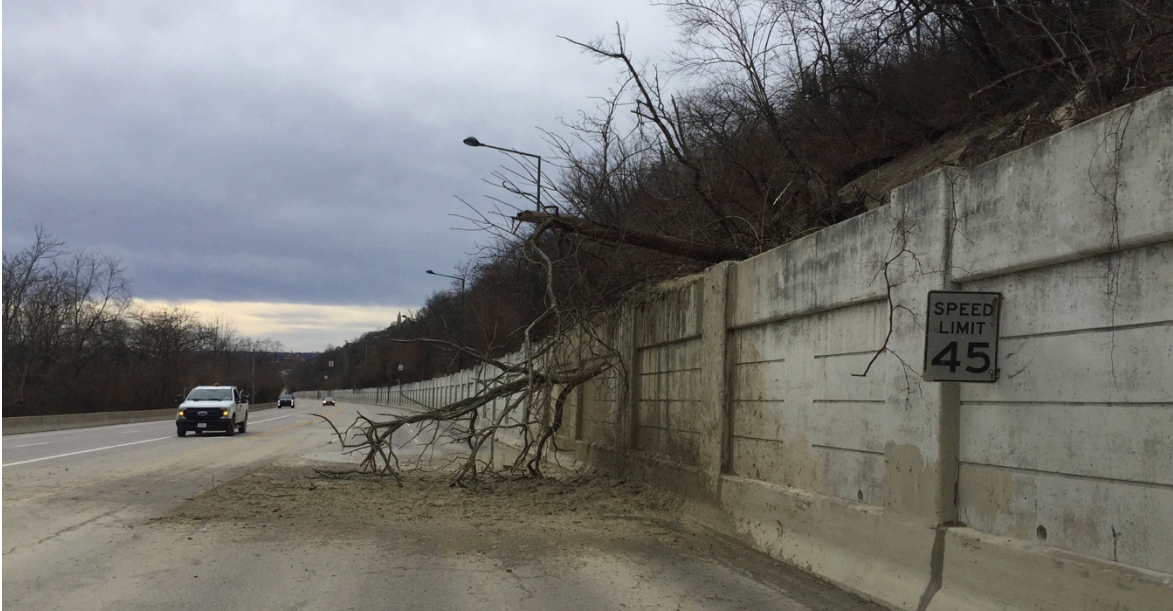
Trees within slide blocks in the upper reaches of the slope broke loose from the slope prior to their scheduled removal. One of the blocks slid completely down the slope on the afternoon of February 14, 2019.

Figure 10: February 15, 2019 300 ft. west of Kemper

The Parkway again had to be closed at his location until the trees could be removed along with a minor amount of soil. The Parkway was reopened on February 15th.

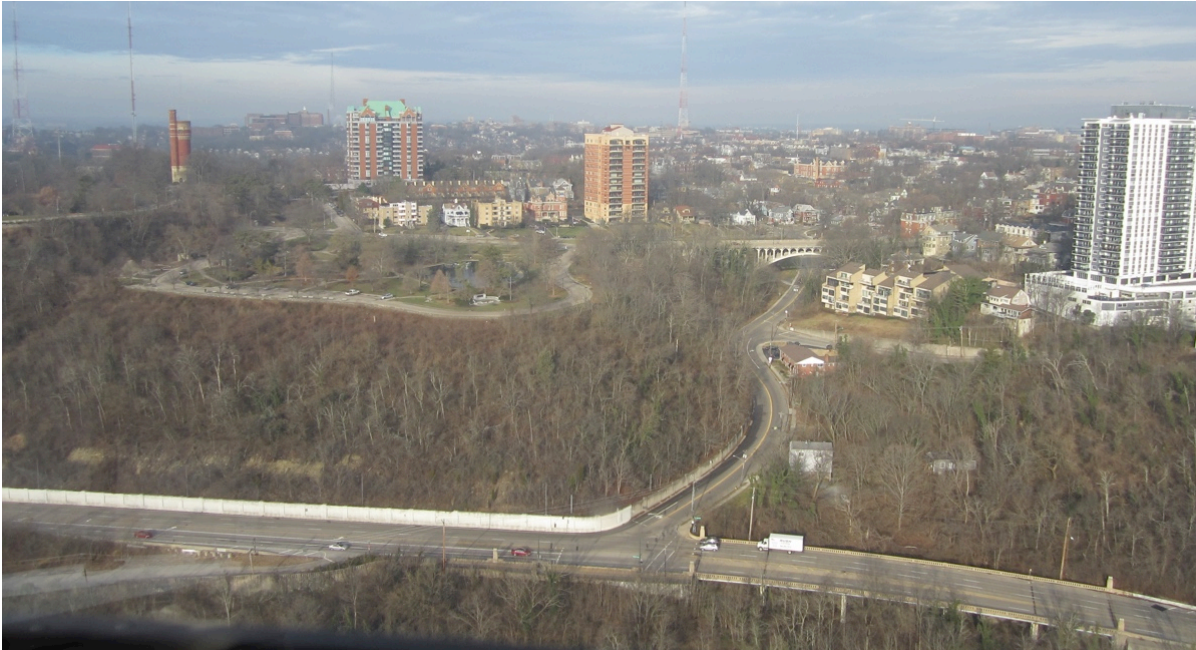
Figure 17: Landslide Area 3, 2017

The lower sliding is in the portion of the slope that was over steepened during construction. Weathered bedrock is exposed above the mass that slid and below the scarp where it broke from, now the lower portion of the landslide.

Soil has been removed from on top of the wall at seven locations (includes landslide on Kemper Lane) with the latest being the most recent landslide that occurred on February 12, 2019. Prior to the February 12th slide, the latest significant preemptive removal along this section was in 2014. Slid debris has remained relatively stable on top of the wall since at least 2010. Simply removing all the slid debris that sits on top of the wall would cost on the order of \$700,000 of thousands in landfill fees alone. This may remove immediate threat but would not restore the slope or prevent future slide blocks from separating from the upper portion of the hill and over the wall. Removal of the lower portion of the slide can also destabilize the upper larger slide mass. The lower portion of a slide provides resistance to movement if it has not completely separated from the larger mass.

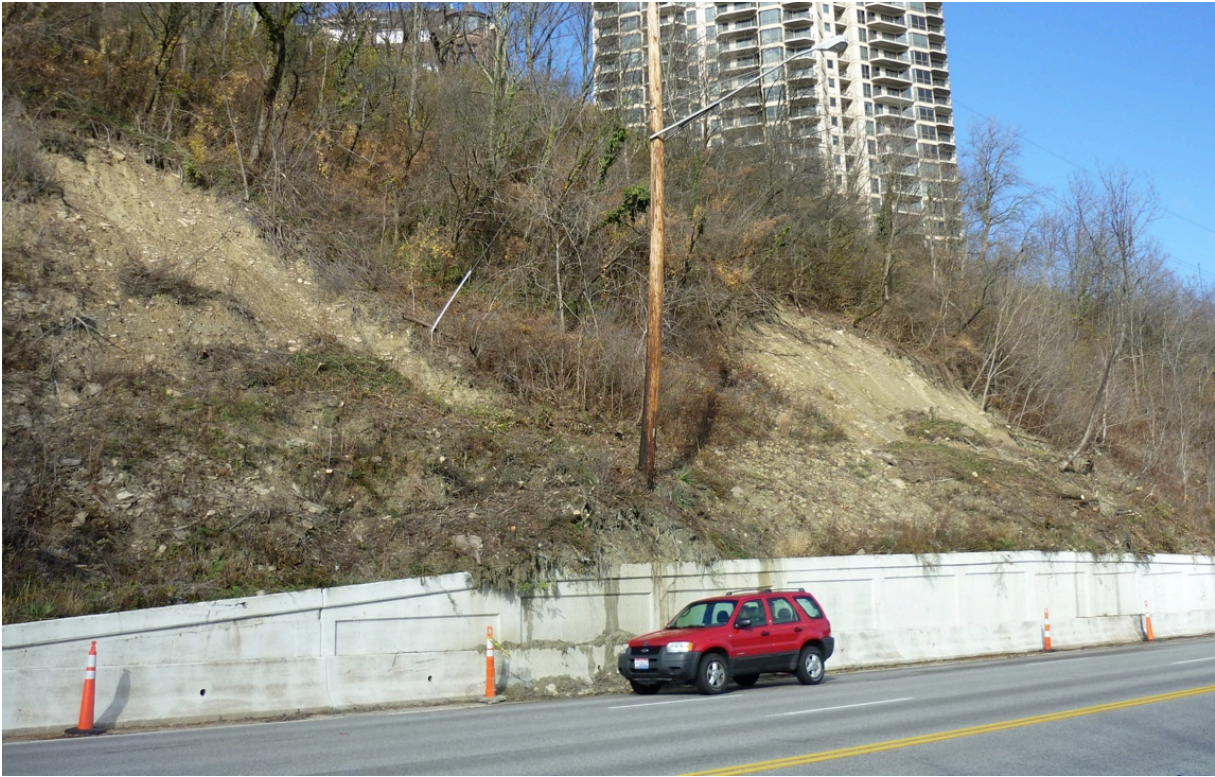
Significant landslides occurred in Landslide Areas 5 and 6 in 1975. Recent landslide activity requiring the removal of the slide mass was done at Landslide Location 5 in 2011. Debris removal in Landslide Area 6 has been active from 2013 into 2019. The area between Landslide Areas 5 and 6 appears stable.

Figure 18: Landslide Area 5, 2011

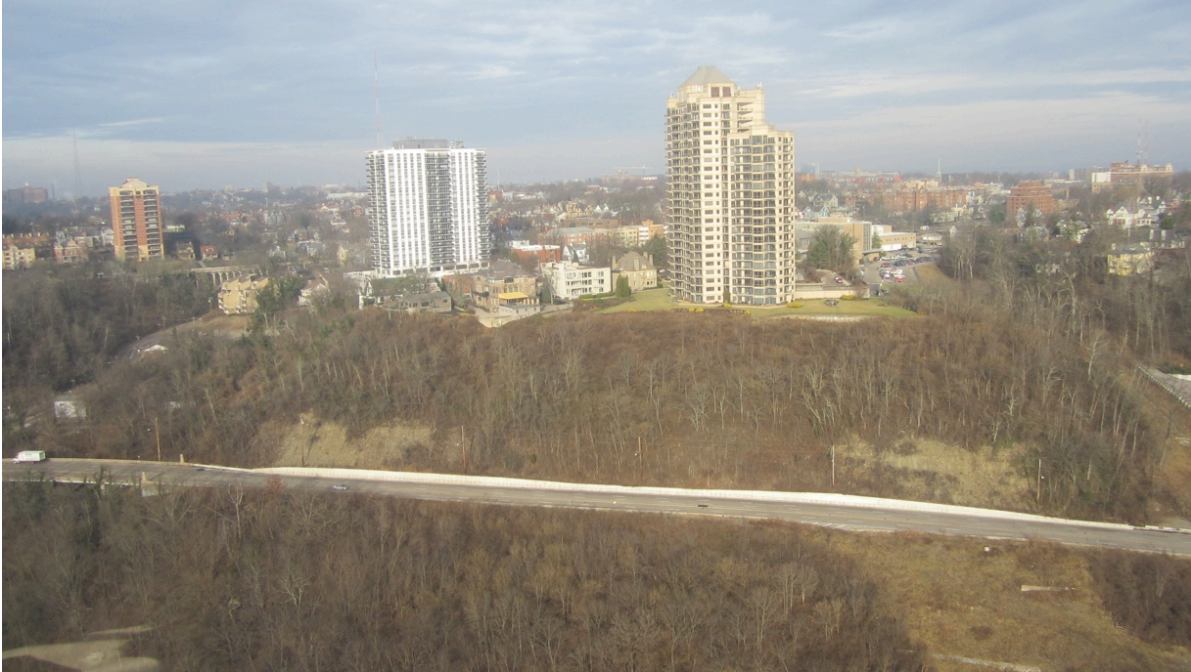
Figure 19: Landslide Areas 5 & 6, 2017

The major portion of the slide masses in Areas 5 and 6 has already slid and been removed. The upper half of the slide mass still exists on the hillside. The portion of the slide, immediately above the scarp line of the previous slides, can continue to slide downhill as blocks or as a large mass. Trees on the slide blocks can slide into the travel lane. This threat will exist unless the lower reaches of the upper portion slide are secured. A possible solution is to remove the trees that are a major hazard when sliding occurs. Simply removing the trees will not prevent slide blocks from sliding down the slope.

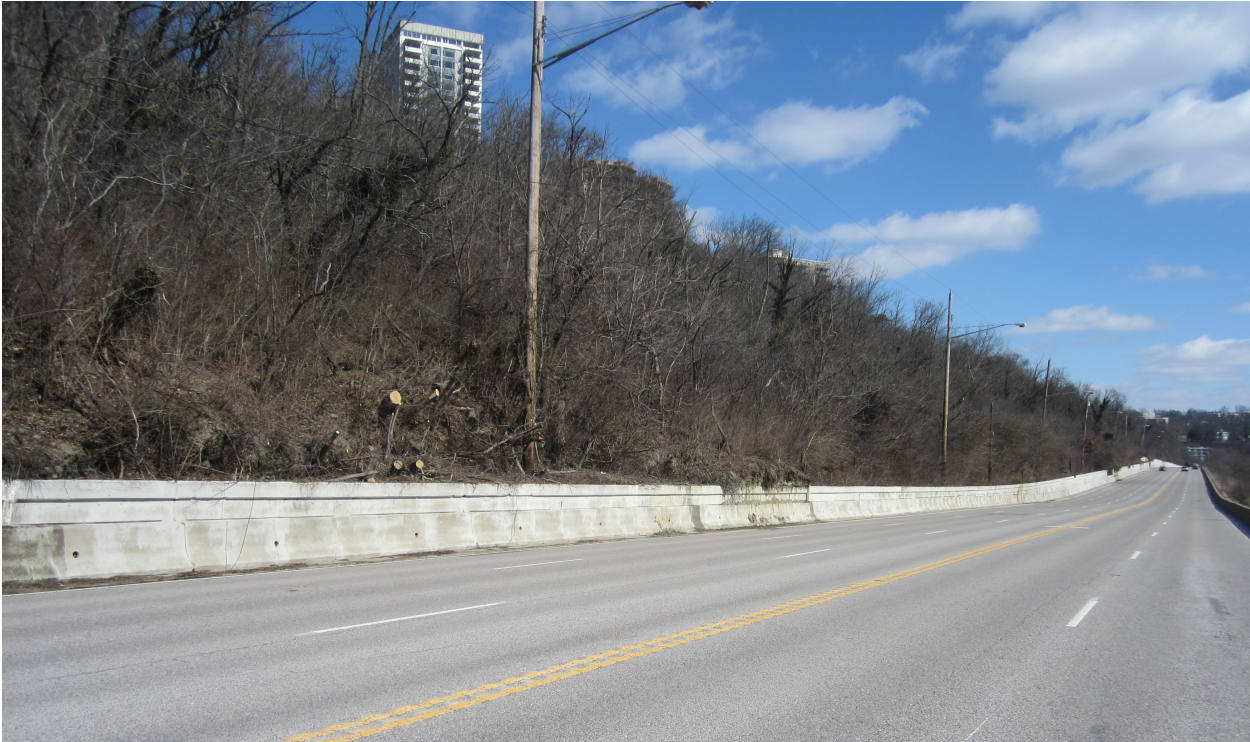
A well-defined landslide toe occurs directly above the retaining wall along the entire length of Landslide Area 7. An approximate 20 ft. long portion of the toe extended out onto the wall where it remained relatively stable since it first appeared in 2010. A prominent linear scarp exists along the entire length of the landslide and coincides with the length toe. The scarp has a vertical offset on the order of three to four feet. The scarp is on the downhill side of what appears to be a bench cut into the hillside. Water pools on the bench. Removal of the toe that extends on top of the wall has not been done because of the possibility of causing additional movement. The soil that overhangs the wall weathers and drops to the base of the wall is periodically removed from the base of the wall. Removal of the soil that overhangs the wall is quickly replaced by additional overhanging soil that then drops to the base of the wall. The amount of time required between removals is decreasing even during dry periods. A second bulge of the toe onto the wall recently developed in February of 2019.

Figure 20: Toe of Landslide 7, 2019

Landslide Areas 7 and 8 are extremely active in 2019. Both of the areas are large. The most economical method of stabilizing Landslide Areas 7 and 8 is by Method A which involves the construction of a retaining wall on the uphill side of the existing wall. Overhead utilities will need to be relocated or accounted for during construction. Landslide Area 7 is on private property. Landslide Area 8 is on City owned property.

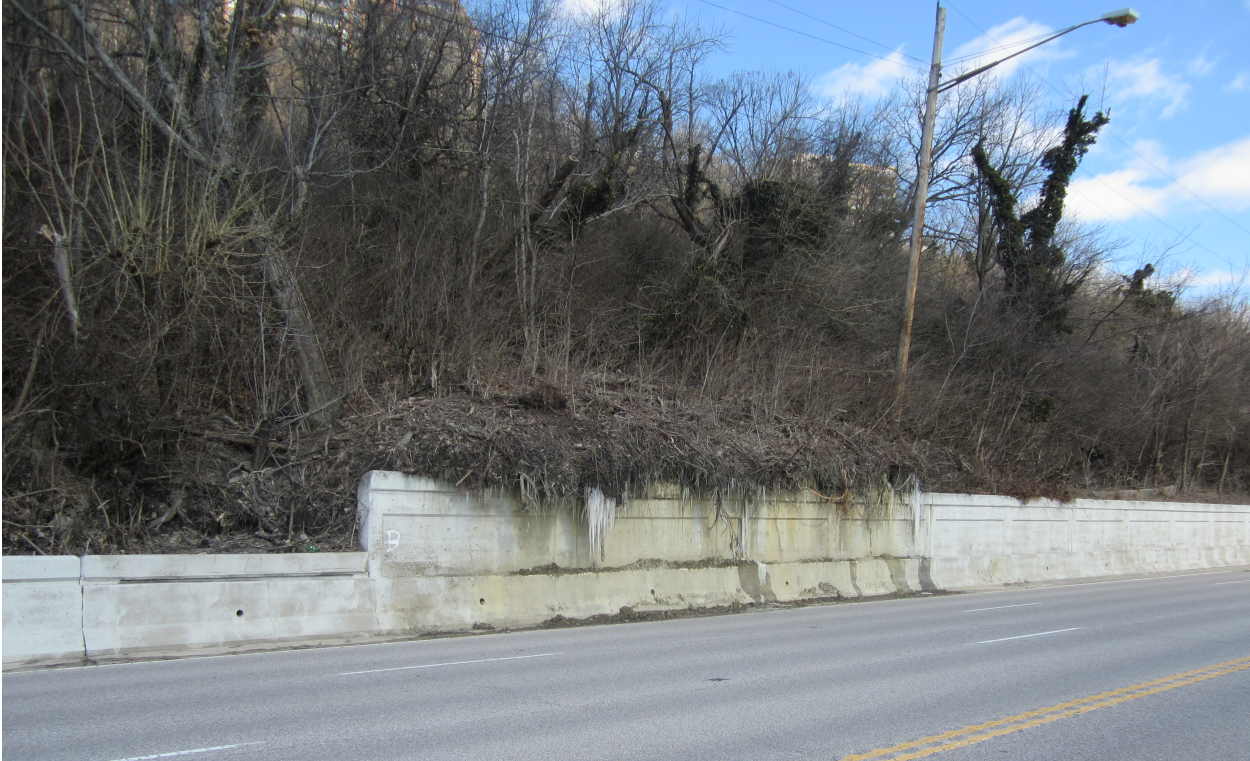
Encroachment of the toe of a landslide onto and over the wall also occurs in Landslide Area 8. The toe of the western portion of Landslide 8 is within an abandoned driveway. This toe of this landslide started encroaching onto the wall since at least 2013. The size of the toe has increased significantly over the last six years. Minor removal of the

soil that overhangs the wall is quickly replaced. As in the case of Area 7 removal of the has not been done because of the possibility of causing additional movement. The eastern half of the landslide toe sits on top of the retaining wall. A light pole is located within the toe and has been leaning for at least the past decade.

Figure 21: Toe of Landslide 8, 2019

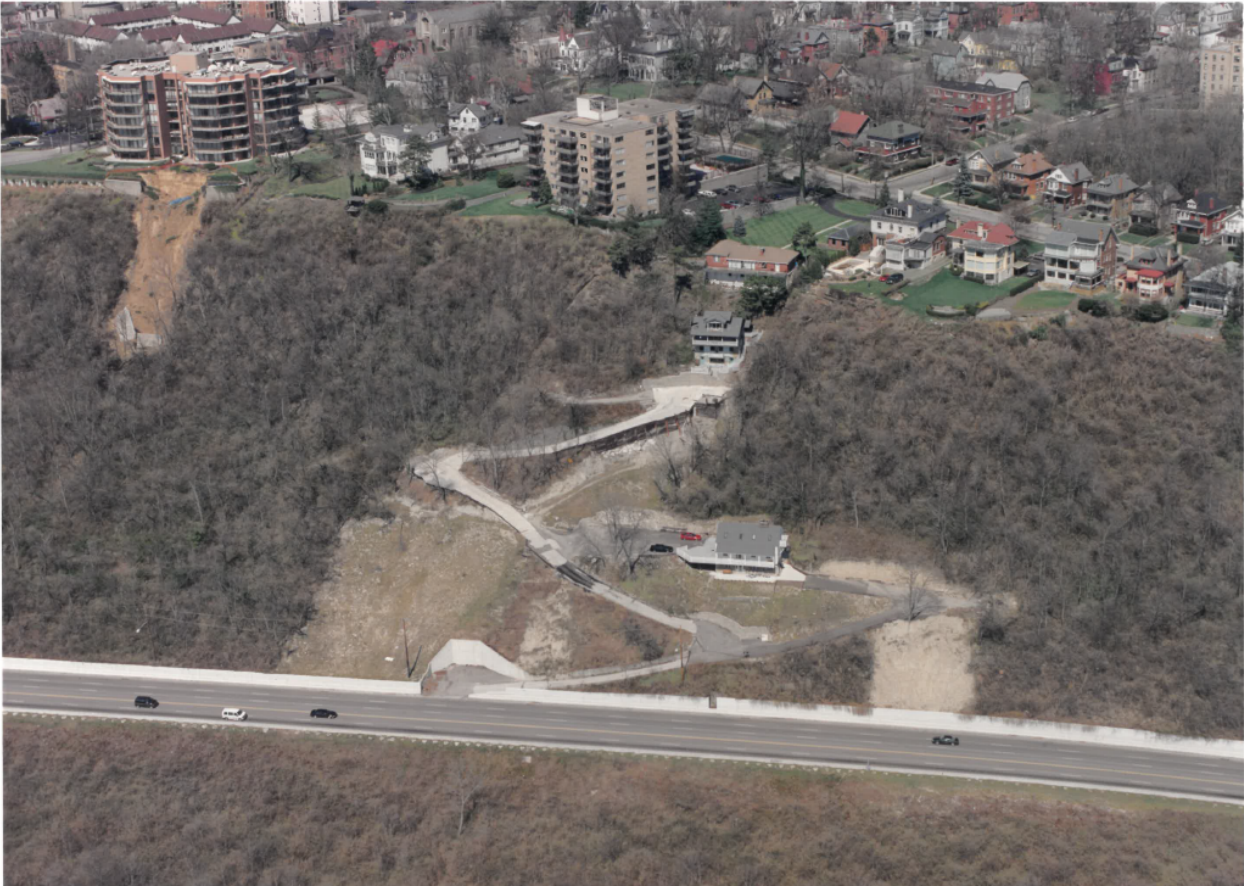
Landslide Area 9 includes a landslide that occurred in 1997 east of the driveway to 2110 Columbia Parkway. DPS removed the slide debris in 1997. The scar from the removal is shown below the switch back of the driveway of Figure 22.

Figure 22: 2110 Columbia Parkway 1997

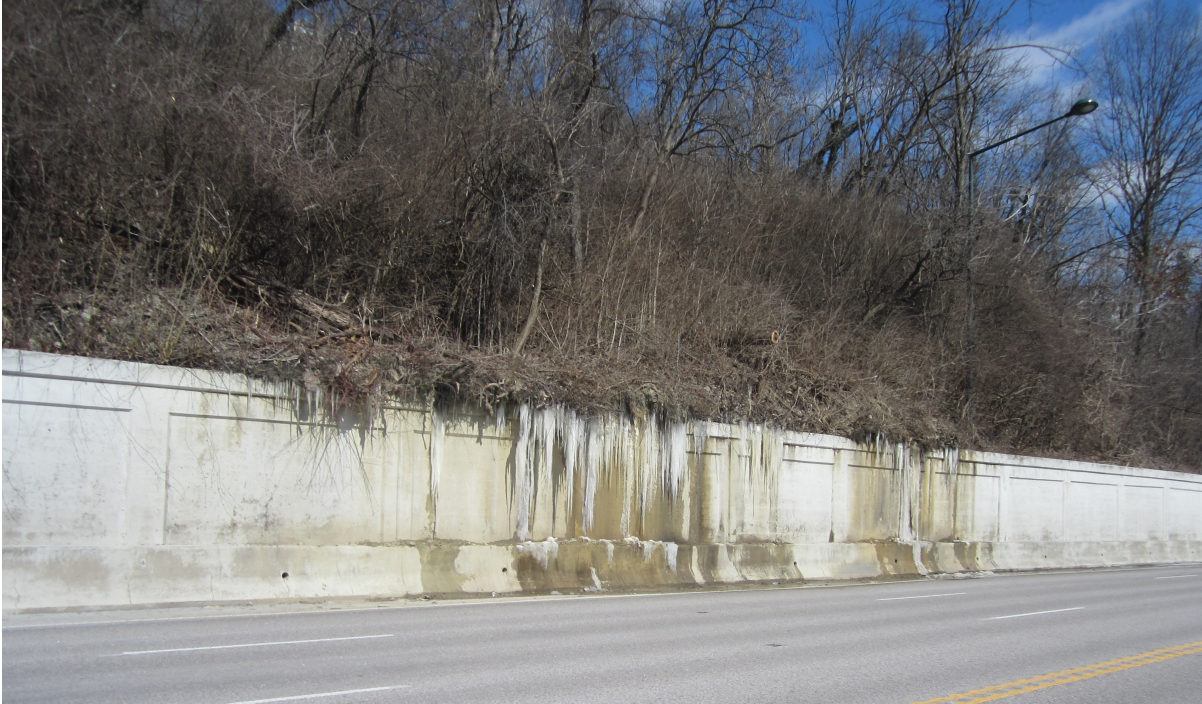
This landslide is an eastern extension of the landslide that occurred on March 21, 2019. The March 25, 2019 slide has a well defined scarp approximately 25 feet upslope of the wall. Additional scarps and tension cracks exist higher up slope. The ground was completely saturated on March 25. Water was standing in puddles and water was flowing from numerous seeps on the hillside.

Figure 23: Landslide Area 9, 2019

Removal of the lower portion of the hillside that broke away and remains on top of the wall will leave an approximate 175 ft. long cut above the wall at the toe of the slope. The immediate stability of the hillside is questionable at best and there is a strong potential for additional movement following or during a period of rainfall. This area needs immediate stabilization. Until the slide is secure, lane closures of westbound Columbia Parkway west of Torrence will be in place.

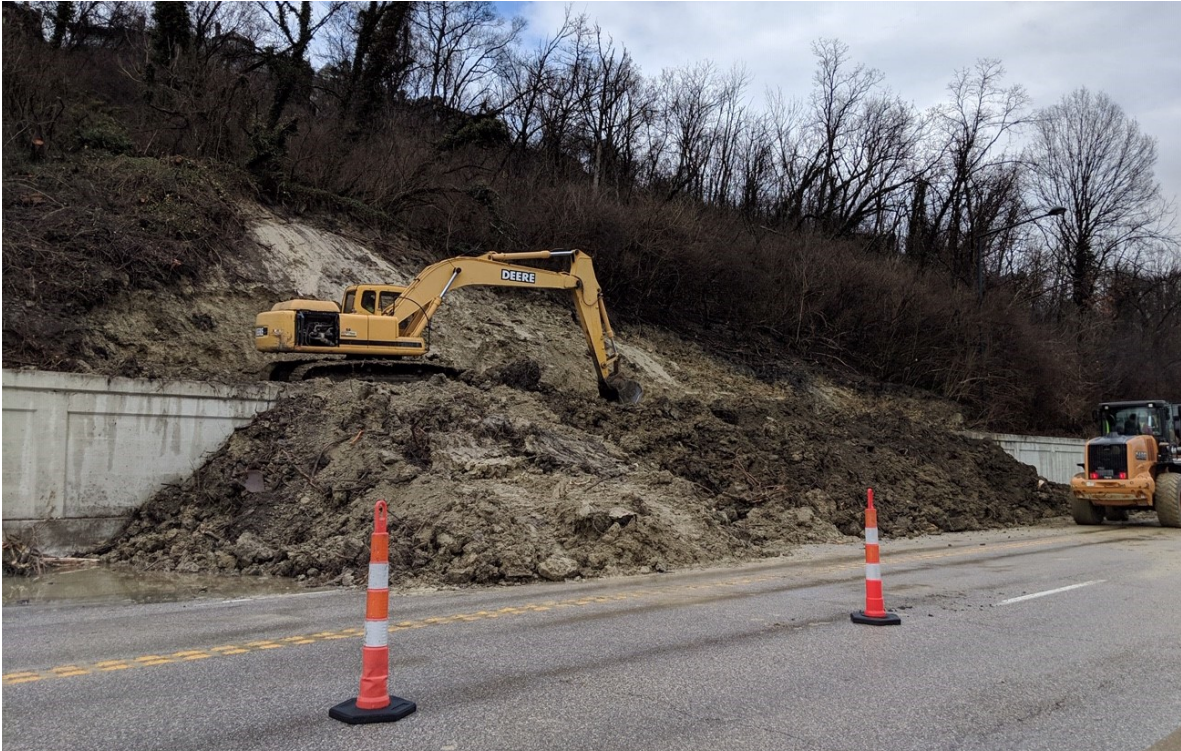
The area east of the 1997 landslide in this section of the Parkway is extremely active and recently started moving at an accelerated rate. This landslide Area started moving onto the wall in 2011. Soil did not start dropping onto the pavement until late February of 2019. Movement on March 20, 2019 resulted in the closure of two lanes. DPS began removal of the slide mass on March 21 and completed the removal on March 22, 2019.

Figure 24: Landslide removal Area 9, March 21, 2019

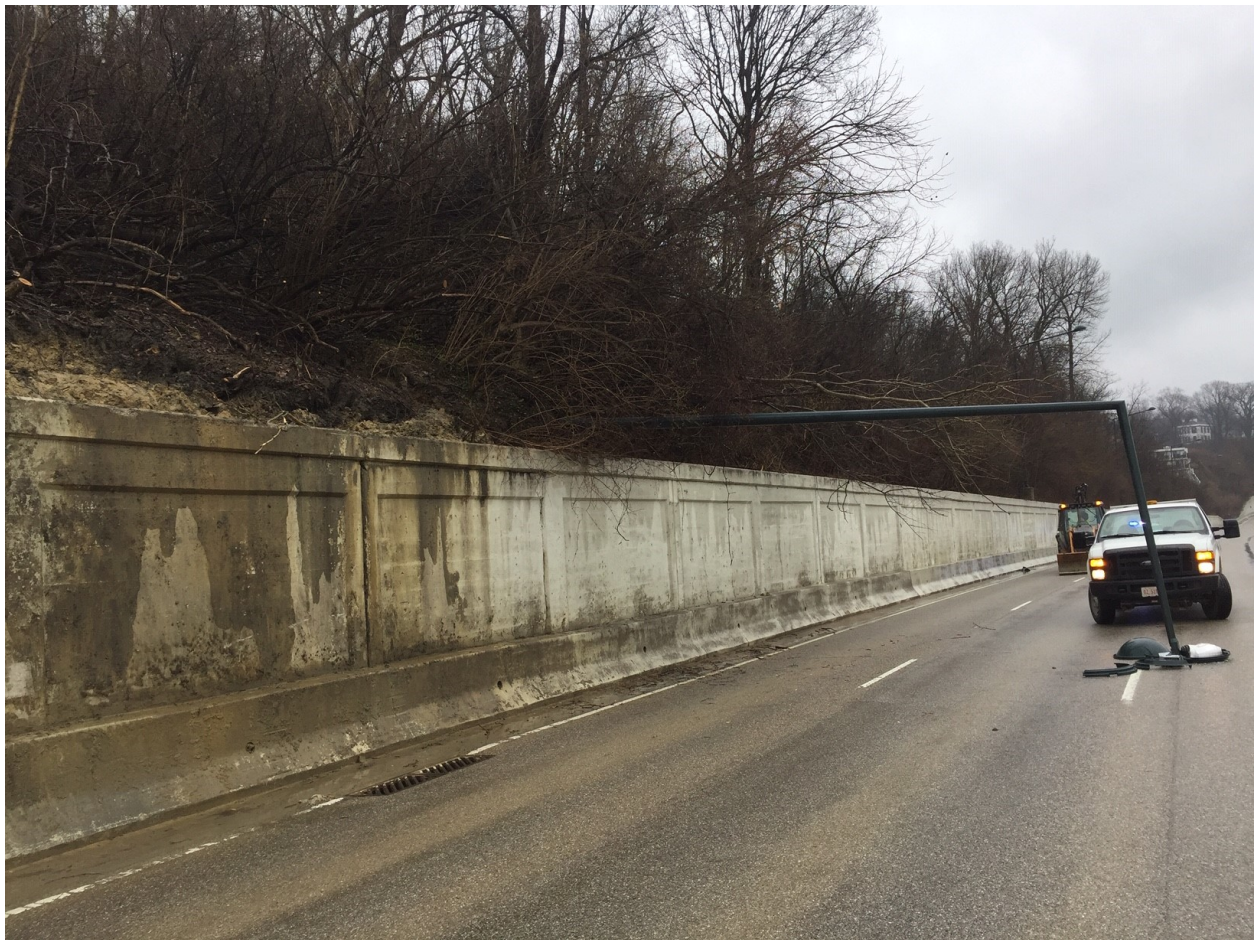
Figure 25: Landslide knocks over light pole, March 25, 2019

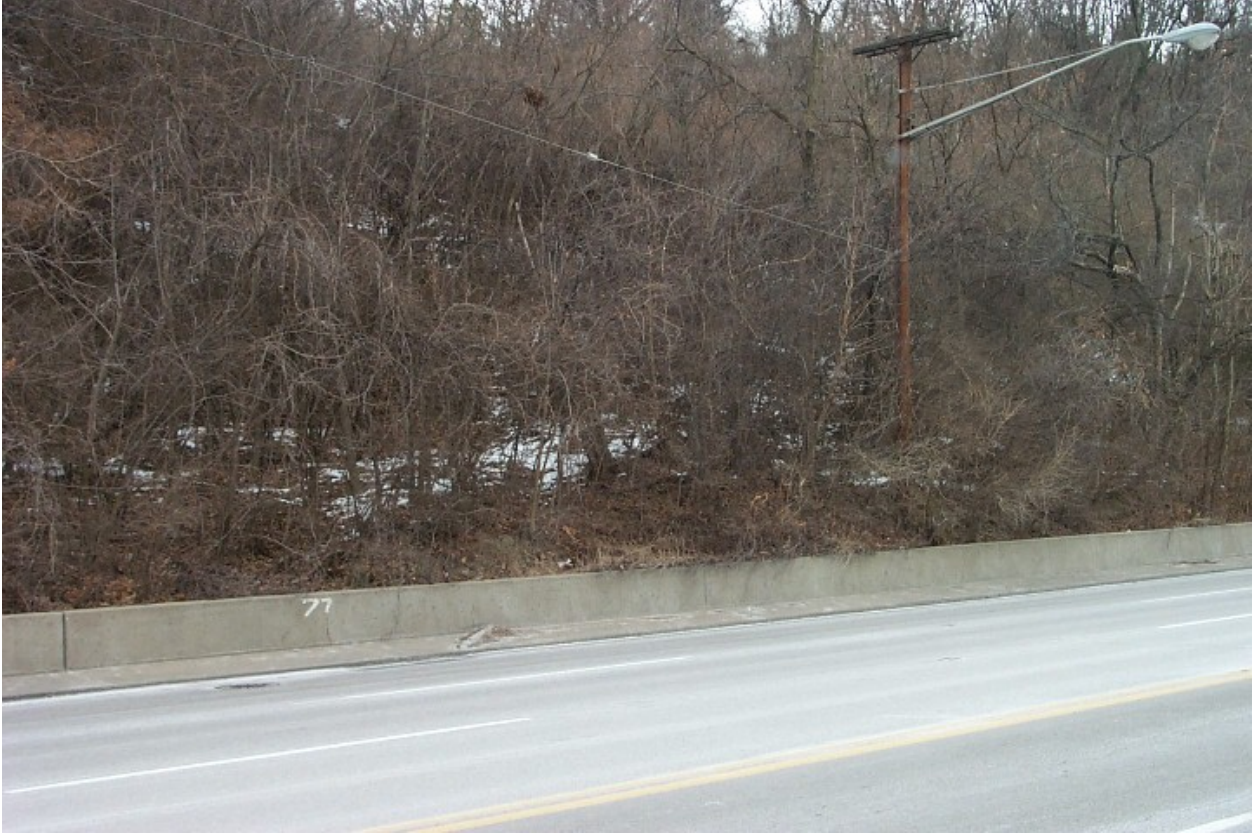
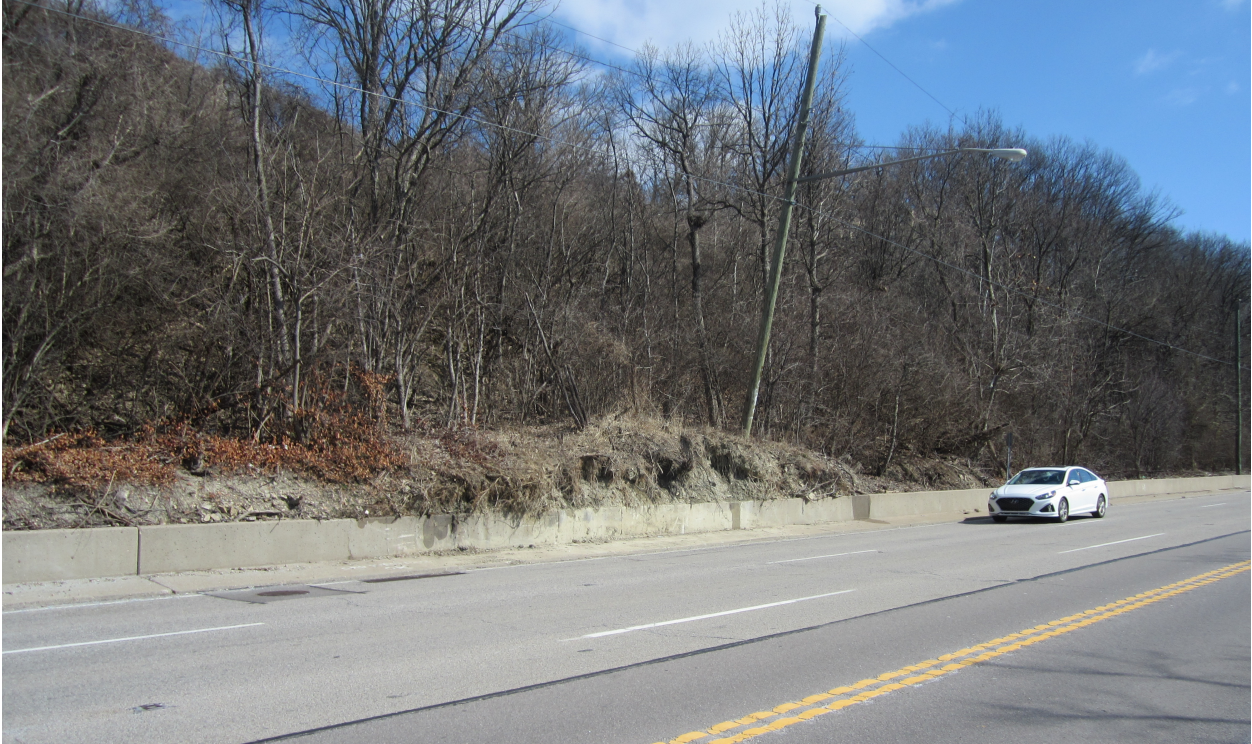
An active landslide exists approximately 750 feet east of Torrence Parkway. The landslide is directly below and predominately on the property of 444 Whitman Court. The landslide has been in existence since at least 2001. A utility pole with a streetlight is in the slide mass. The landslide causes the pole to lean over time. The pole has been reset a least once since 2008. The existing wall along the length of the slide is only on the order of 2 ft. The toe bulge of the slide continually overtops the low wall. Debris accumulates at the base of the wall and requires constant removal by DPS. Duke has been notified in 2018 and 2019 about the leaning pole and recently straightened the pole on March 20, 2019.

Figure 27: Landslide Area 10, 2001

Figure 28: Landslide Area 10, 2019

The construction of a wall, most likely a pier wall is the probable method of stabilizing the area. Overhead utilities will need to be relocated or accounted for during construction.
