## 2016 & 2017 RETAINING WALL AND LANDSLIDE REPORT

City of Cincinnati

Department of Transportation and Engineering

Structures and Geotechnical Section

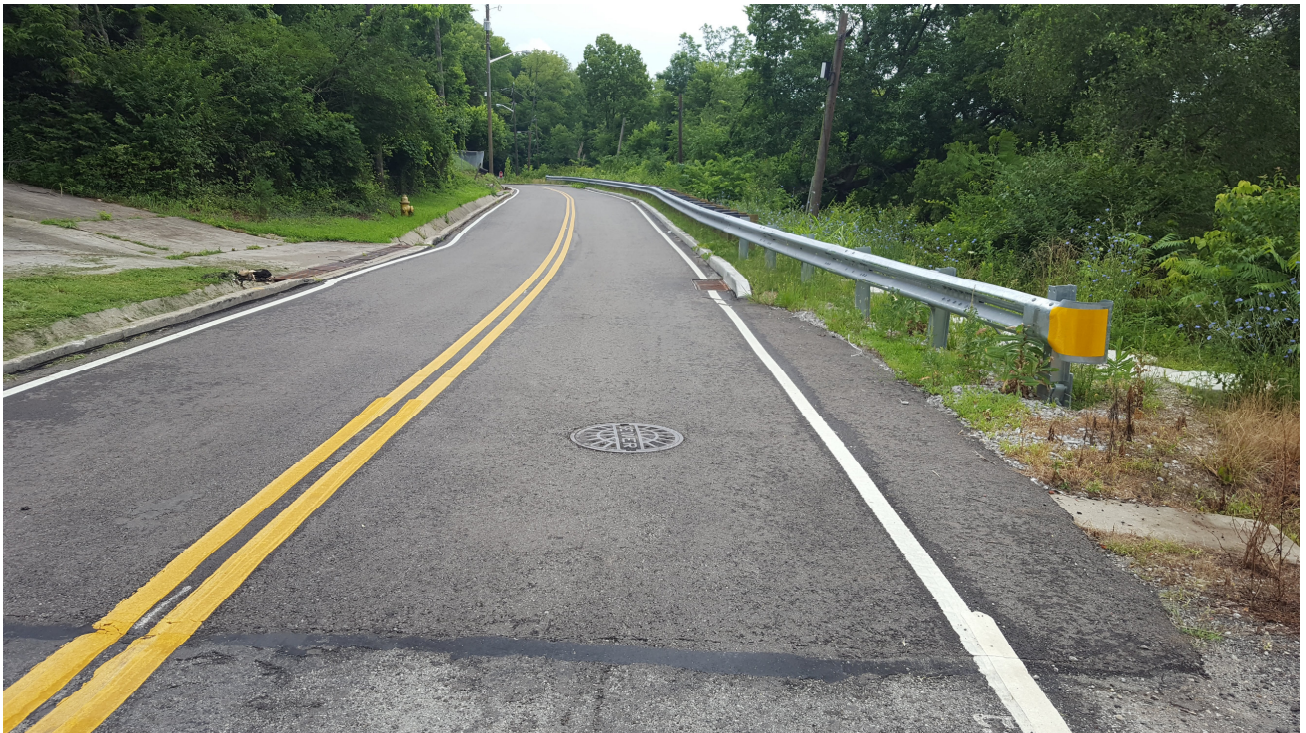
### **Hillside Avenue at Tyler Street** (Riverside)\_ (2016) - Construction cost - \$461,445

The landslides at the intersection of Hillside Avenue and Tyler were repaired in 2016. A pier wall was constructed to stabilize the landslide on the west side of the intersection and a fill buttress was constructed to stabilize the landslide on the east side of the intersection. This work was completed in June 2107. Fifty percent of the construction cost was funded from the State of Ohio Capital Improvement Program (SCIP).

Newly paved surface of Hillside Avenue looking east towards Tyler Street. Roadway stabilized with a drilled pier retaining on the downhill side of the guardrail.

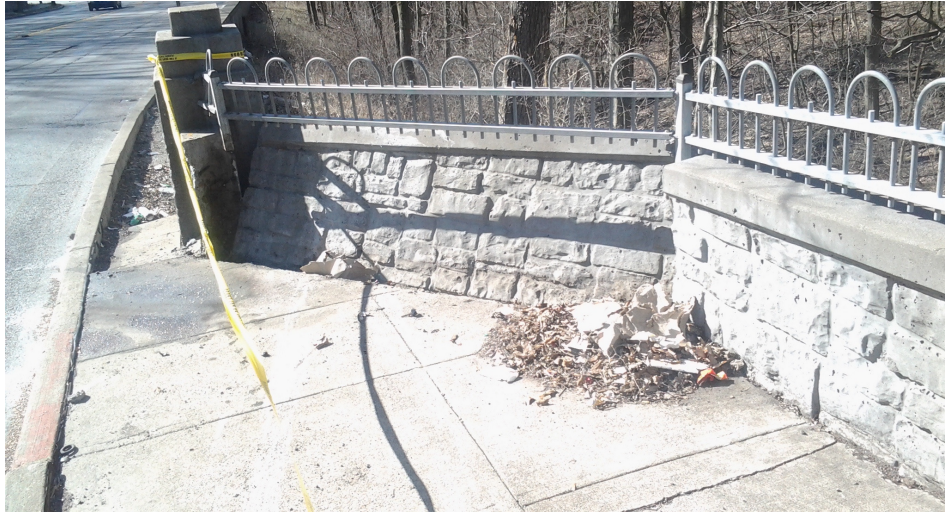
**Colerain Avenue Bus Stop Barrier Walls** (Mt. Airy) (2016) - Construction cost - \$15,000

The bus stops bump-outs along the southbound side of Colerain Avenue are constructed on top of a drilled pier retaining wall and include vehicle barriers. Two of the bus stops were heavily damaged in vehicle crashes and required reconstruction. DOTE worked with the Department of Public Services to reconstruct the two damaged areas.

Damaged bus stop opposite Tranquility Lane.

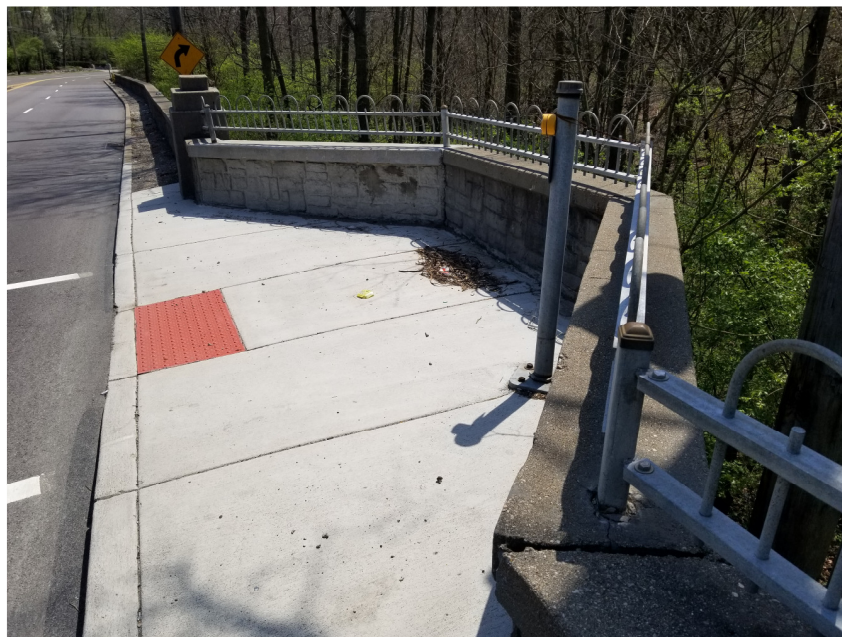
Repaired bus stop opposite Tranquility Lane.

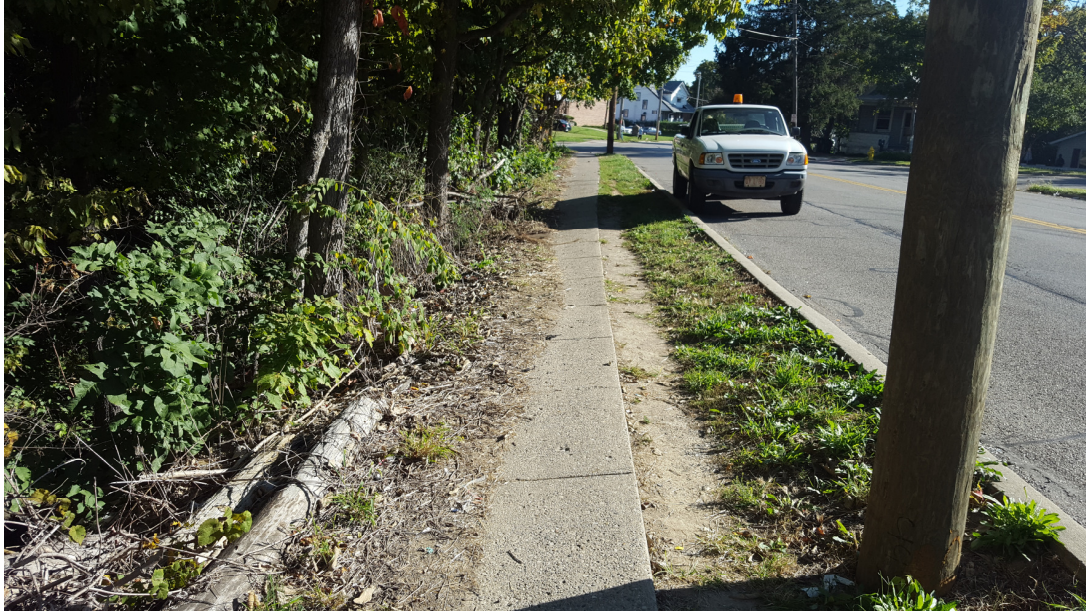
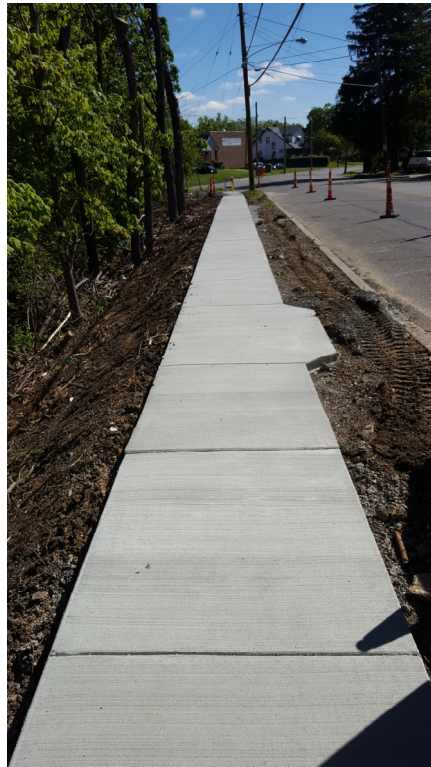
**McHenry Avenue Sidewalk Replacement** (East Westwood) (2017) – Construction cost - \$23,512

A heavily used section of sidewalk had been sinking due to slow hillside movement (creep). The area was re-graded with lightweight fill and the sidewalk was replaced to City standards, including ADA requirements. This work was funded jointly by the Wall Stabilization and Landslide fund and the Sidewalk Maintenance Program of DOTE.

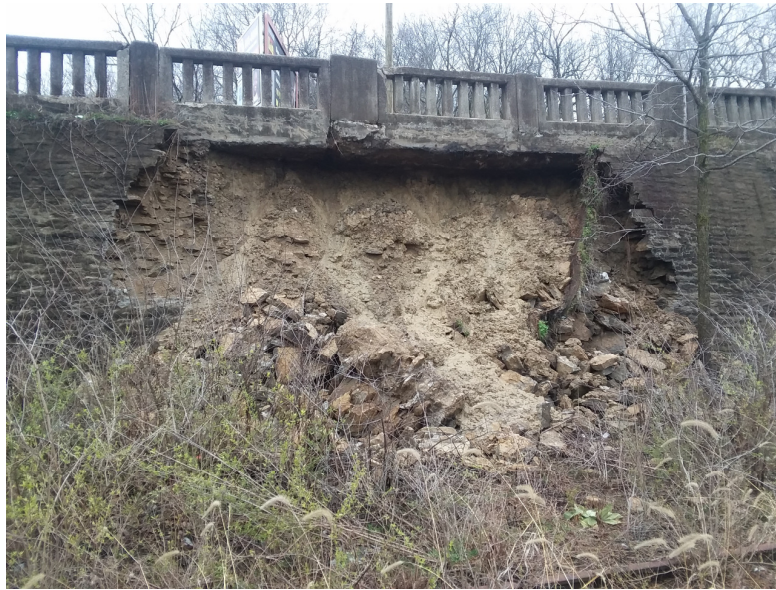
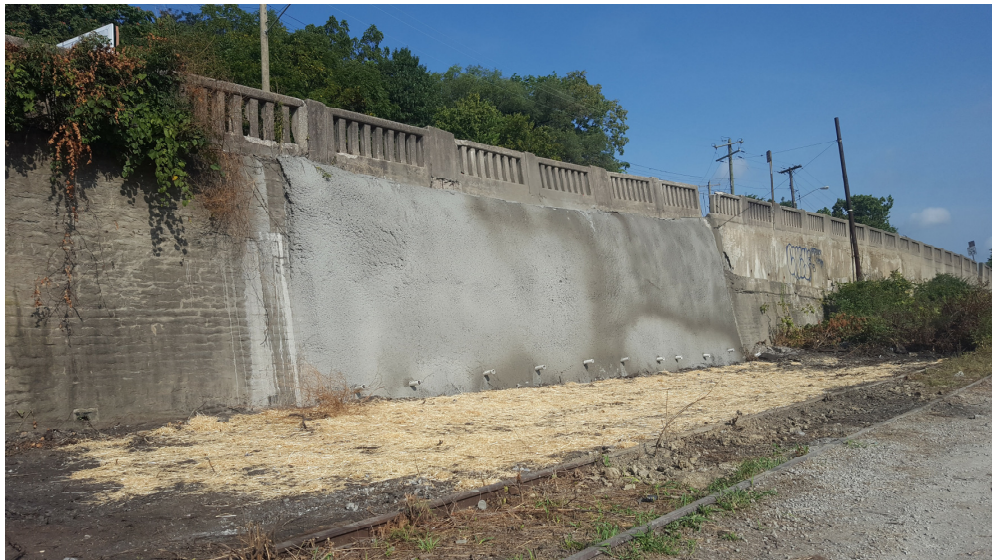
**Beekman Street** (North Fairmont) (2017) - Construction cost - \$174,000

A section of the retaining wall supporting Beekman Street in South Fairmont failed in March 2017, closing one lane of the north bound roadway. DOTE applied for and received Ohio Public Works Commission Emergency Funding to cover 80% of the repair cost for this project.

The wall was repaired using soil nails and a shotcrete facing. Once a series of critical utility issues were resolved, the Contactor completed the stabilization work in 2 weeks.

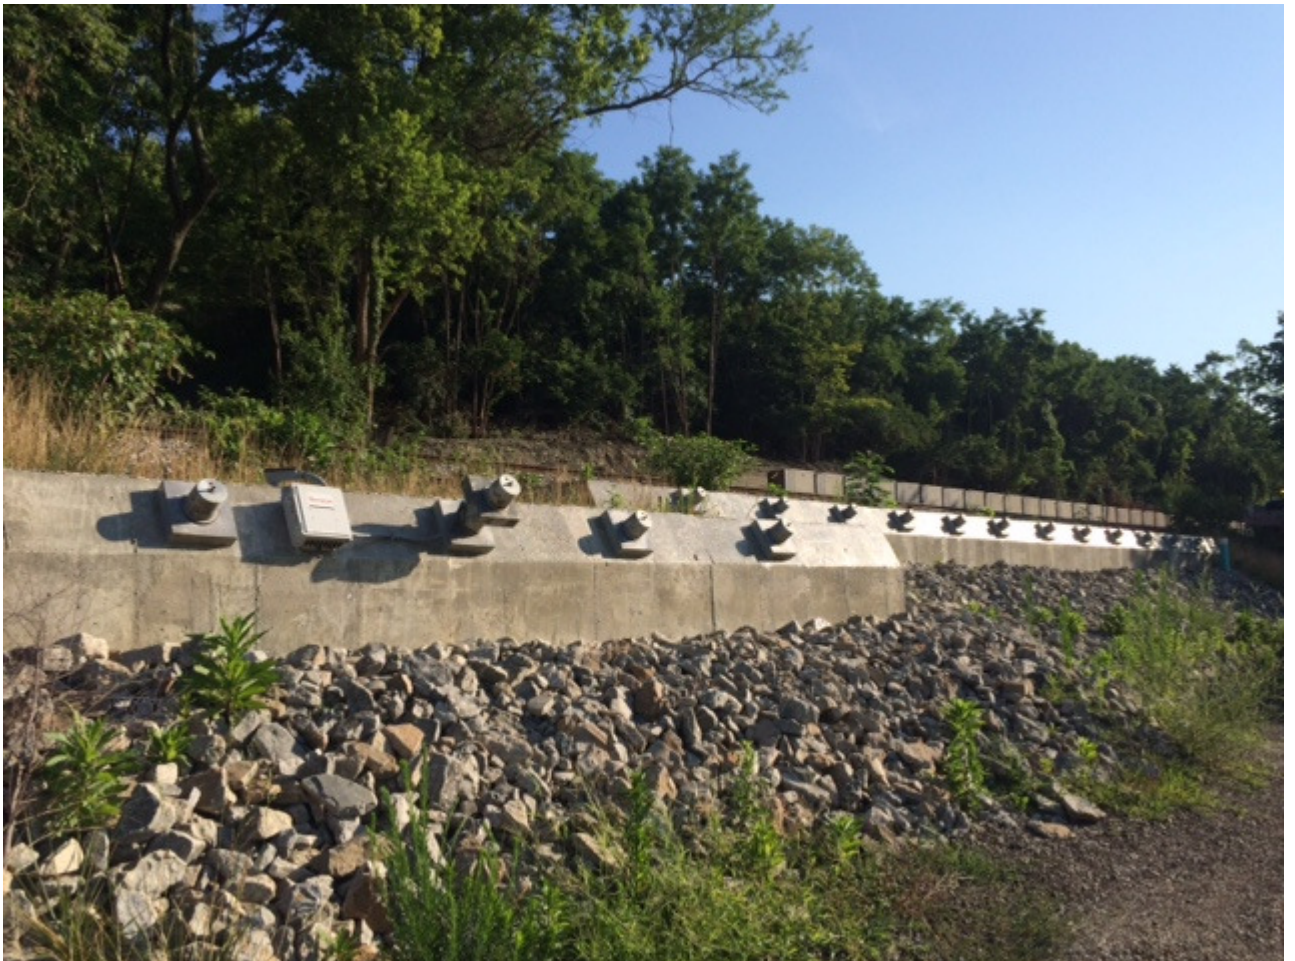
East end of Area 1 Retaining Wall

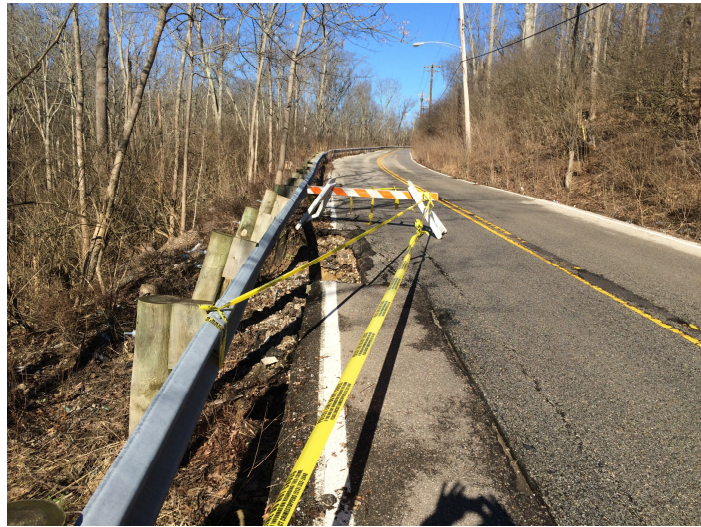
The rain event which caused the February 2018 Flood in southern Ohio resulted in a failure of roadway on Kirby Avenue that required the southbound road to be closed. The failure was the result of concentrated surface runoff directly onto an unstable slope due to a clogged inlet. DOTE designed an emergency repair and initiated emergency procurement procedures while concurrently applying for funding relief from FHWA. A drilled pier wall approximately 120 feet in length was installed to close the gap between two existing pier walls and the roadway was completely reopened less than 2 months later. DOTE anticipates being reimbursed by FHWA for this work.

Closure of inbound lane on Kirby Avenue

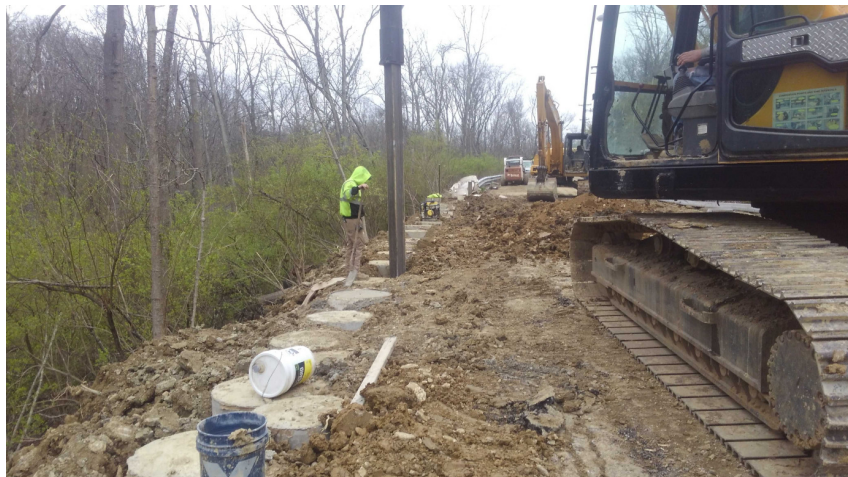
Drilling Piers on Kirby Avenue

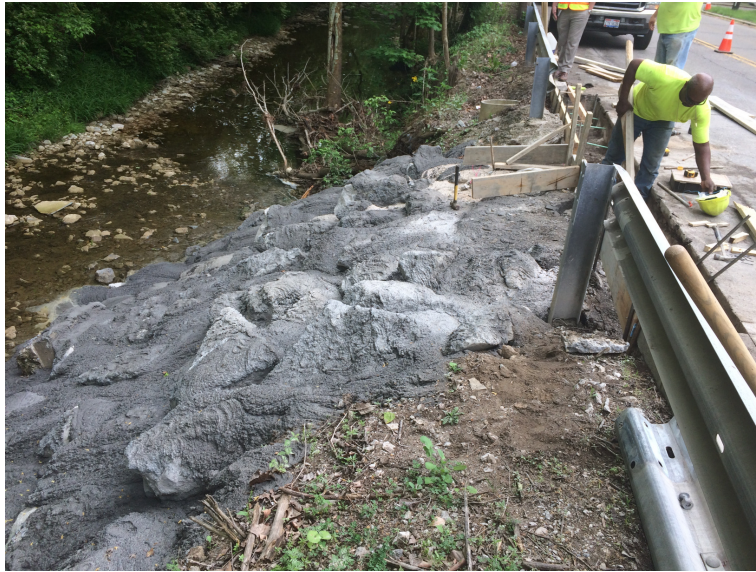
Grouted Rip-Rap at Camargo Road

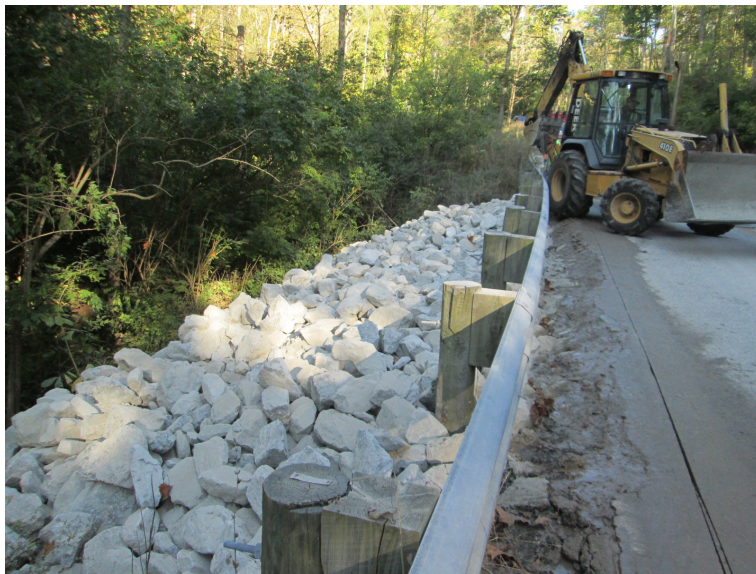
Rip-Rap placed on Kirby Avenue.

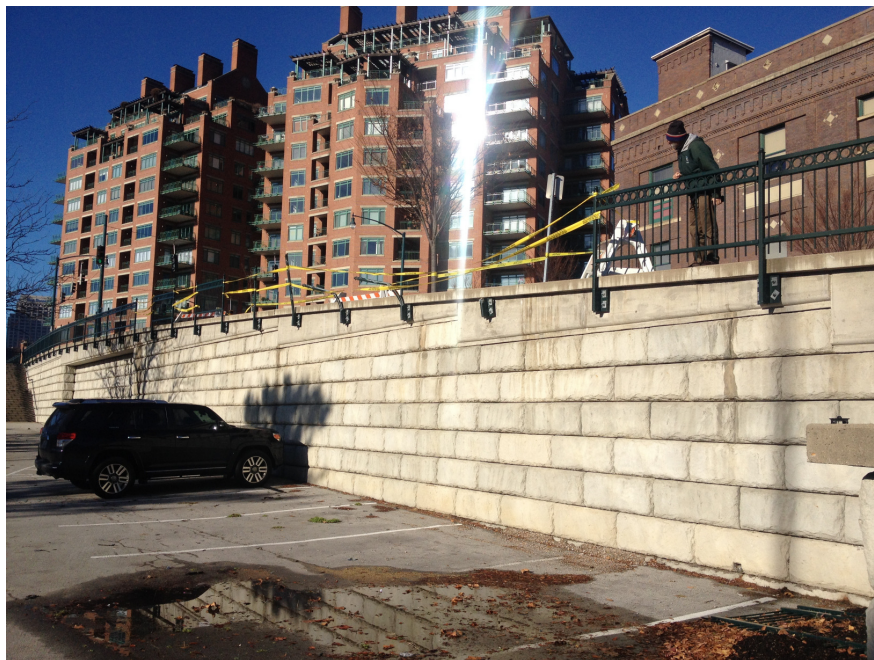
Seventy-two feet of railing needed to be replaced on the Riverside Drive Retaining Wall (Wall #335-143B) due to an automobile accident on December 27, 2016.

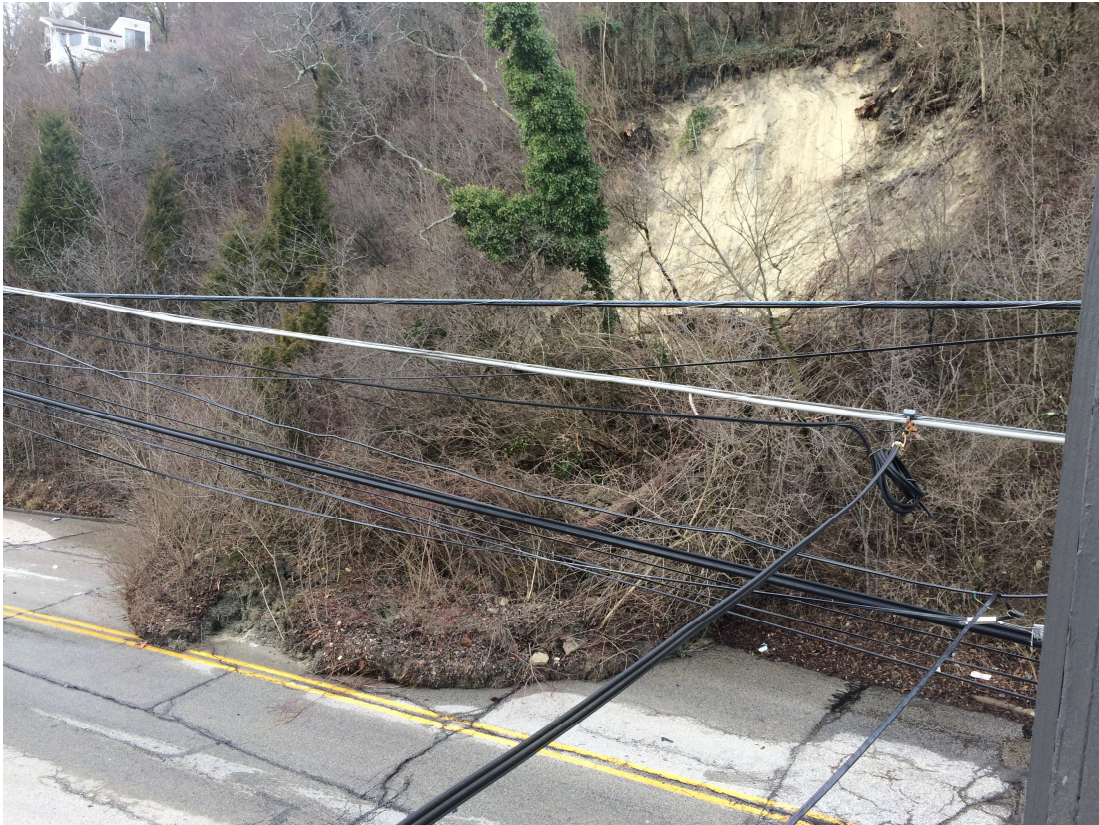
The landslide on Martin Drive occurred on February 25<sup>th</sup>, 2018. This landslide and the need to remove additional debris from Columbia Parkway approximately 1,100 feet east of Kemper Lane occurred after a significant storm event.

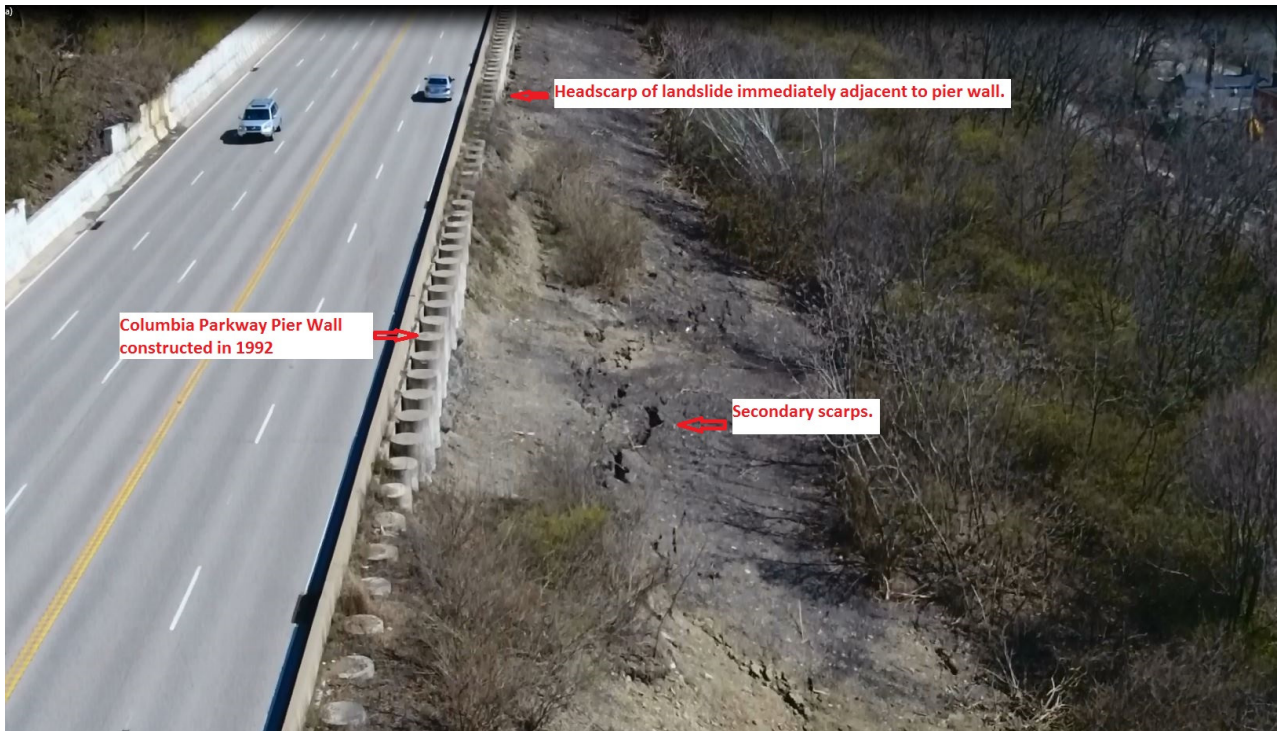
### **Columbia Parkway Retaining Wall Restoration** (Riverside)

The Riverside Drive Landslide originates along the downhill side of the existing pier wall which supports Columbia Parkway. The existing pier wall is a continuous wall consisting of a series of thirty, thirty-six and forty-two inch diameter piers all installed at a center to center spacing of seven feet. Concrete lagging was constructed behind and between the piers and extends eight feet below the top of the piers. The lagging retains the soil between the piers. The piers are embedded ten (10) to seventeen (17) feet into the bedrock and effectively separate and protect the Parkway from the landslide. The Riverside Drive Landslide, however, caused the ground surface in front of the piers to drop several feet below the bottom of the existing concrete lagging. The project consists of the construction of cast in place panels to retain the soil exposed between the existing piers and below the existing lagging to prevent the eventual loss of granular backfill from behind the existing panels. State of Ohio Capital Improvement Program (SCIP) funding has been approved by the Ohio Public Works Commission (OPWC). The funding is at a 50% local match. Municipal Road Funds from Hamilton County have also been obtained for project funding.

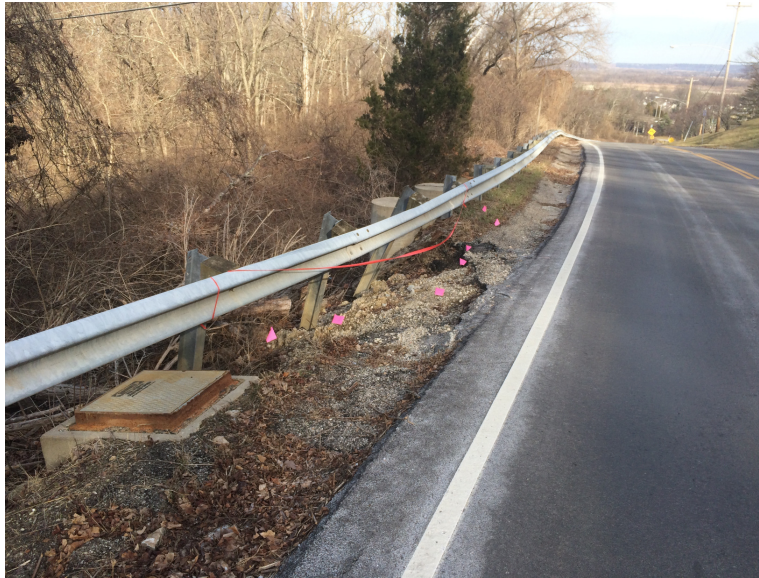
**Grandin Road Wall Extension** (Mt. Lookout) – Estimated construction cost – \$350,000 - \$400,000

A portion of Grandin Road between the driveways for the NIOSH facilities and opposite Tuscany Place is being subjected to slope movement. The most significant movement has undermined guardrail and has damaged a paved drainage channel in the roadway shoulder. The movement begins at the west end of a pier wall that was constructed in 1995 and continues for 230 feet.

Limited funding will more than likely restrict the extent of the repair of Grandin Road to the section where the guardrail is being undermined (above) leaving the section shown below unsupported.

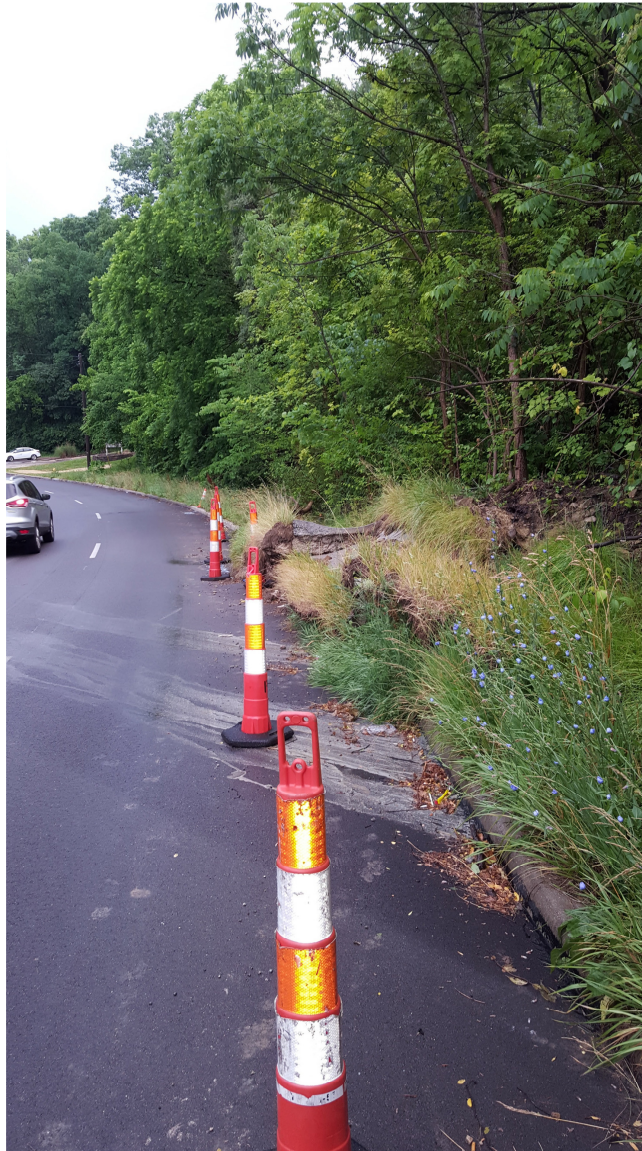
**Sunset Avenue Retaining Wall** (West Price Hill) – Estimated construction cost – \$150,000 - \$250,000

The toe of the landslide that occurs below the private driveway accessing the Eagle Watch Apartments has slid in to the roadway along Sunset Avenue. The initial movement resulted in damage to the concrete storm ditch and resulted in the concrete from the ditch sticking into the roadway. Department of Public Services promptly removed the concrete debris from the roadway and has had to remove additional soil from the advancing slide on several occasions. Limited funding prevents the immediate construction of the wall. Plans are being prepared in case additional movement absolutely necessitates construction of a wall. Construction of a retaining wall along the toe of the slope would not only prevent further movement into the travel lane but also allow for the reestablishment of the concrete drainage ditch.

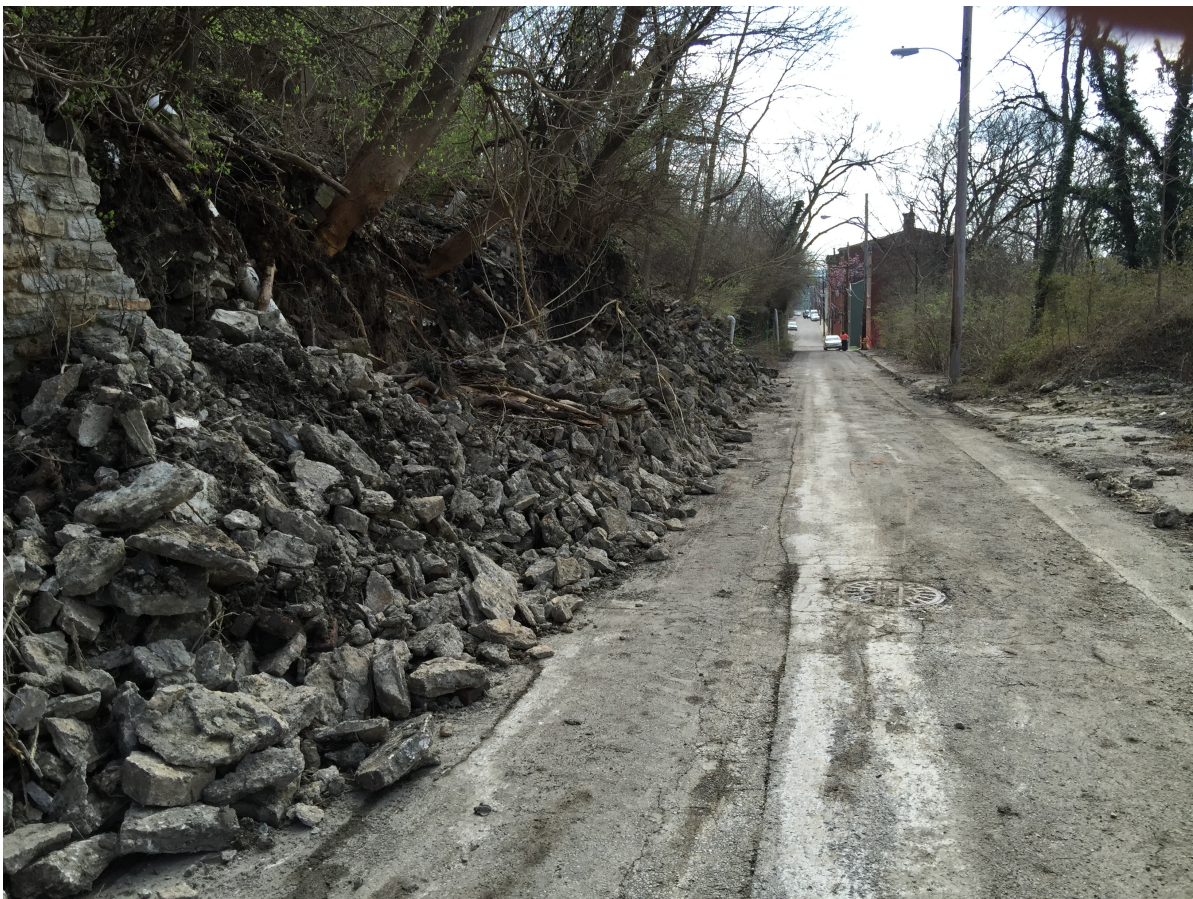
A series of privately owned mortared limestone retaining walls along Peete Street have been failing since 2015. These walls were built in the late 1800's when the lots that front along Mulberry Street were developed. A continuous stretch of 10 private walls have failed or are failing, prompting the Department of Buildings and Inspections to issue repair orders to the Mulberry Street Homeowners. At the request of the Homeowners, City Council passed a motion in June 2017 requesting that the City Administration begin the process of designing and constructing a public retaining wall to maintain the right-of-way and assess the Homeowners the project cost. Requests for Proposals (RFP) were requested in February 2018. The cost of the wall presented in the proposals was higher than expected. At the homeowner's request, a second request for RFP's was made in July of 2018. Three RFP's were submitted and are being reviewed by the Selection Committee.

Looking east down Peete Street. Public Services cleared the retaining wall debris from the roadway and stockpiled the stone against the slope to support it. Photo taken on March 3, 2016.

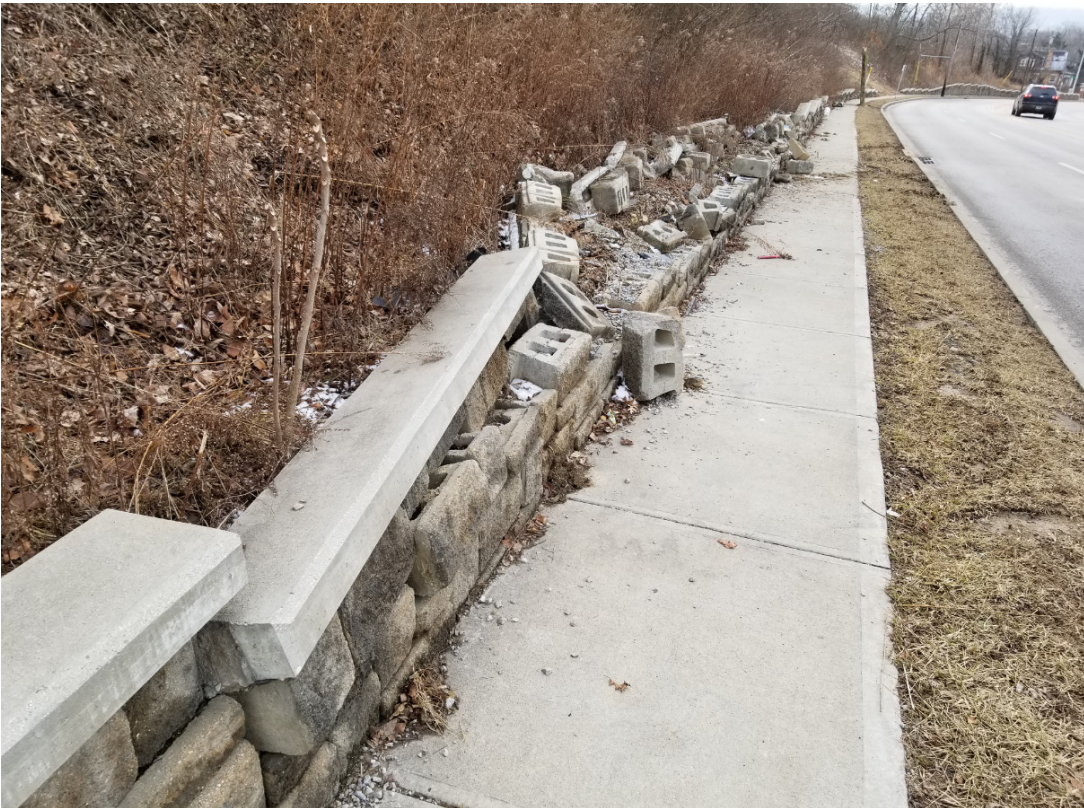
**Hamilton Avenue Segmental Wall Repair** (Northside)- Estimated construction cost  
– \$35,000 - \$50,000

A segmental retaining wall constructed in 2009 as part of the Hamilton Avenue Roadway Improvement Project has been repeatedly struck in vehicle crashes. The wall was repaired on several occasions only to be struck again. DOTE applied for State of Ohio funding for safety upgrades to the roadway. The wall will be reconstructed as part of the project once improvements are made to improve drainage and the pavement surface to eliminate or at least reduce the number of crashes that have destroyed the wall.

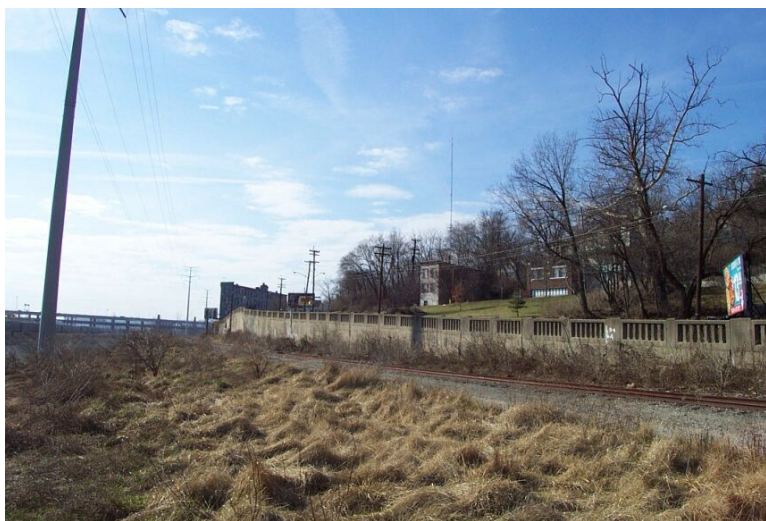
The existing wall is in fair condition, the coping which is attached to the wall and the concrete railing which is attached to the coping is in a failed to critical condition. Sections of the railing have deteriorated, exposing reinforcing steel. Sections of the railing which appear visually sound crumble within a grasp of the hand. Guardrail sections have been bolted to the pilasters throughout the years to temporarily repair the railing.

Southern portion of Cummins Street retaining wall from below.

The project requires removal of disintegrated concrete down to sound concrete and replacement of concrete removed. Soundings revealed approximately 2,000 square feet of unsound concrete. Joints between the panels need to be reconstructed and the entire wall will need to be sealed. The repairs to the retaining wall are essential in order to avoid complete replacement of the retaining structure. The existing concrete railing and coping needs to be replaced with a Texas Style railing by doweling into the existing retaining wall. The installation of the new concrete railing will require the removal and replacement of the curb.

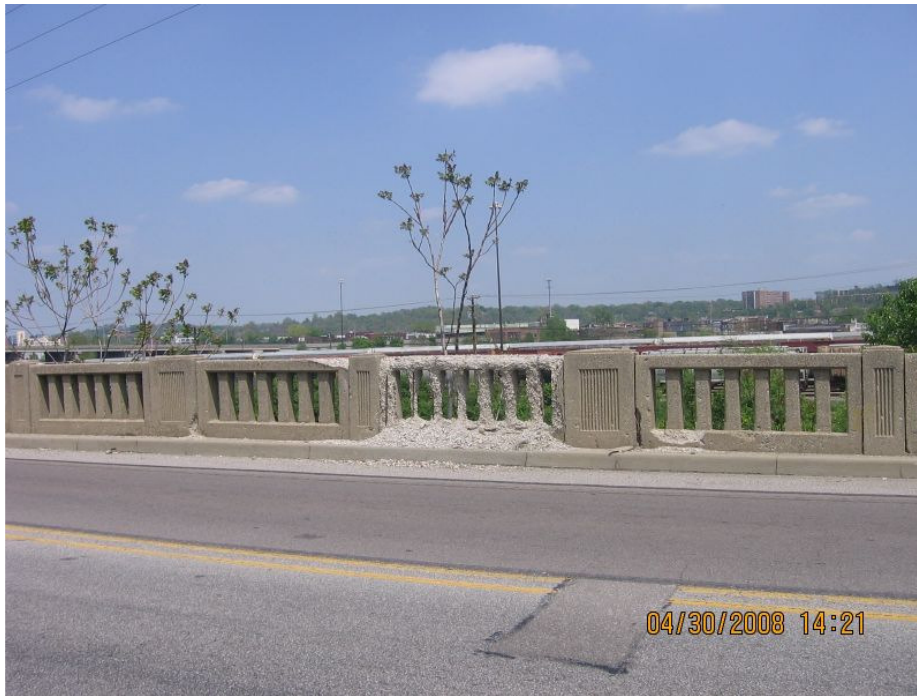
Disintegration of railing exposing steel reinforcement most likely due to salt spray.

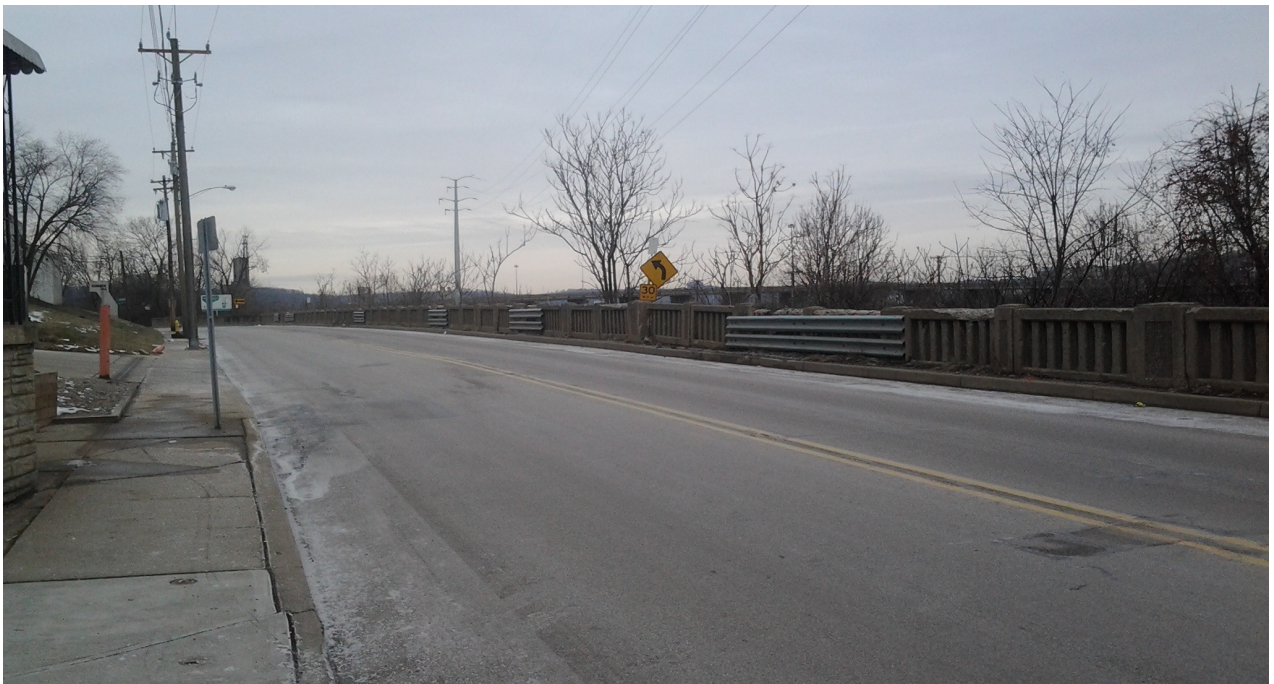
Sections of concrete railing replaced with guardrail sections bolted to pilasters on Cummins Street.

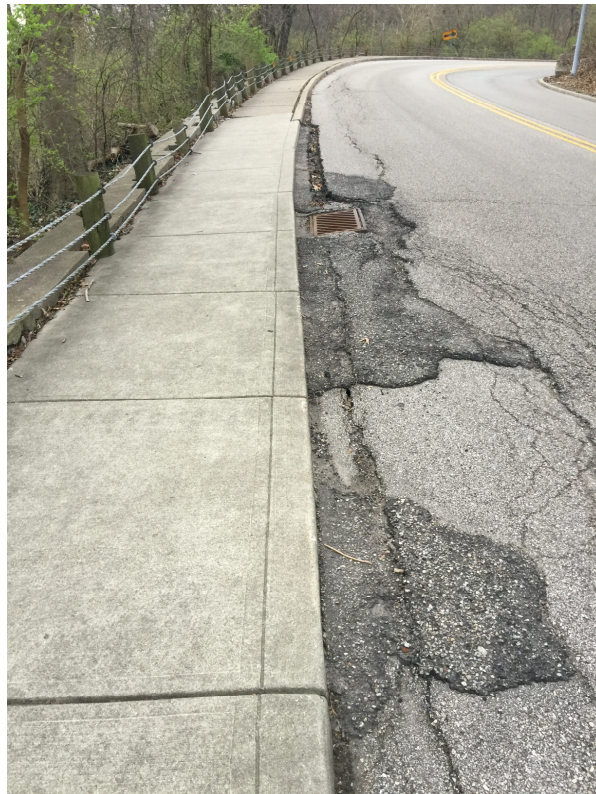
Hillside movement affects Art Museum Drive for a distance of approximately 500 feet from its intersection with Eden Park Drive. Separation of the sidewalk from the curb, separation of the curb from the roadway and tension cracks within the pavement continues to occur. Sections of the cable guardrail system are in need of repair.

Patchwork to fill gaps due to hillside movement between curb and pavement.

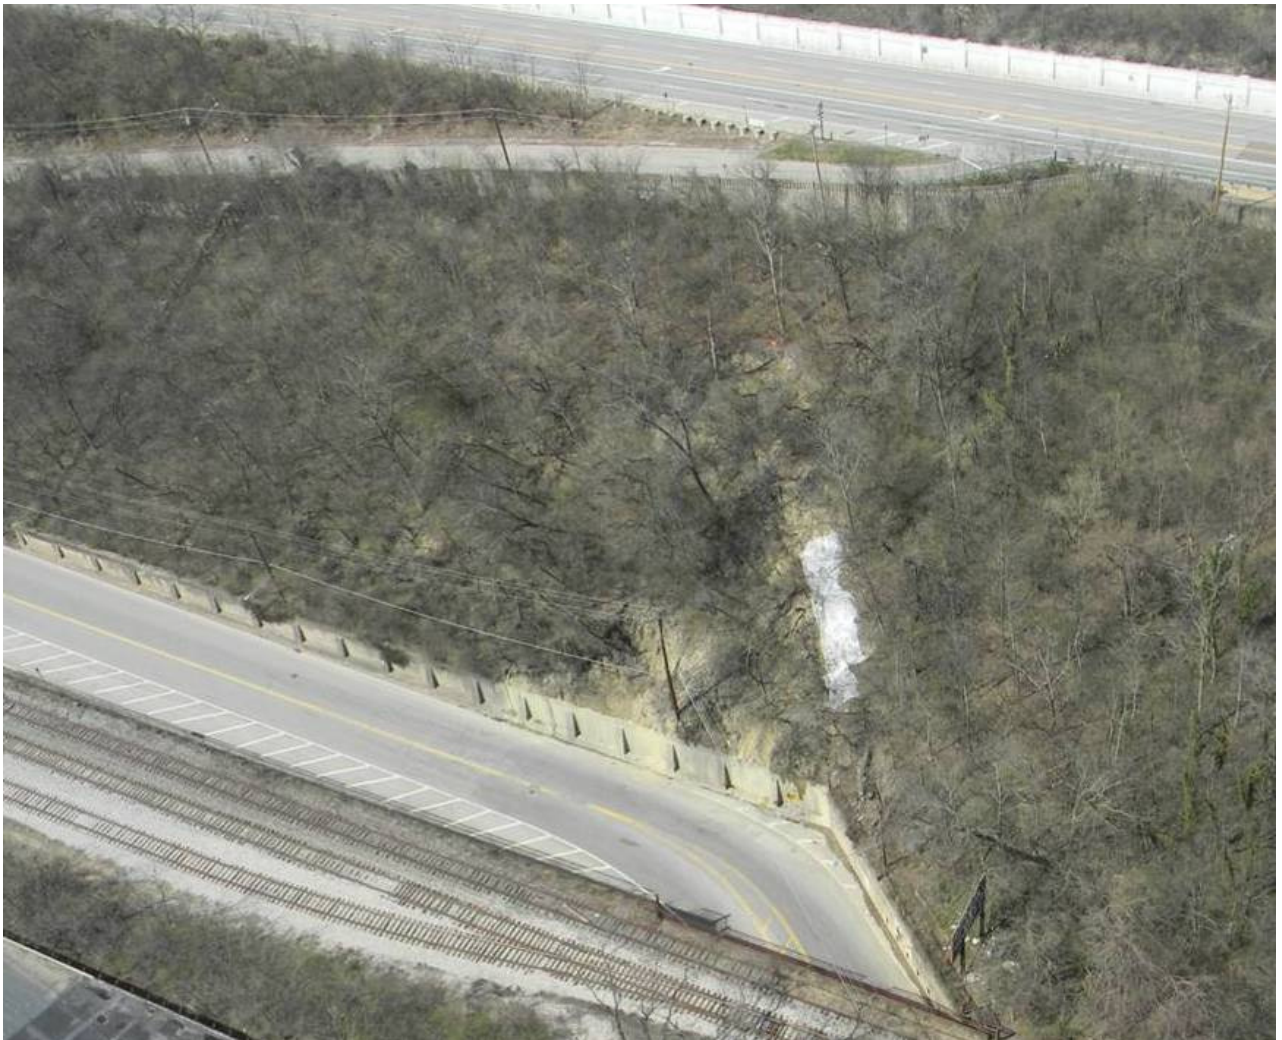
As described in the 2015 Wall Report, a landslide occurs above the existing retaining wall on the north side of Riverside Drive, US Truck Route 50, immediately west of the Rookwood Railroad Overpass. It extends up the hillside to immediately below Kemper Lane and Columbia Parkway US Route 50. The slide area covers nearly 1.5 acres of hillside. Riverside Drive, US Truck Rt. 50 is one lane in each direction through the Rookwood Overpass. The road curves as it goes under the overpass. Significant movement has not occurred since the spring seasonal rains of 2011. Riverside Drive is routinely inspected following periods of heavy rainfall.

Aerial view of landslide on Riverside Drive west of the Rookwood Overpass. The property above the wall is owned by the Park Board. Note extent of headscarp. Plastic sheet left behind after test pits were dug in 2011 to prevent water from seeping along scarp line into the slide mass. Plastic has since deteriorated and no longer exists.

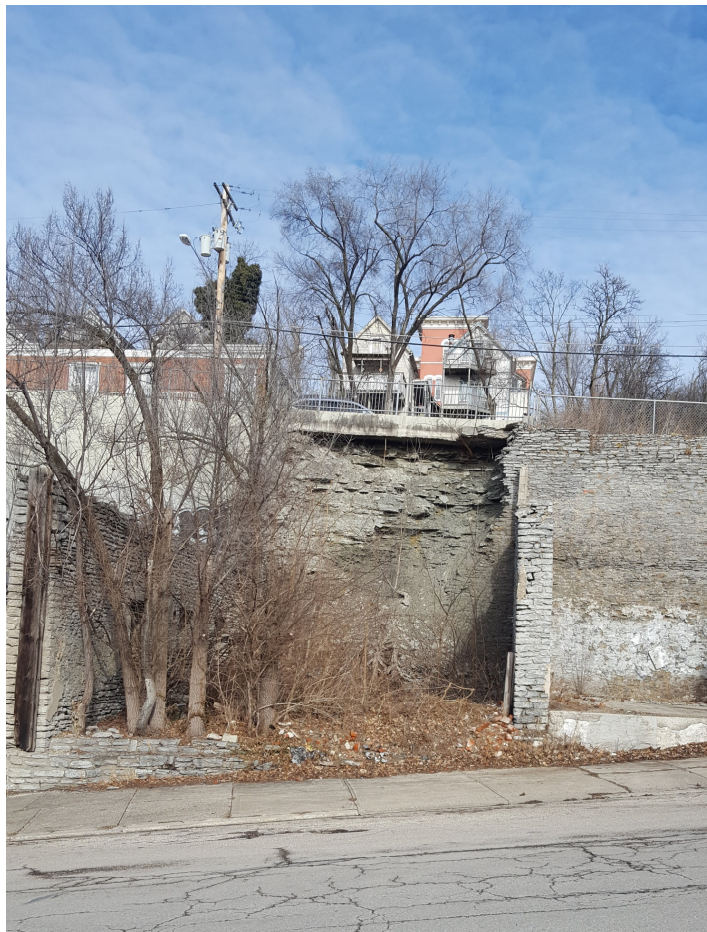
**Dorchester Avenue Wall Repair** (Mt. Auburn) – Estimated construction cost – \$100,000 - \$150,000

The sidewalk on Dorchester Avenue remains closed due to the collapsed wall. The collapsed wall served as the foundation wall of a private building on Sycamore and was a privately owned wall. DOTE has prepared designs to either temporarily or permanently repair the wall, but logistical and legal issues have prevented this work from proceeding. It was also decided that since the exposed face is stable bedrock that the project could be postponed with the possibility that future redevelopment of the parcel will restore support of the rock cut. Protection of the rock face however remains on the list of potential projects.
