# 2019 RETAINING WALL AND LANDSLIDE REPORT

Department of Transportation and Engineering  
Division of Engineering  
Structures and Geotechnical Section

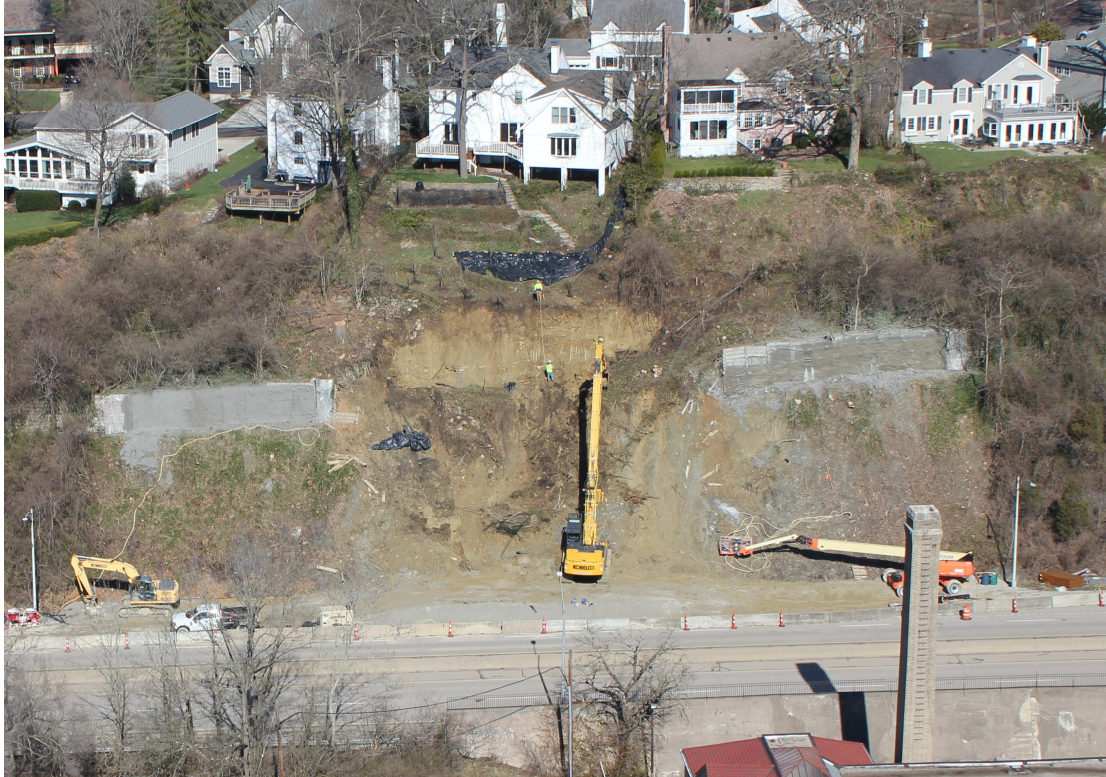
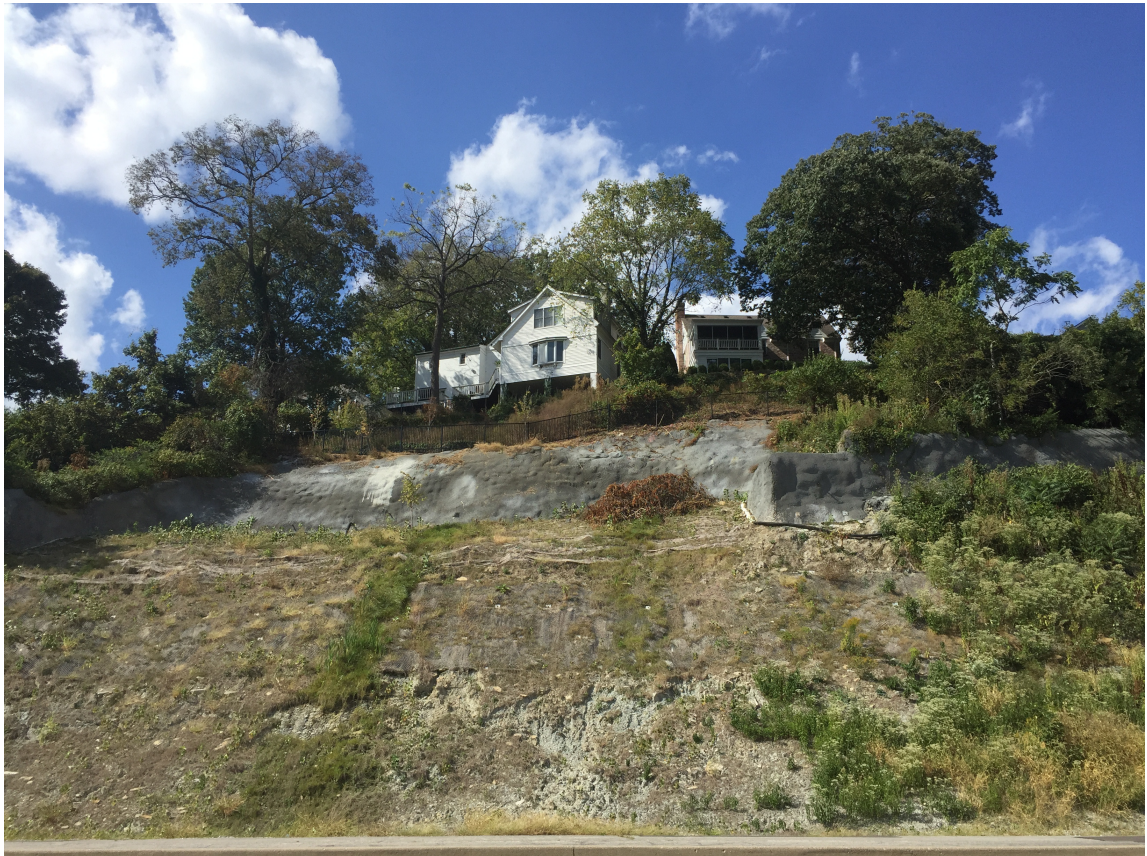
**2100 Columbia Parkway** - Project cost – \$715,308

The 2100 Columbia Parkway Landslide Project mitigated a landslide that occurred between Kemper Lane and Torrence Parkway on March 25, 2019. Landslide activity cracked a light pole in half which then fell across three lanes of the roadway. The project was an emergency repair of the landslide identified as Area 9 DOTE's Columbia Parkway Landslide Evaluation and Report dated March 27, 2019. The mitigation of this area required immediate action through emergency procurement. Three contractors submitted proposals for the emergency repair. The selected method of stabilization for the site consisted of soil nails and a turf reinforcing mat placed under the steel mesh.

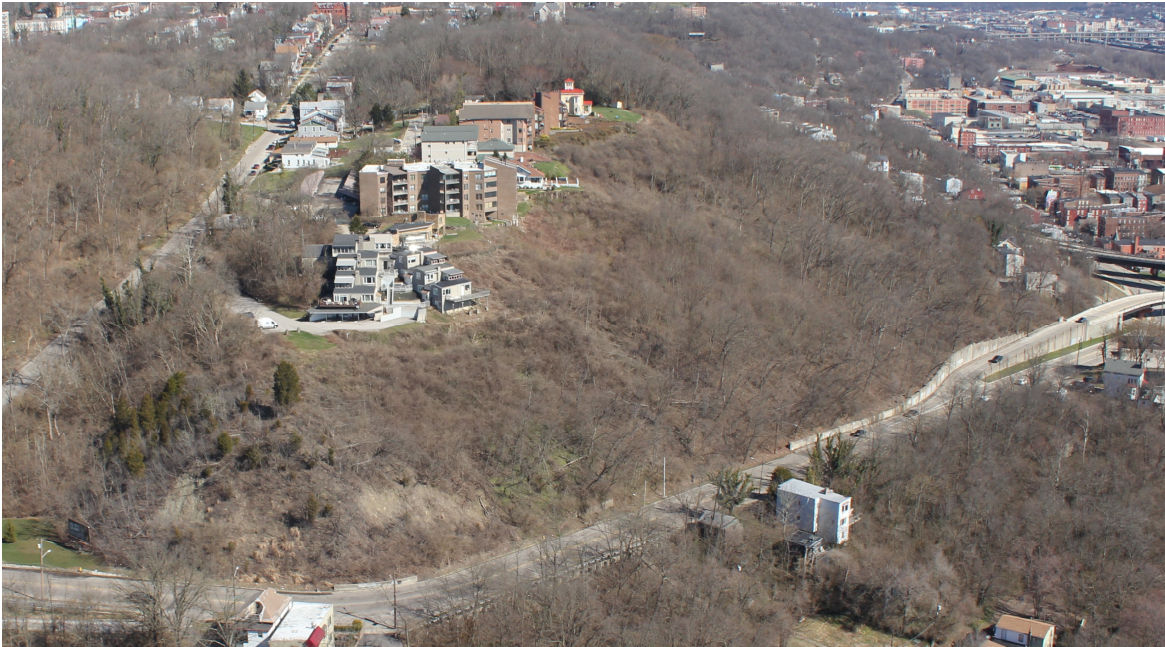
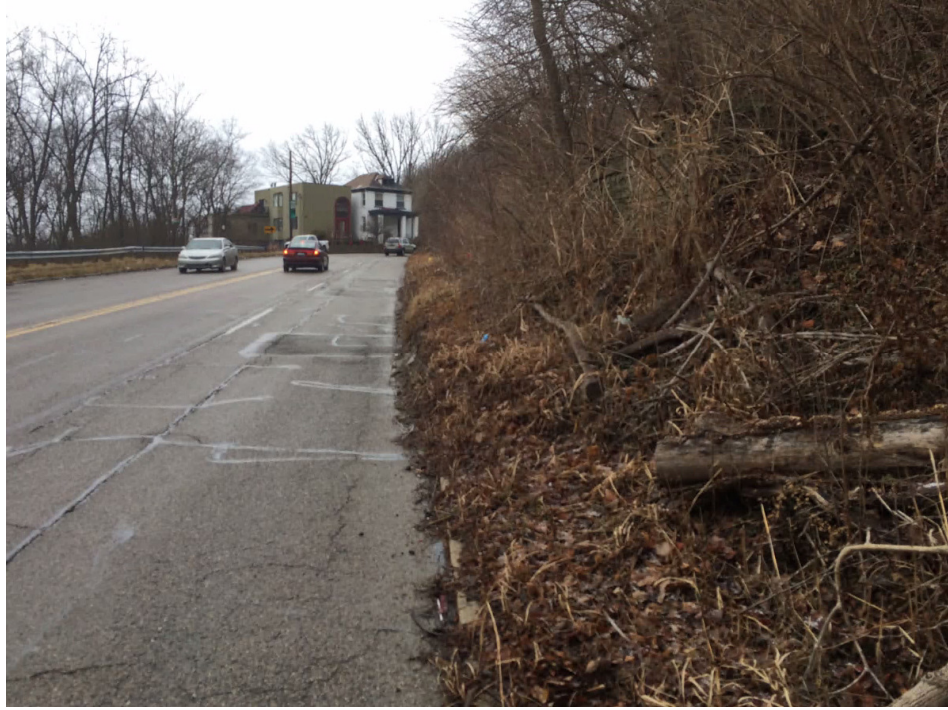
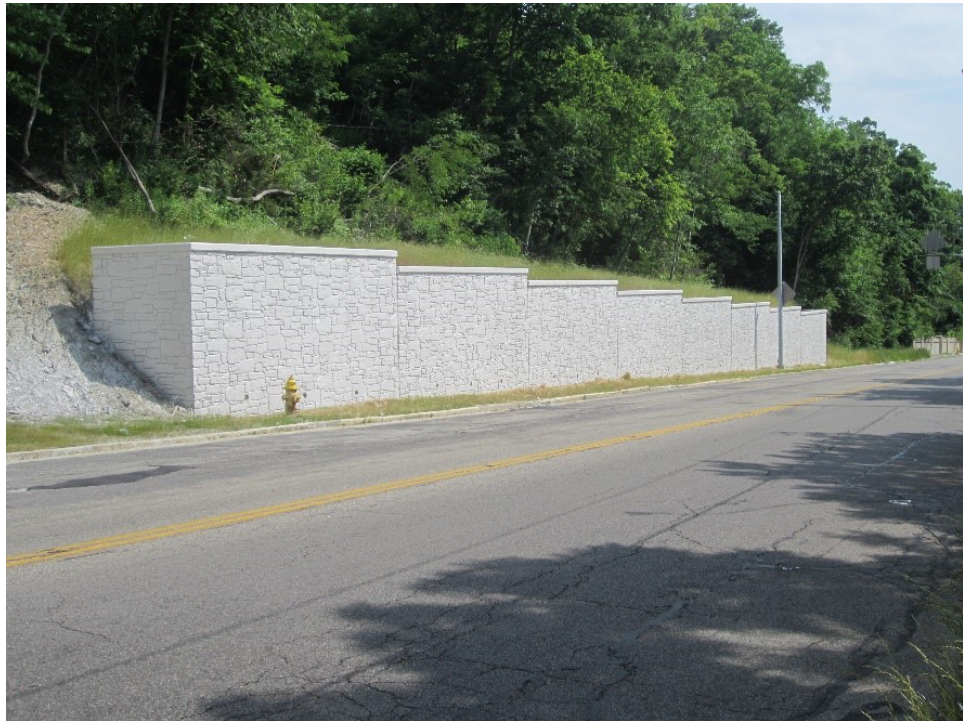
**Elberon Avenue Retaining Wall** – Project contract price – \$728,240

The hillside on the outbound side of Elberon Avenue east of Mt. Hope frequently slid into the outbound curb lane require the closure of the lane and the removal of soil. Historic and active landslide features were prominent on the slope above Elberon Avenue. An active scarp occurs on the slope approximately 30 feet above the roadway. The prevention of the encroachment of soil into the outbound travel lane required the construction of a 200 ft. long retaining wall having a height on the order of 12 feet. The wall was constructed of H-pile set in drilled shafts anchored in the bedrock with a reinforced cast in place wall face. The project was done as an emergency project because of the potential for sudden and drastic movement. The wall was substantially completed in December 2019 using project specific funds 980x233x192361 (Ordinance 154-2019), and Wall Stabilization and Landslide Program funds.

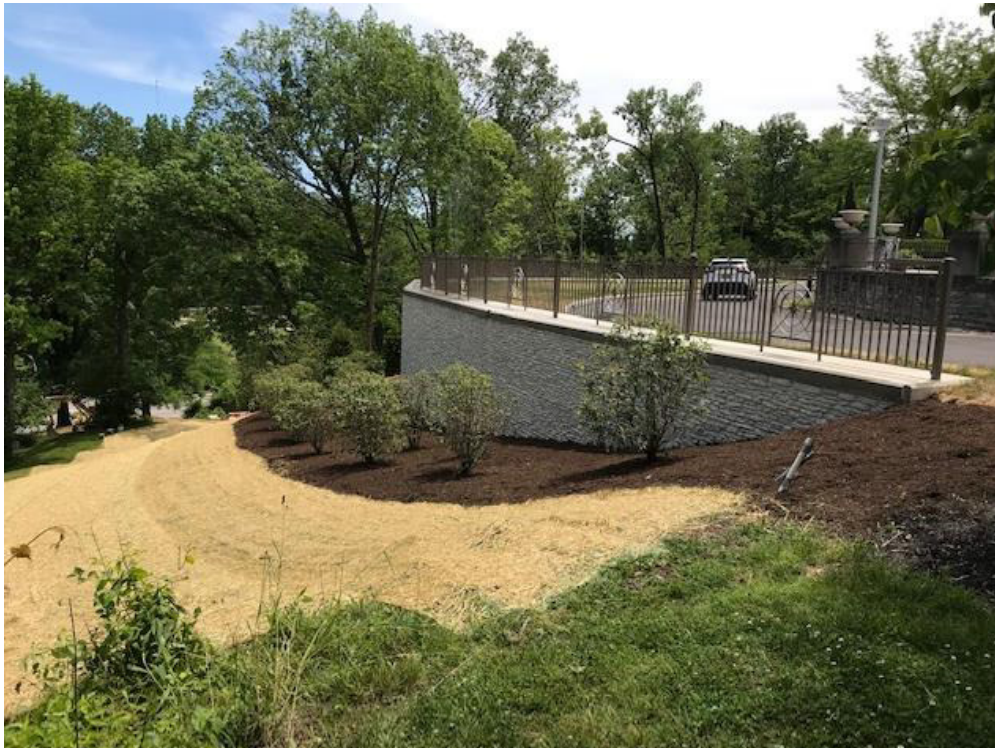
### **Art Museum Retaining Wall**

Earth movement along the hillside outside the museum that impacted the overall structural integrity of the hillside, as well as the access road between two parking lots off Art Museum Drive. The issue required immediate attention. Engineers in the Wall and Landslide worked with the project's geotechnical consultant to design the retaining wall.

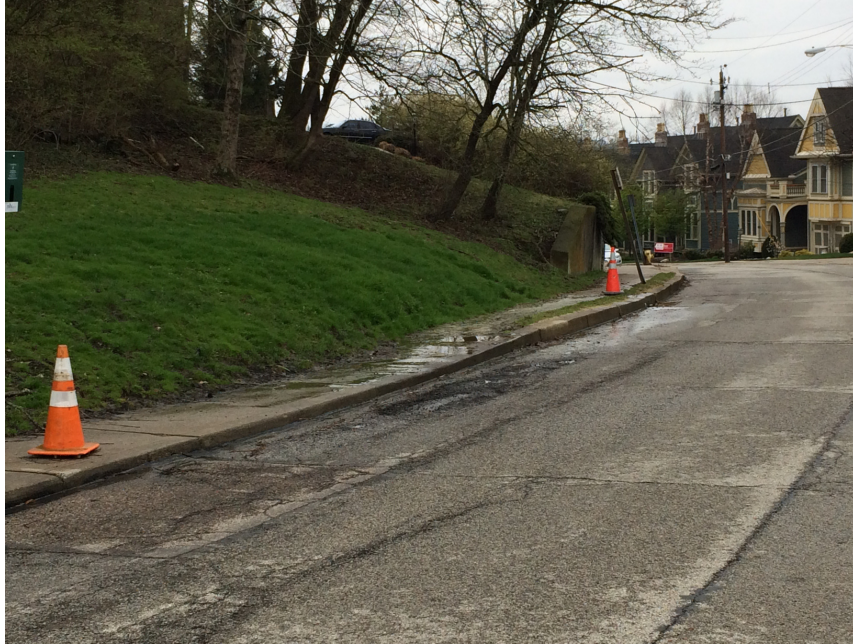
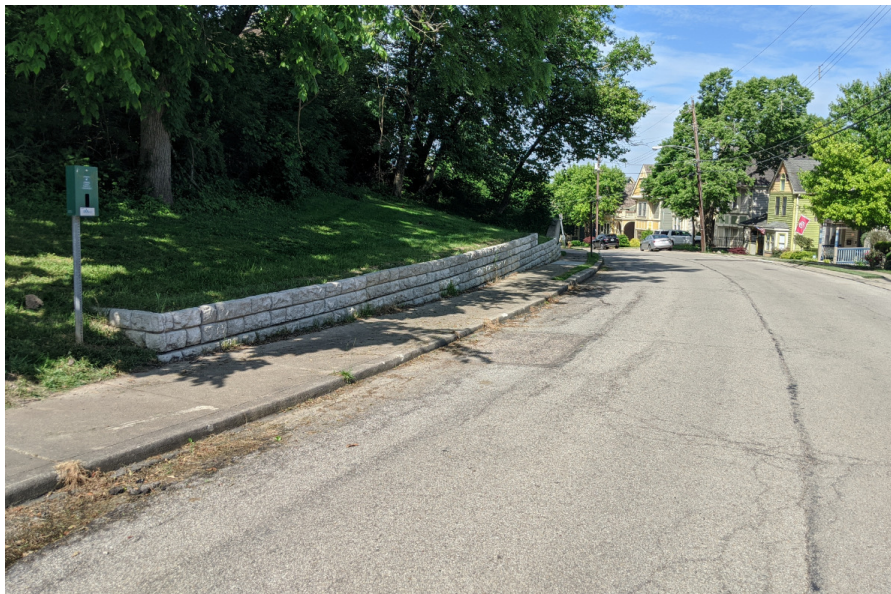
## **Tusculum Avenue Walls and Drainage**

The base of a slope in Alms Park was creeping over the sidewalk along Tusculum Avenue, reducing the sidewalk width. Constant seeping of water made the walk dangerous and occasionally impassible. DOTE worked with the Parks Department to design 2 small retaining walls and drainage improvements to remediate the area. This work was completed by Public Services and paid by Parks.

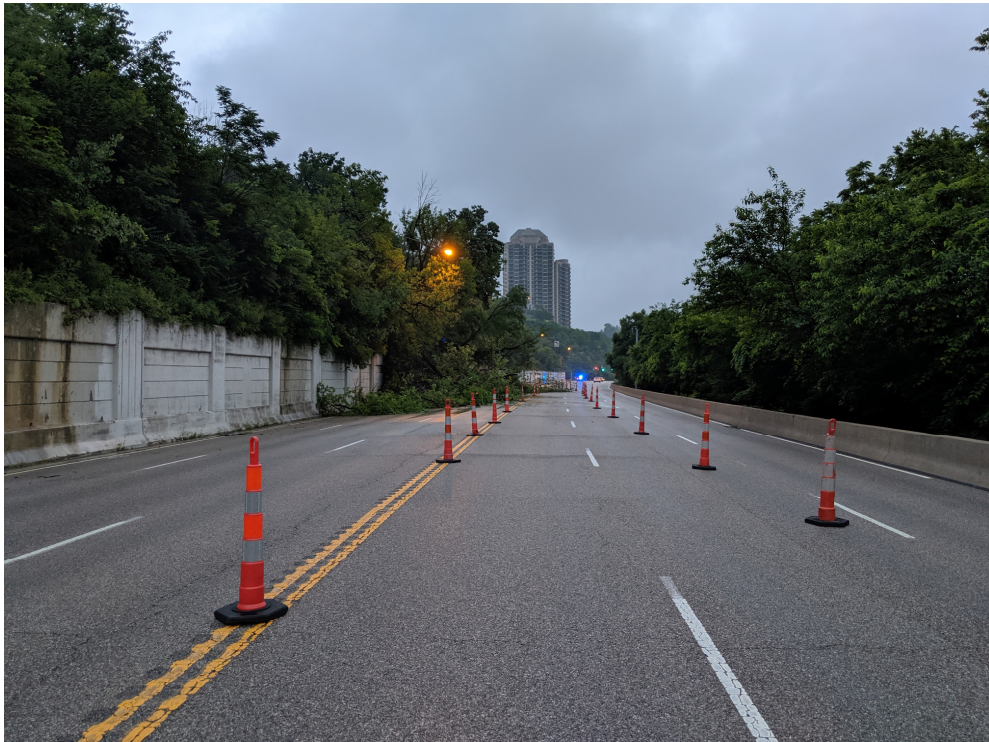
Columbia Parkway west of Kemper Lane 6/20/2019
