# 2020-2021 RETAINING WALL AND LANDSLIDE REPORT

Department of Transportation and Engineering  
Division of Engineering  
Structures and Geotechnical Section

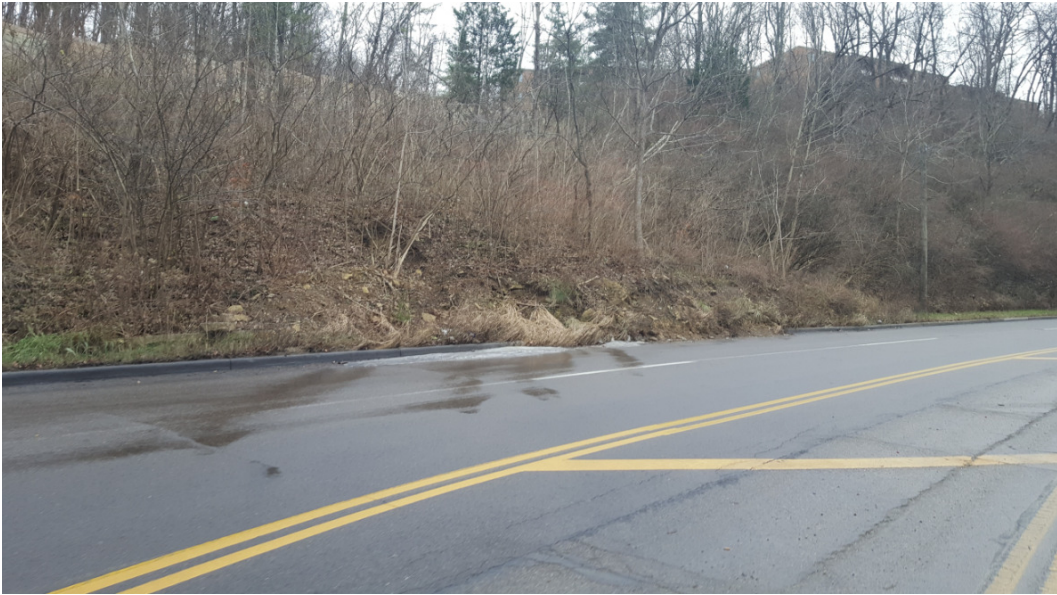
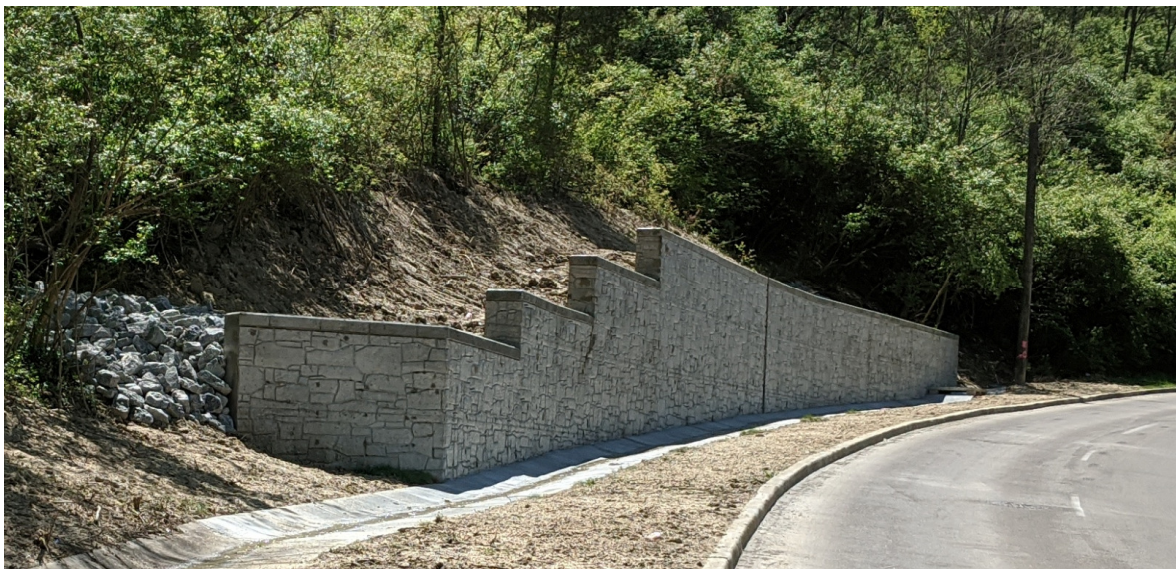
The toe of a landslide occurring in and below the private driveway accessing the Eagle Watch Apartments slid into the roadway along Sunset Avenue and caused drainage issues in the area. A “solider pile” wall was constructed, then faced with a permanent concrete facing. The wall was completed in April 2020 using Wall Stabilization and Landslide funds.

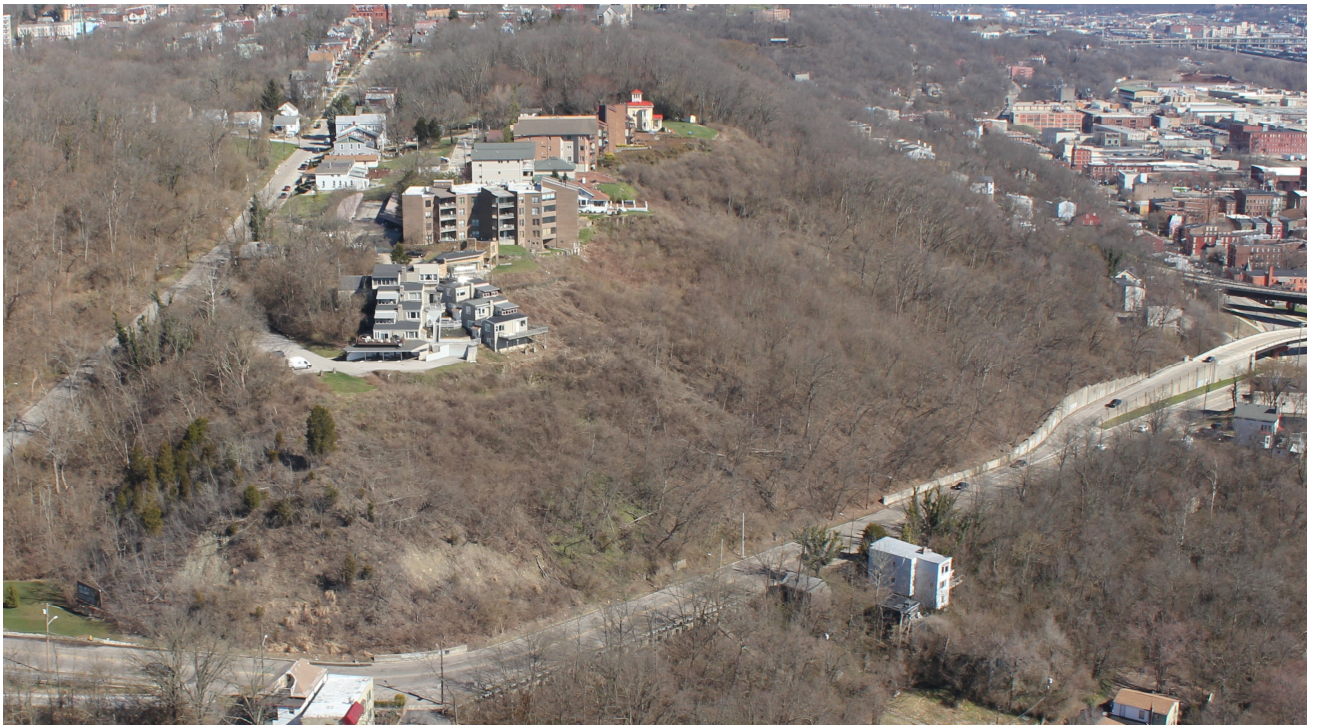
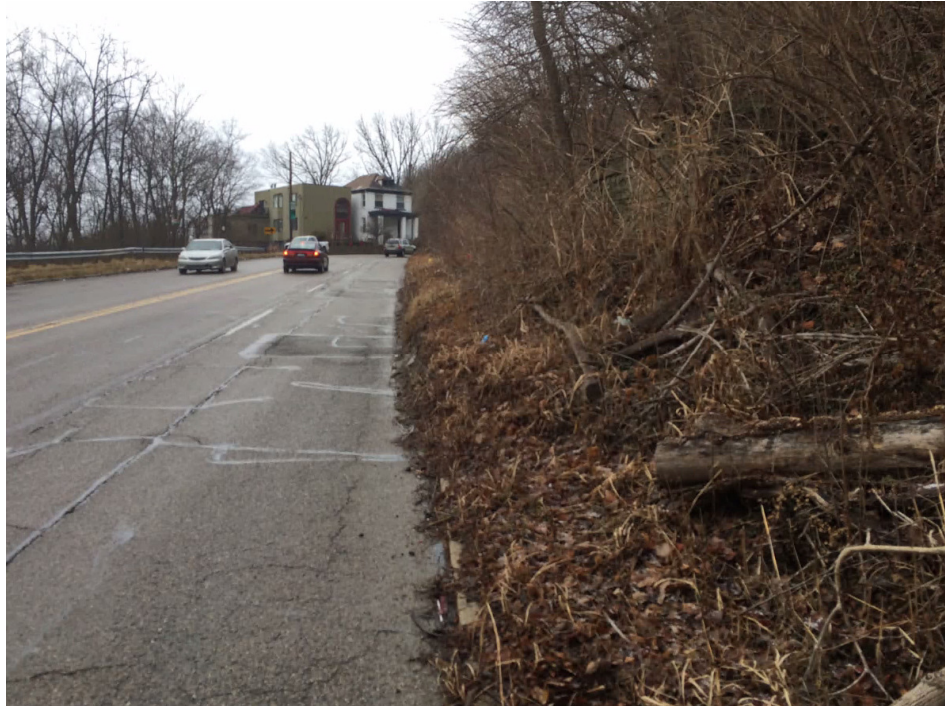
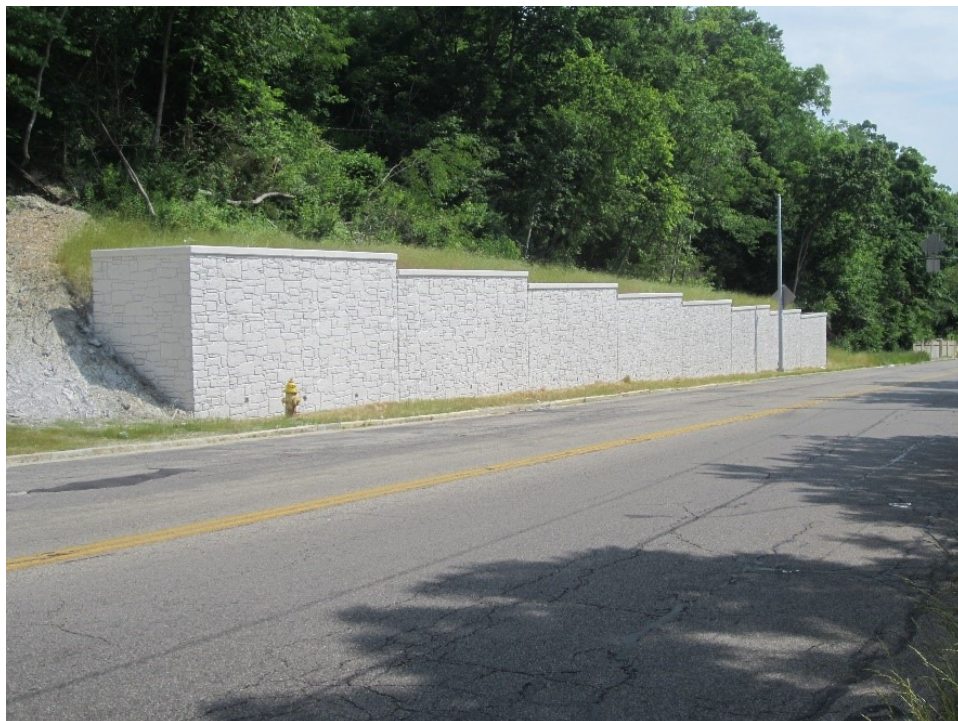
**Elberon Avenue Hillside Stabilization** (Continued)

The hillside on the outbound side of Elberon Avenue east of Mt. Hope frequently slid into the outbound curb lane requiring the closure of the lane and the removal of soil. Historic and active landslide features were prominent on the slope above Elberon Avenue. An active scarp occurs on the slope approximately 30 feet above the roadway. The prevention of the encroachment of soil into the outbound travel lane required the construction of a 200 ft. long retaining wall having a height on the order of 12 feet. The wall was constructed of H-pile set in drilled shafts anchored in the bedrock with a reinforced cast in place wall face. The project was done as an emergency project because of the potential for sudden and drastic movement. The wall was substantially completed in December 2019 using project specific funds 980x233x192361 (Ordinance 154-2019), and Wall Stabilization and Landslide Program funds. Final completion was in June of 2020.

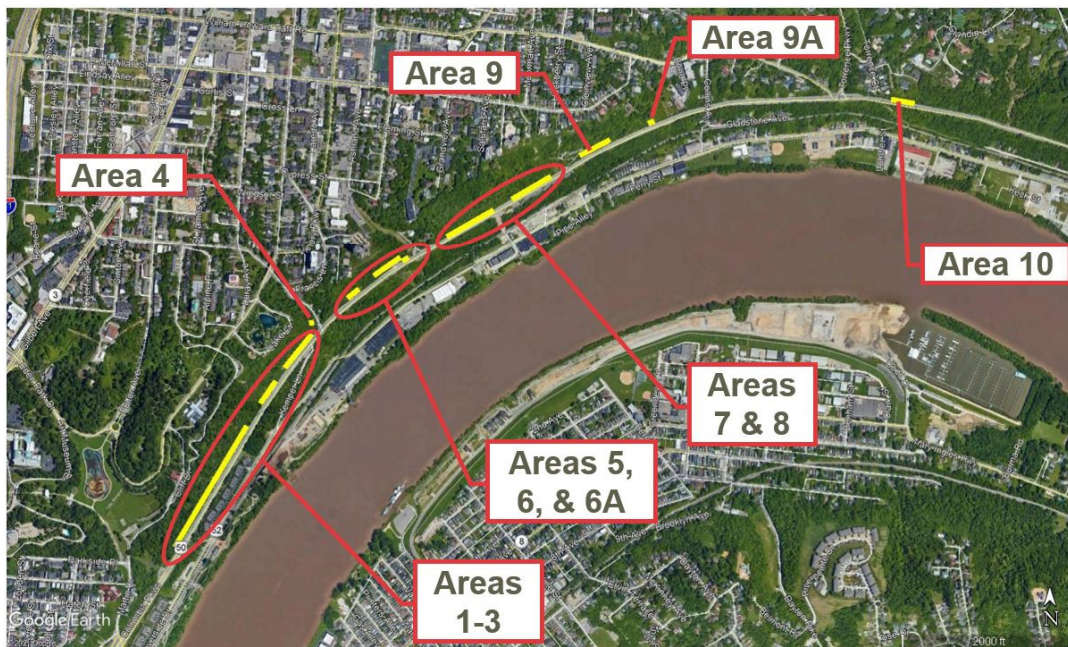
## Stabilization Areas

The project addressed landslides on the uphill side of the Parkway from Bains Street to Torrence Parkway and one slide location east of Torrence. The landslide locations as presented in the 2019 Columbia Parkway Landslide Evaluation and Report, Bains Street to Torrence Parkway is shown below.

Heavy rainfall in June of 2019 triggered hillside movement and caused a significant amount of material to slide onto the pavement in Areas 1-3. Beaver immediately responded and was able to mobilize to remove the slide debris on June 25<sup>th</sup>, 2019.

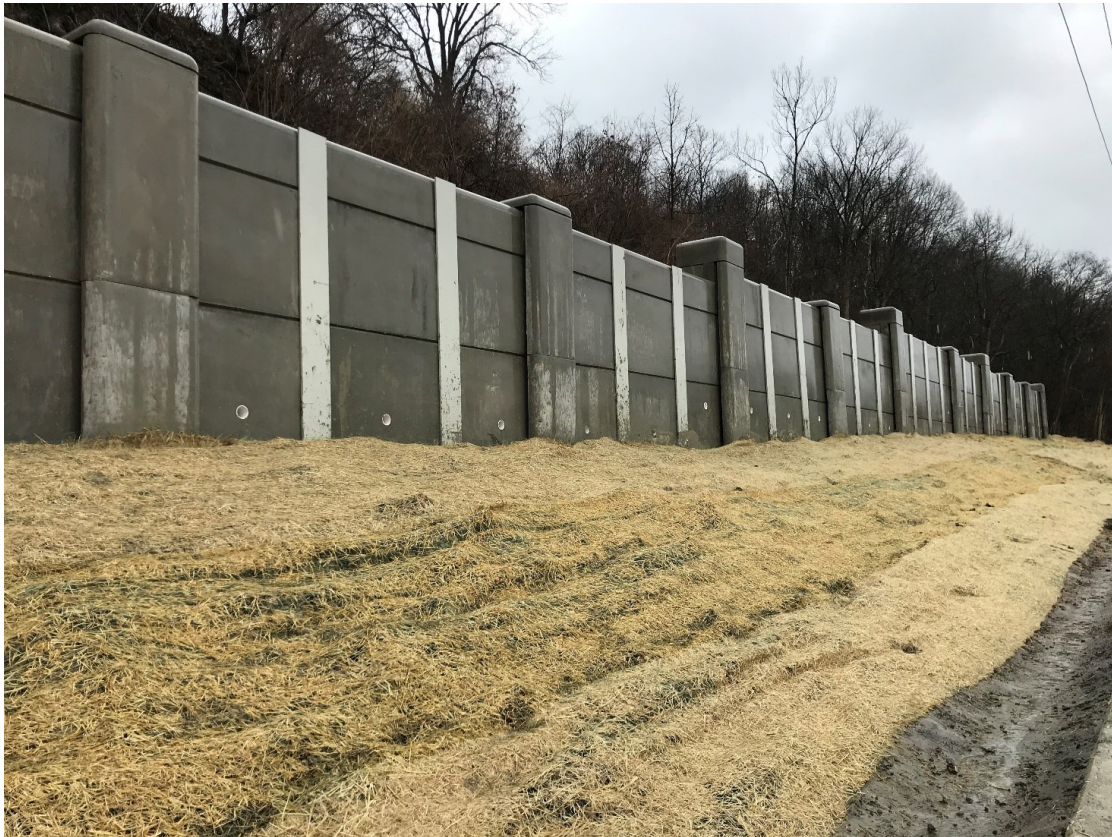
Area 10 was stabilized by the construction of a 280 ft long Soldier Pile and Lagging Wall composed of thirty-two 36-inch diameter piers. Piles were W24x131, with lengths of 25 to 30 feet and were socketed into bedrock a minimum of 11 feet below the bottom of the lagging. The wall was set back 20 feet from the existing Columbia Parkway wall. Wall aesthetics included precast concrete beam covers and caps to mimic existing walls in this section of the parkway. Replacement of a section of the existing (original) wall that was tilting was also included with construction of Area 10.

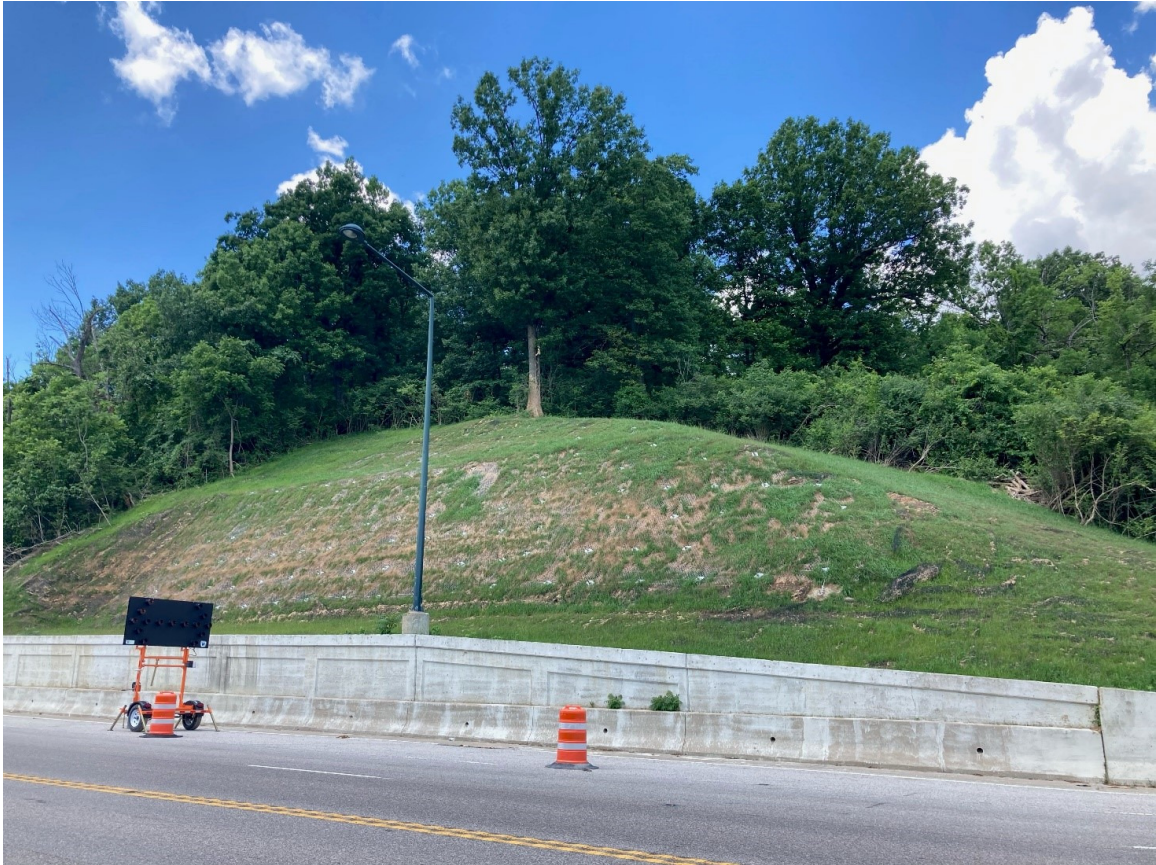
Area 9A was stabilized using soil nails over an area of 6,600 square feet. One hundred and thirty nails were drilled into the hillside. The nails were No. 9, Grade 75 bars with lengths between 30 and 40 feet. The nails were placed and grouted into 6-inch diameter boreholes drilled at an angle of 15 degrees and extended 25 feet into bedrock. A Turf Reinforcing Mat (TRM) was then placed on the slope for erosion control and to assist in revegetating the slope. A high strength steel mesh was then placed over the TRM. The mesh was bolted to the nails with spike plates. The hillside was then hydroseeded with a mixture of seed, fertilizer, and mulch.

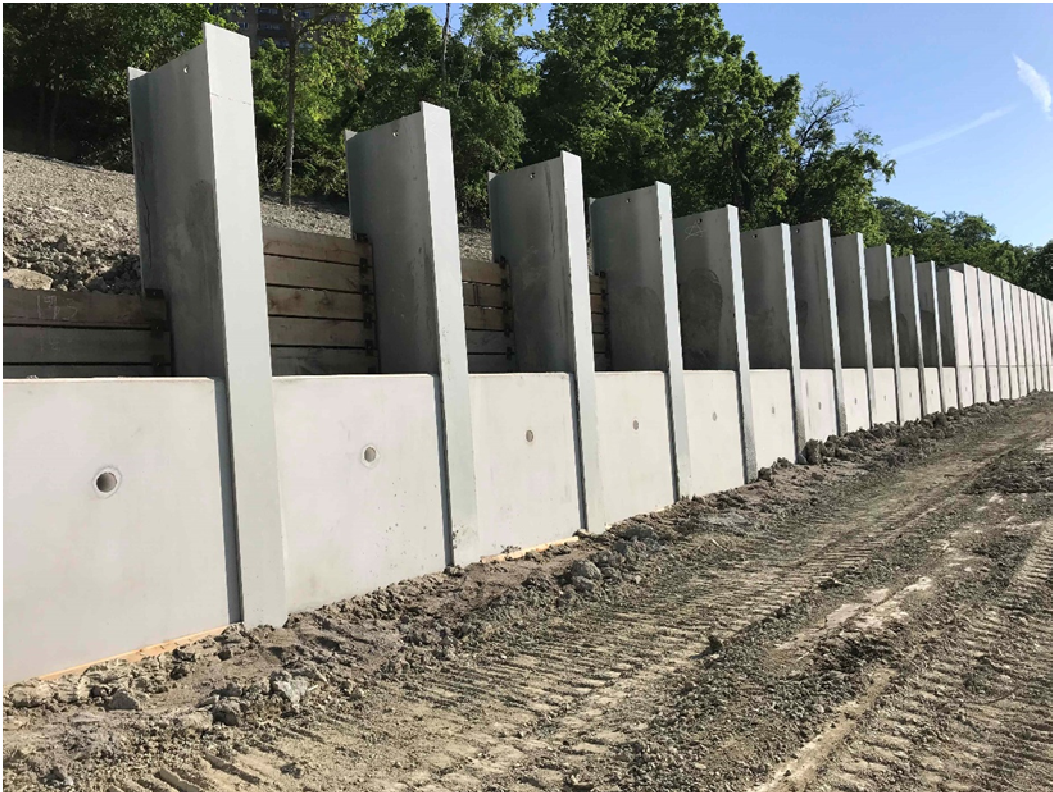
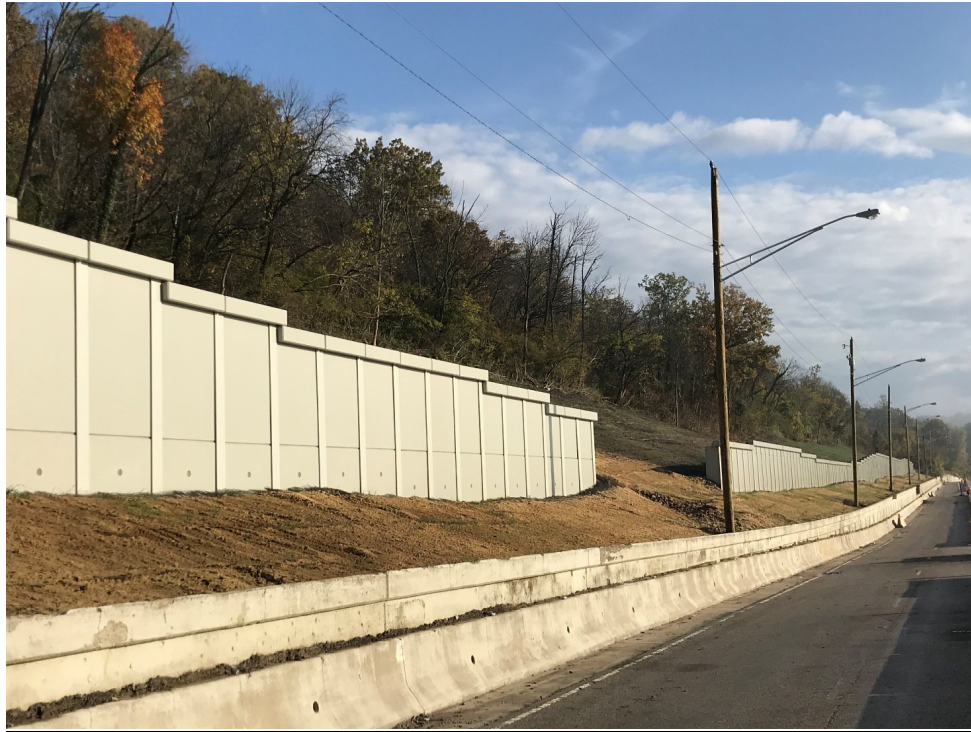
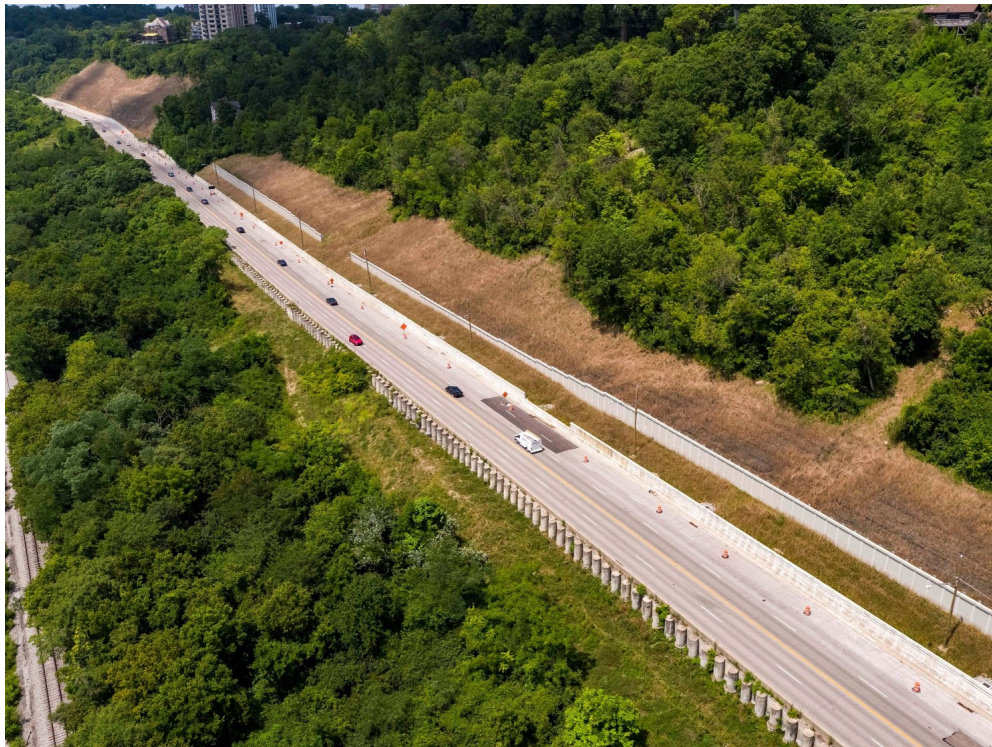
Areas 7 & 8 - (Continued)

Areas 7 and 8 were stabilized by the construction of a soldier pile and lagging wall having an overall end to end length of 1,450 feet. The two areas were essentially combined leaving only an eighty-foot-wide gap in the wall for an existing sewer line and drainage channel.

Two-hundred and thirty piers were installed at a center to center spacing of six feet. The piers were reinforced with W30x124 or W36x160 piles placed in drilled boreholes having diameters of 36 and 48 inches. Pile lengths ranged from 25 to 34.5 feet and were socketed 13 to 16 feet into the bedrock. Wood lagging followed by precast concrete panels were installed between the piles. A precast concrete cap was installed on top of the piles and panels. A turf reinforcing mat was placed on all disturbed ground and hydroseeded.

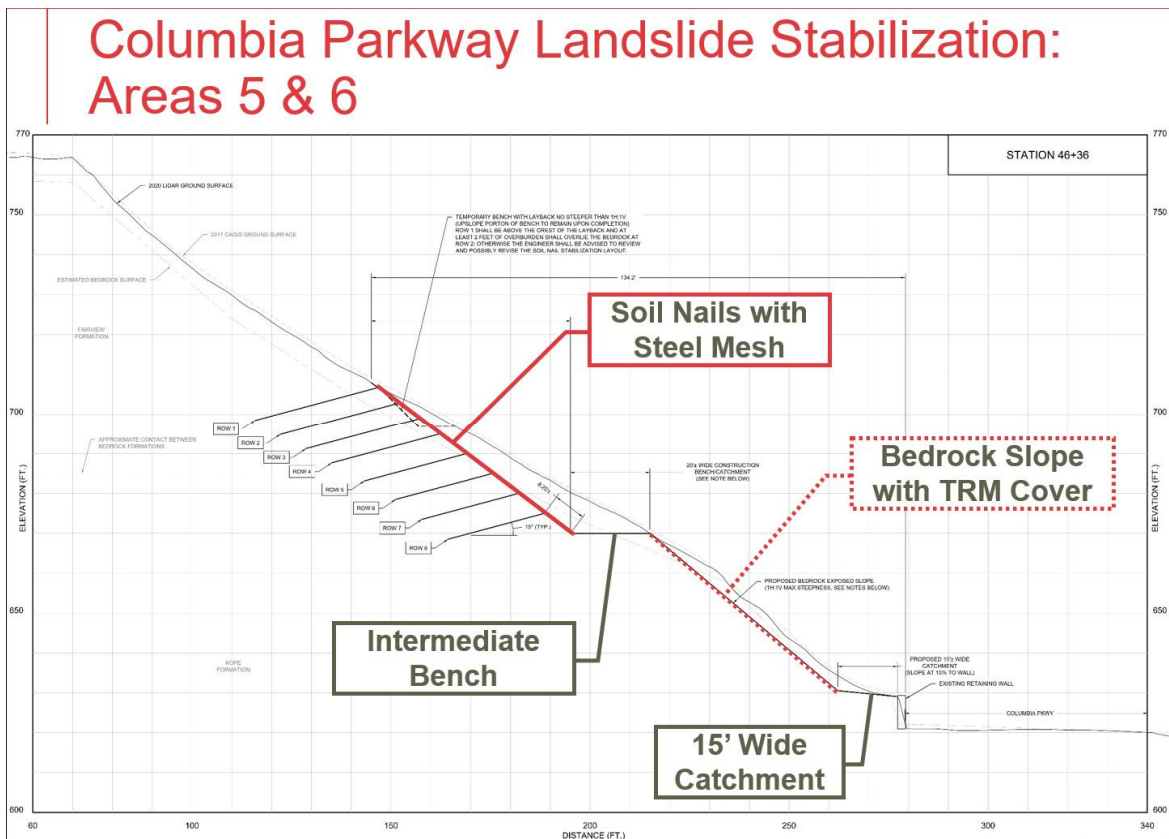
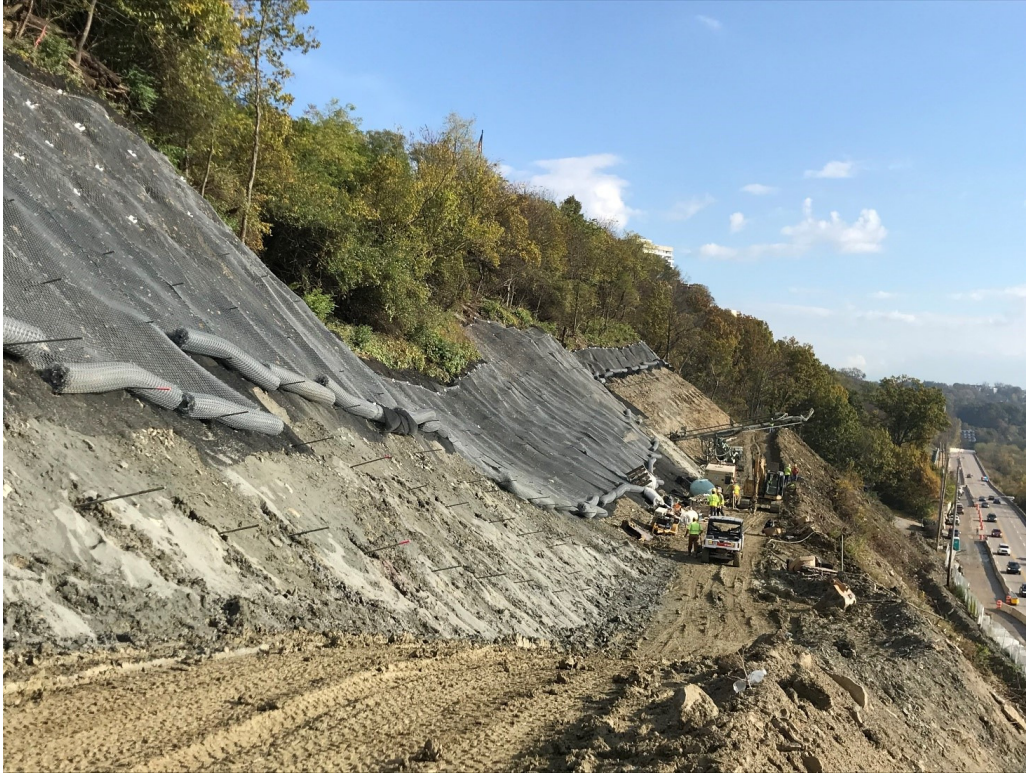
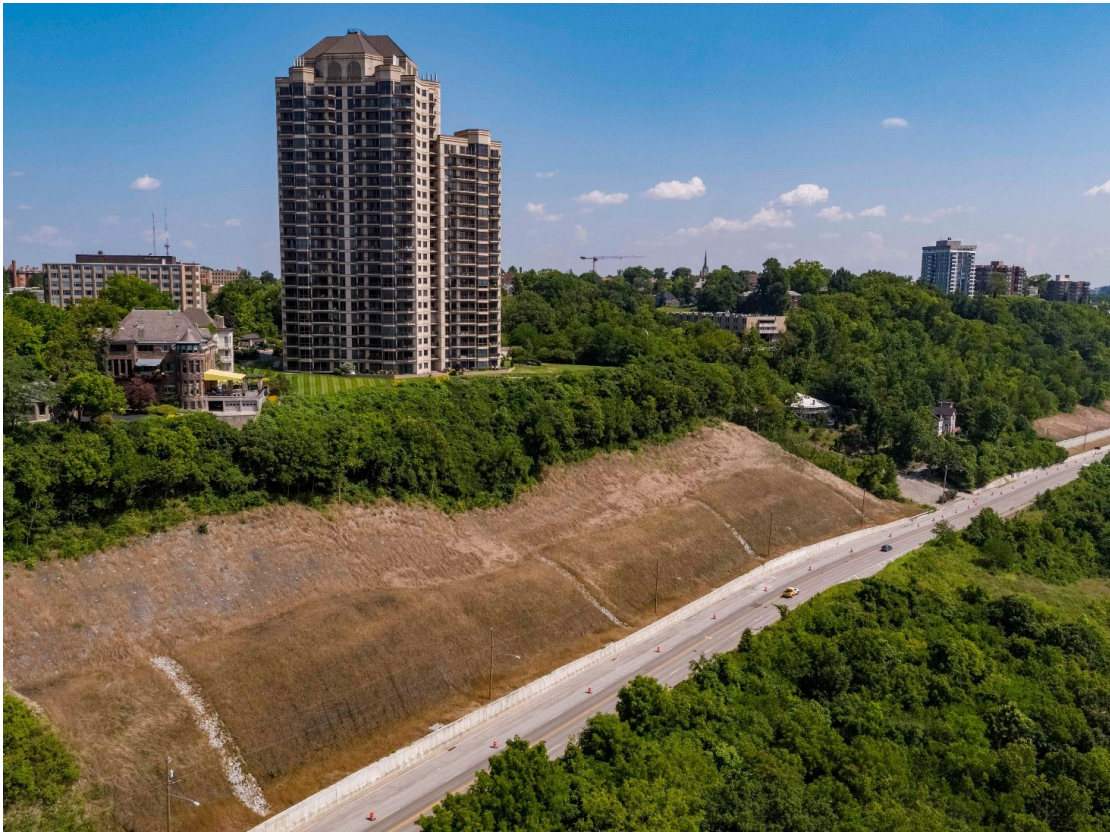
Area 5, 6 & 6a – (Continued)

The soil nails stabilization method used at Area 9A was used at Areas 5, 6 & 6A. Eight-hundred-and-seventy nails were installed in the upper slope. The nails and mesh covered an area of 42,000 square feet. A mid-slope bench was constructed at the bottom of the areas that were soil nailed. The lower half of the slope was entirely within shale. This lower slope was cleared of loose material and then covered with a turf reinforcing mat (TRM). Four armored rock channels were installed from the mid-slope bench to newly installed drainage inlets behind the existing wall on Columbia Parkway. A fifteen-foot-wide catchment bench was created at the base of the slope and behind the existing wall. The entire slope was then hydroseeded.

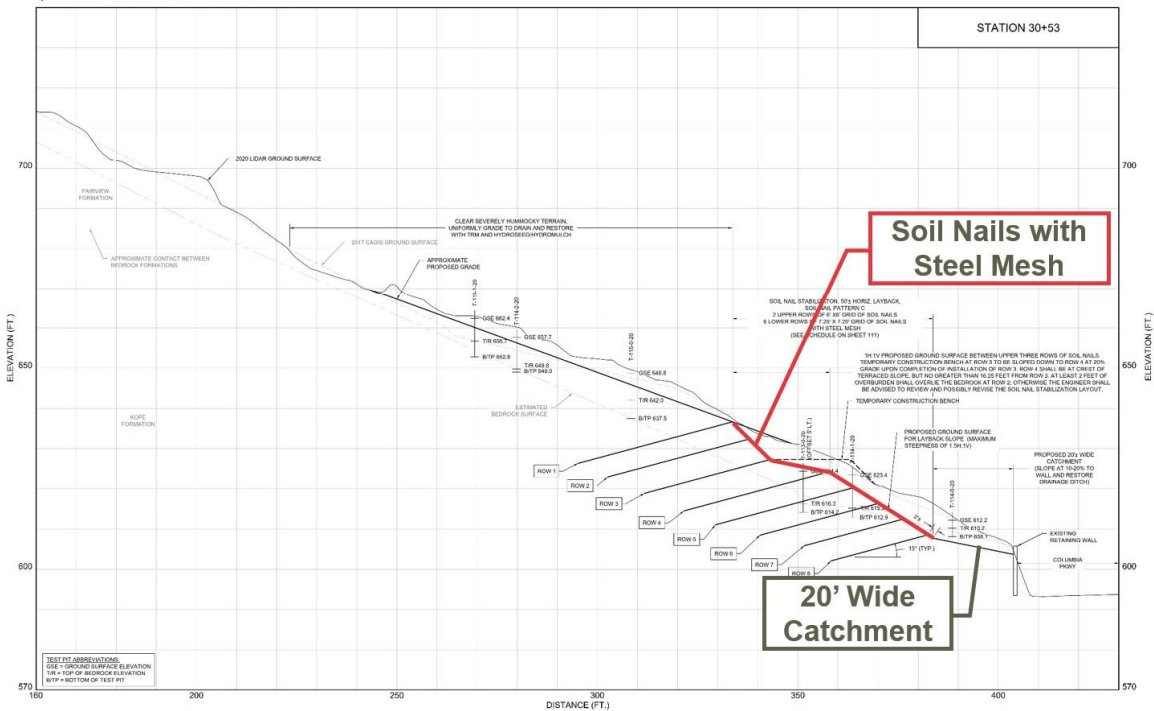
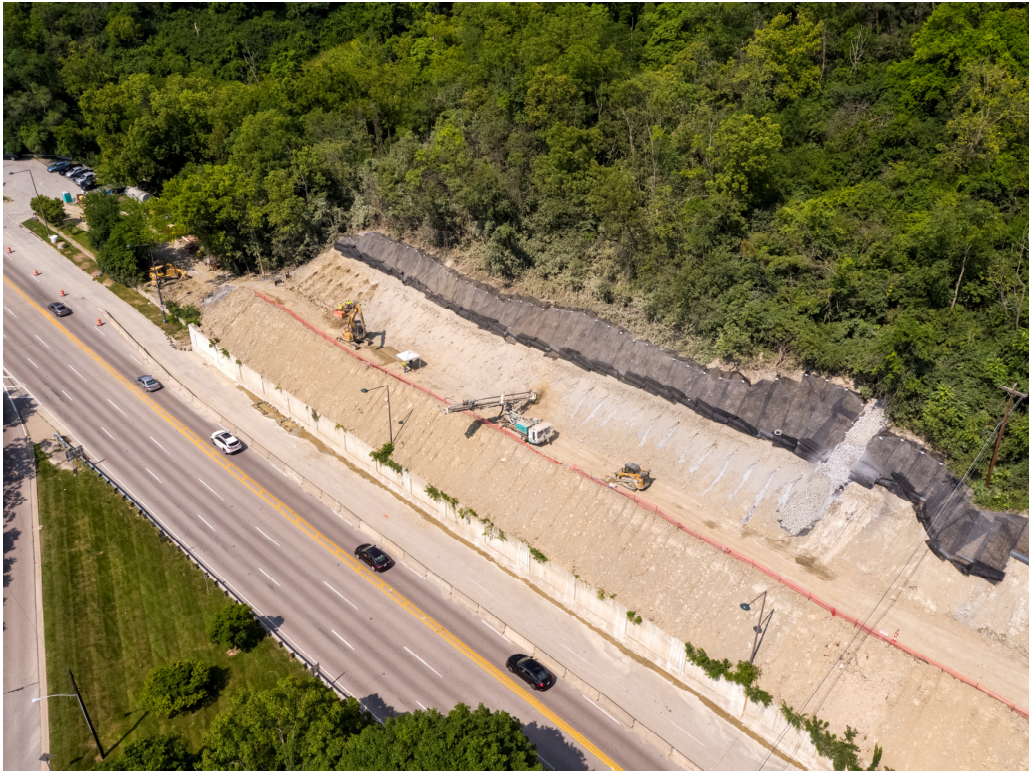
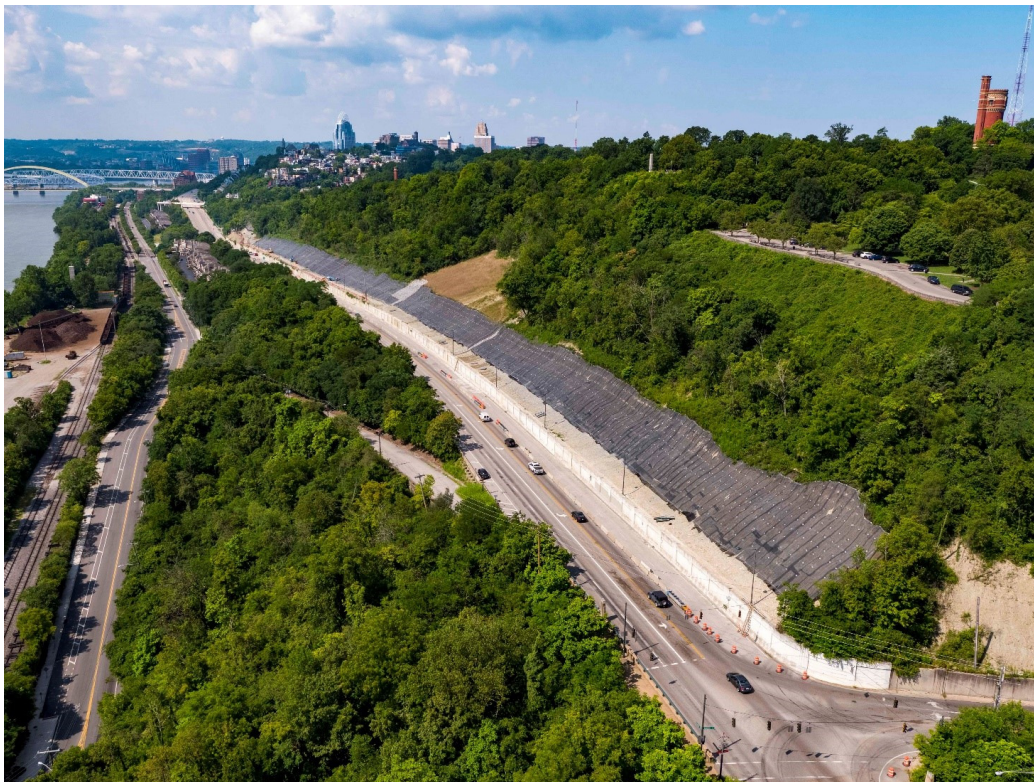
## Columbia Parkway Landslide Stabilization: Areas 1-3

The section of the project from Bains Street to Kemper Lane was initially divided into three separate sections Areas 1, 2 and 3 and include lengths between the Areas where work was not originally proposed. Further inspection of the hillside revealed sections between the defined areas that needed stabilization. Access and constructability also required a continuous path above the existing retaining wall on Columbia Parkway. The entire length of the hillside, 3,045 feet, from Bains Street to Kemper Lane was stabilized with the soil nail stabilization system. Three-thousand-one hundred soil nails were installed on the hillside. The wire mesh covers an area of 169,000 square feet. Over 40,000 cubic yards of soil was removed from the slope.

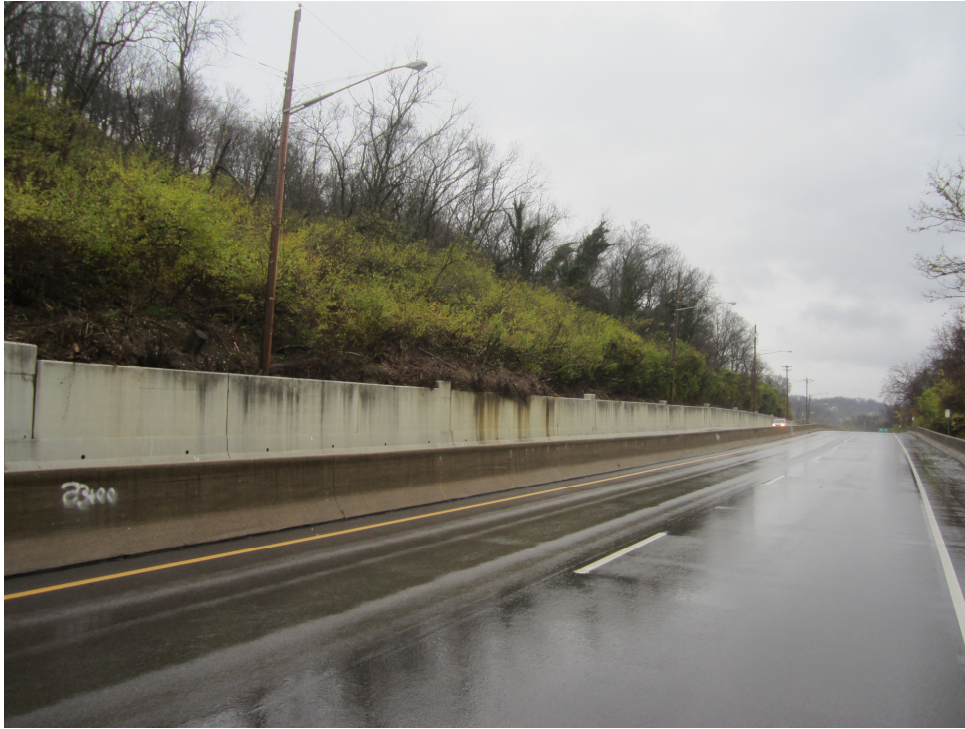
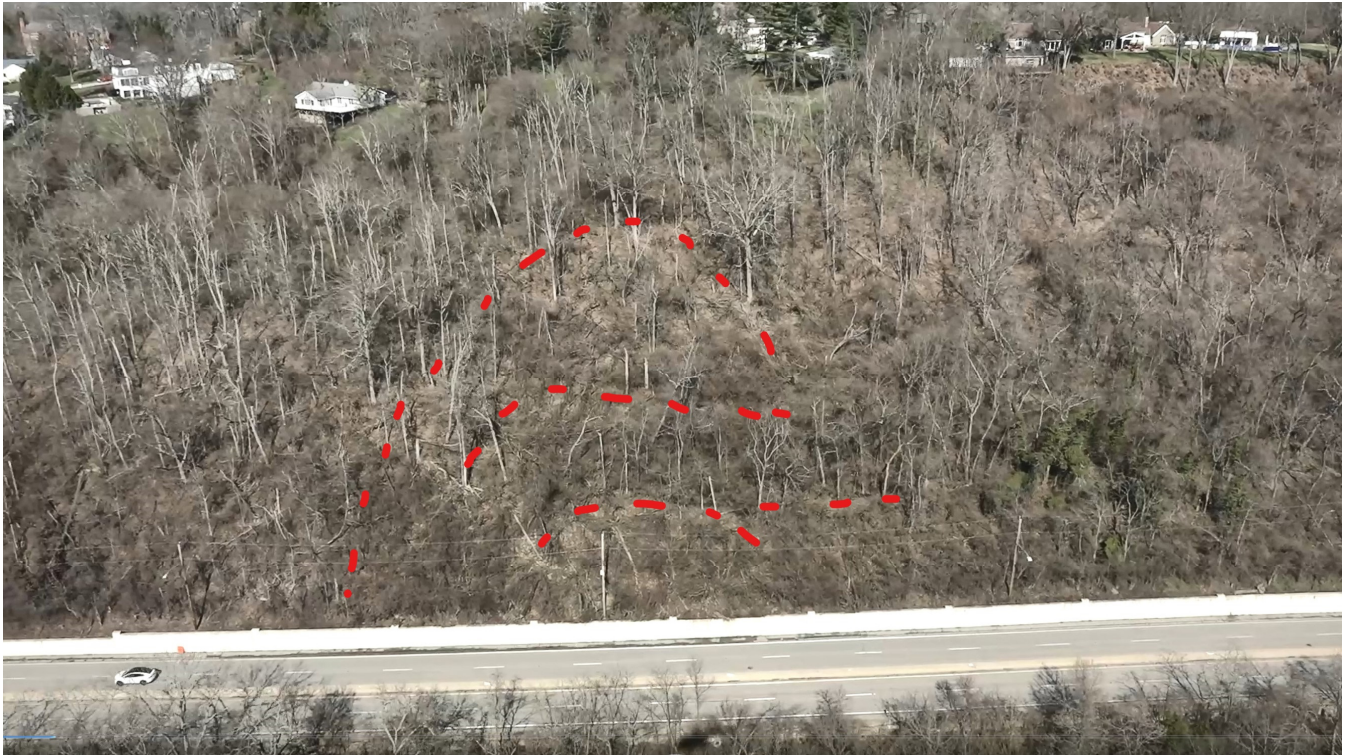
**Columbia Parkway – South of Beechmont Avenue** – (Continued0

A reconnaissance of the hillside revealed that the landslide extends more than halfway up the hillside and that there are at least two internal scarps within the slide mass in addition to the primary head scarp. Many of the trees within the slide mass, which are more than likely Ash trees are dead. The slide remains relatively stable on top of the wall. Removal of the toe can not take place until the slide is thoroughly investigated and more than likely not until the mass is stabilized. The slide mass is routinely observed and appears dormant for now.

Corrective measures, if determined to be necessary, will more than likely be soil nails although a second retaining wall may also be a feasible alternative. Construction costs are not known until further investigation is performed but will be above \$700,000. Residual funds from the Columbia Parkway Bains to Torrence Project will be used for investigation and possibly for partial funding.

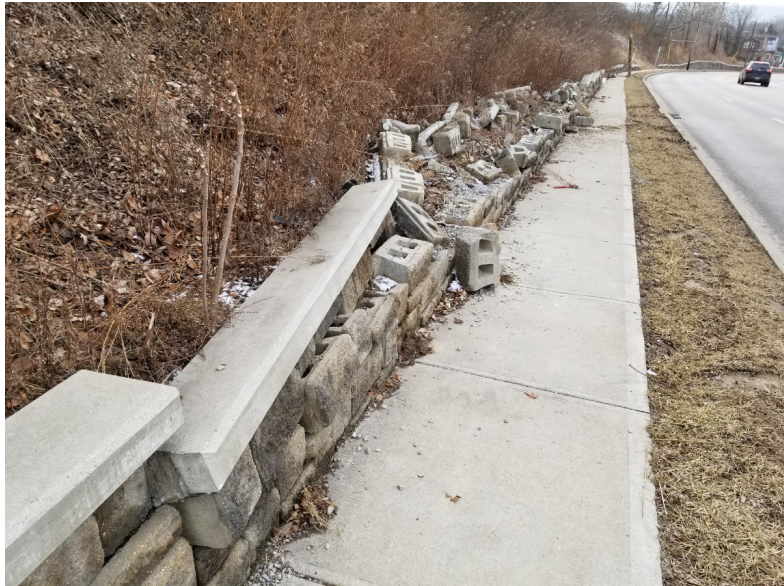
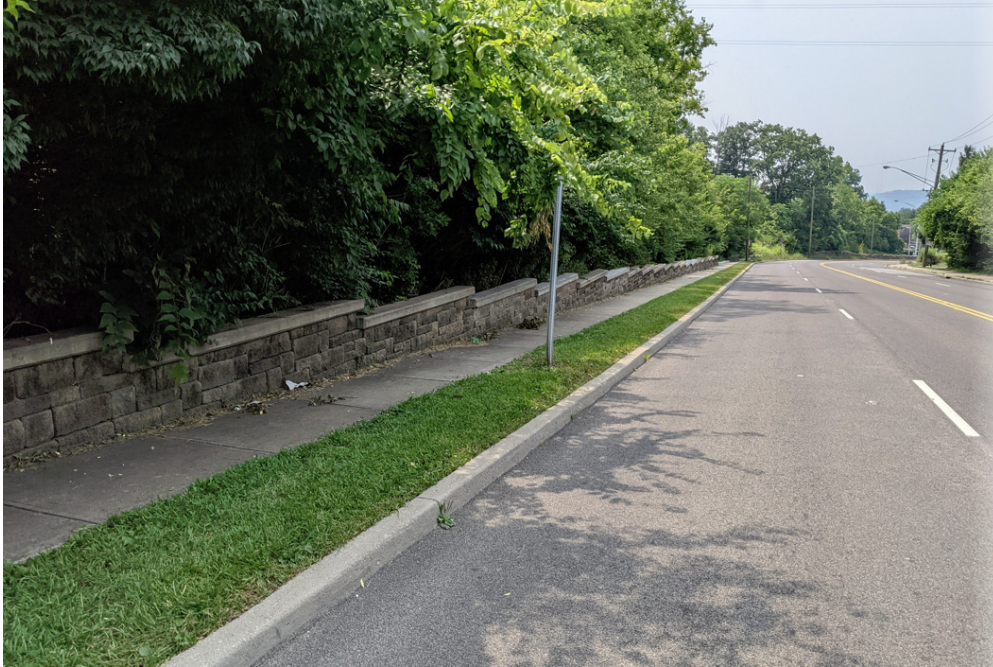
**Hamilton Avenue Segmental Wall Repair- (Continued)**

A segmental retaining wall constructed in 2009 as part of a roadway improvement project had been repeatedly struck in vehicle crashes. DOTE received State of Ohio funding for safety upgrades to the roadway, but the matching costs associated with the bids received for the proposed wall repairs and improvements were beyond available funding. Following the completion of the roadway safety improvements the reconstruction and removal of the damaged sections of the retaining wall were done by TROD and funded by DOTE Wall Program.

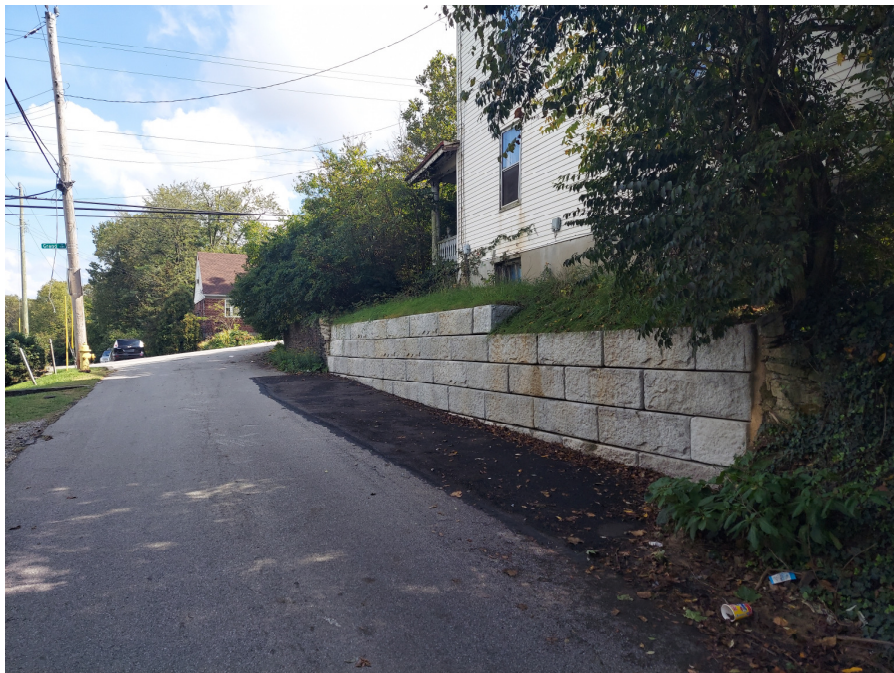
**Grand Avenue at West Liberty Retaining Wall** – ID Bill to be submitted.

The stone retaining wall on the north side of 1271 Grand Avenue failed and was replaced with a large block modular retaining wall. The wall was constructed by TROD and funded by DOTE Wall Program.
