2019 COLUMBIA PARKWAY

Landslide Evaluation and Report

Bains Street to Torrence Parkway

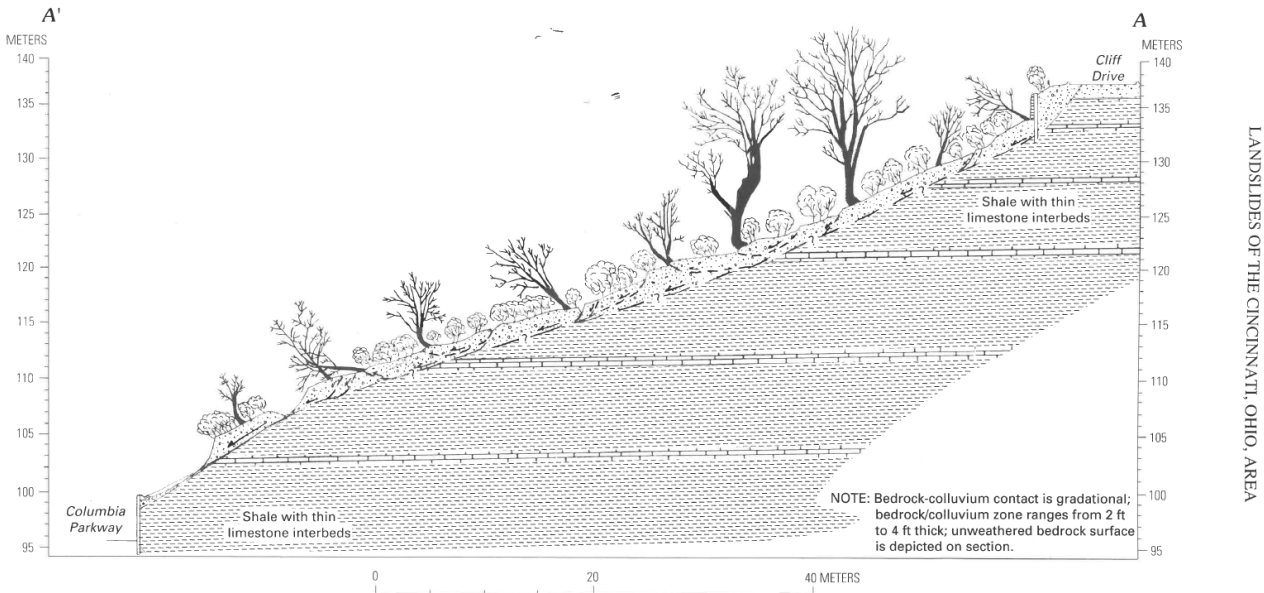
Movement of colluvium on the hillside above Columbia Parkway has been a continuous problem since its construction. The landslides involve a thin mantle of clay soil, typically less than 5 feet thick, that moves over the steepened slope when it becomes saturated due to prolonged periods of rainfall. The failure or slip surface of the landslides is located along the soil-bedrock interface. The landslides are classified as rapid earthflows commonly referred to as “mudslides”. The areas in which soil encroaches upon the retaining wall are slide blocks that have separated from the lower portions of much larger landslides, which extend much higher up the slope.

Figure 2: Cross section through landslide (Richards 1982)

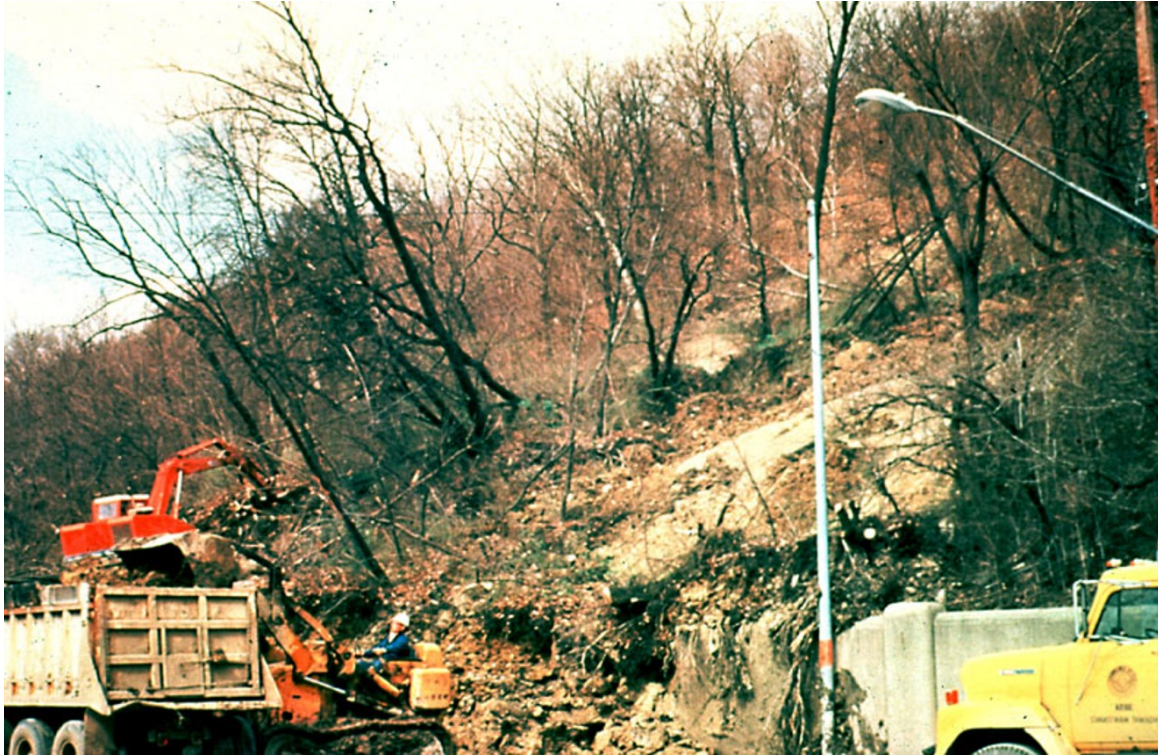
Figure 4: 1975 Landslide clean-up. U.S.G.S. Website

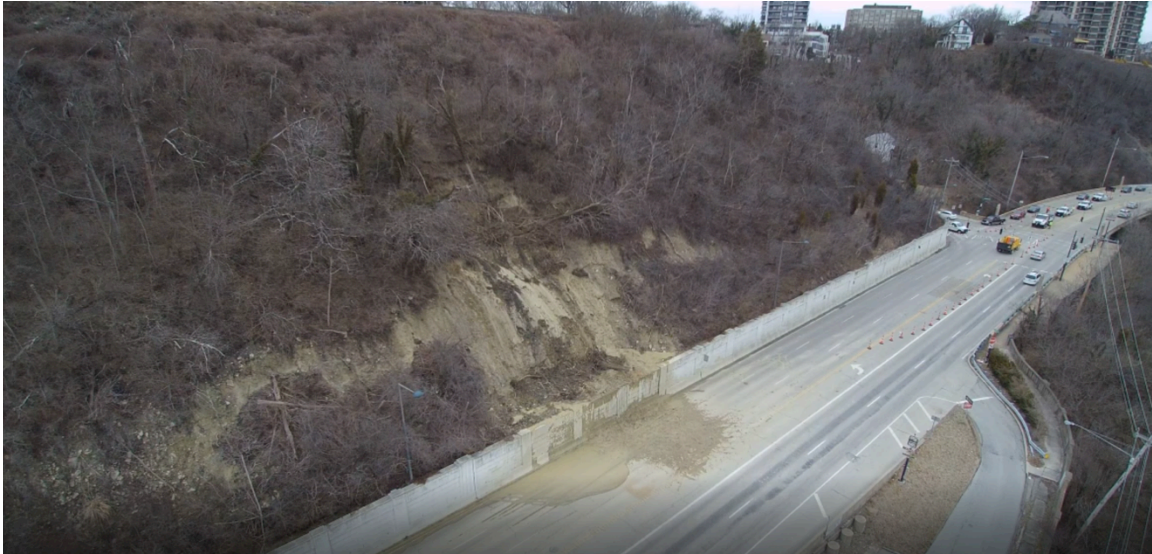
Trees within slide blocks in the upper reaches of the slope broke loose from the slope prior to their scheduled removal. One of the blocks slid completely down the slope on the afternoon of February 14, 2019.

The Parkway again had to be closed at his location until the trees could be removed along with a minor amount of soil. The Parkway was reopened on February 15th.

Figure 11: February 15, 2019 300 ft. west of Kemper. FOX 19 drone coverage

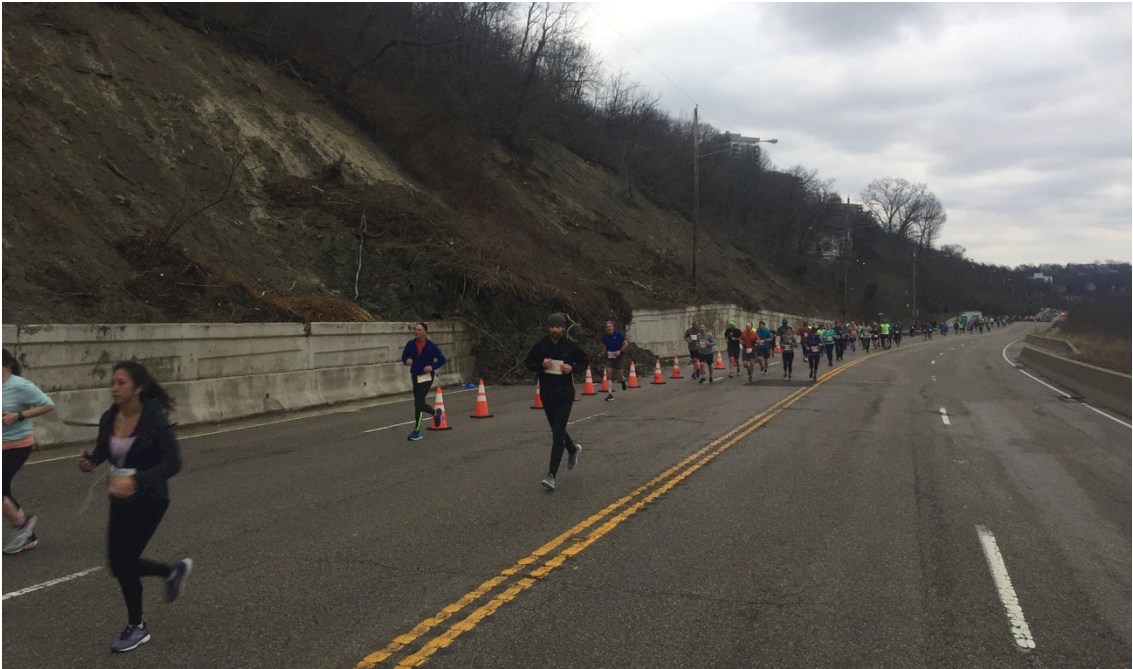
Continued movement of soil left on the hillside at the landslide 1,000 ft. east of Kemper was observed on March 6th. The trees were removed from the slide mass in preparation for removal. Immediate removal of the slide mass could not be done because DPS was committed to winter operations. Movement of the slide mass occurred in the early morning of March 10th following a heavy rainstorm. The Heart Mini-Marathon took place on March 10th and the Parkway was closed to traffic for the marathon. DOTE personnel secured and remained on site to monitor the slope during the Marathon. The Parkway remained closed until DPS completed the removal of the debris mid-morning of March 12th.

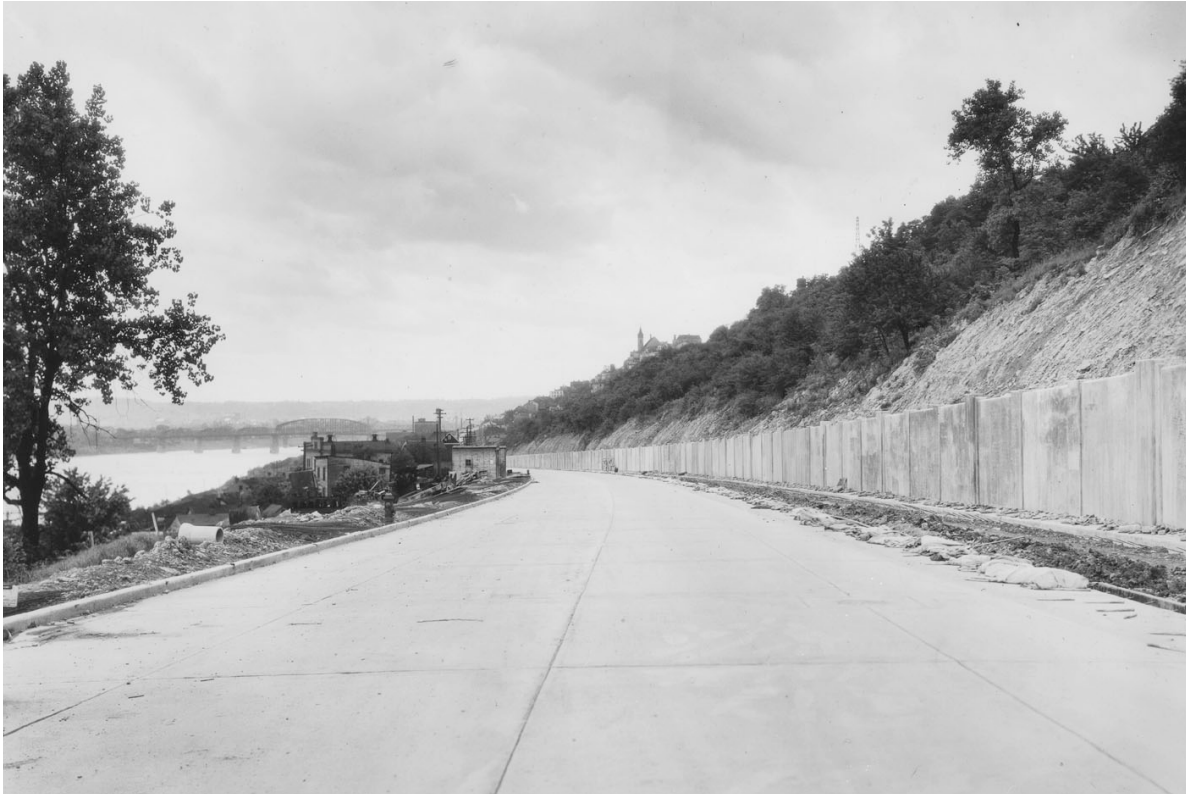
The lower portion of the hillside was over steepened during construction of the retaining walls for the Parkway. The over steepened slope decreased the height of the retaining wall. Most of the excavation behind the retaining walls and above the walls during construction was within bedrock. The over steepened bedrock cut slope was stable after construction of the wall.

Figure 14: 1938 looking west From Kemper Lane

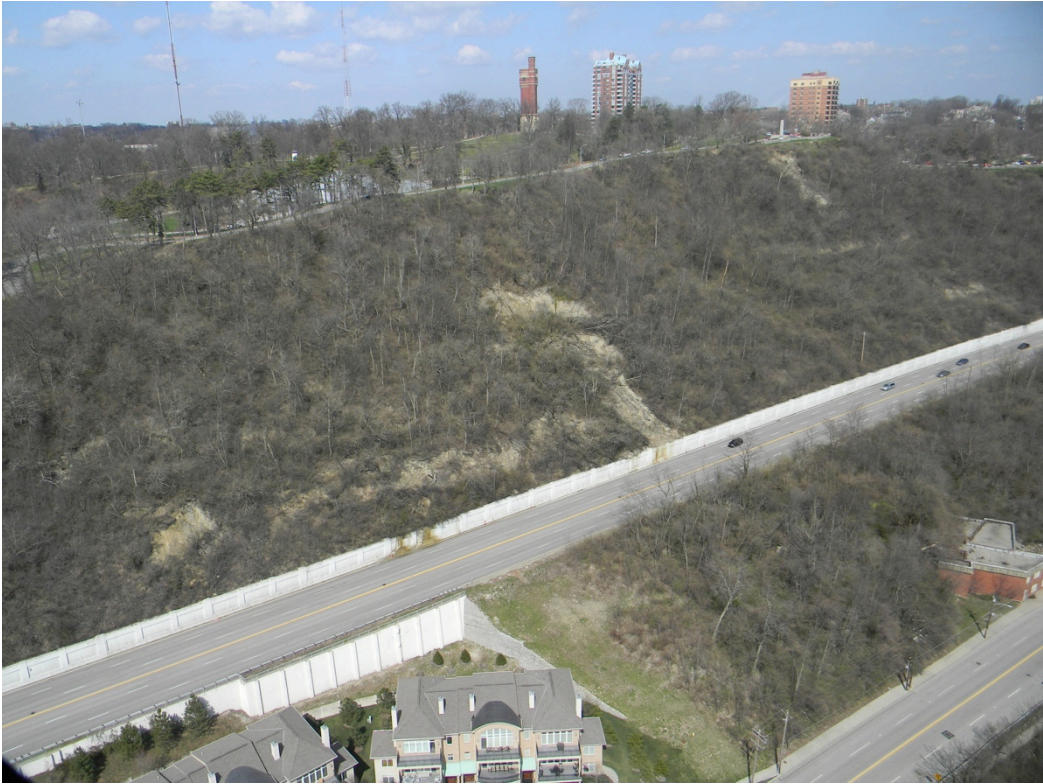
The Bains to Kemper Lane area is below Eden Park and contains the most active and most numerous landslides. Designated as only four areas, it does contain numerous individual landslides. Throughout almost its entire length the lower 60 feet of hillside immediately above the existing retaining wall has separated from the lower portions of larger landslides that extend further upslope. The slide blocks that separated from the upper slope block the drainage ditch and cause water to spill over the wall. Persistent areas of seepage freeze into icicles during the winter.

Figure 15: Landslide Areas 1 & 2, 2012

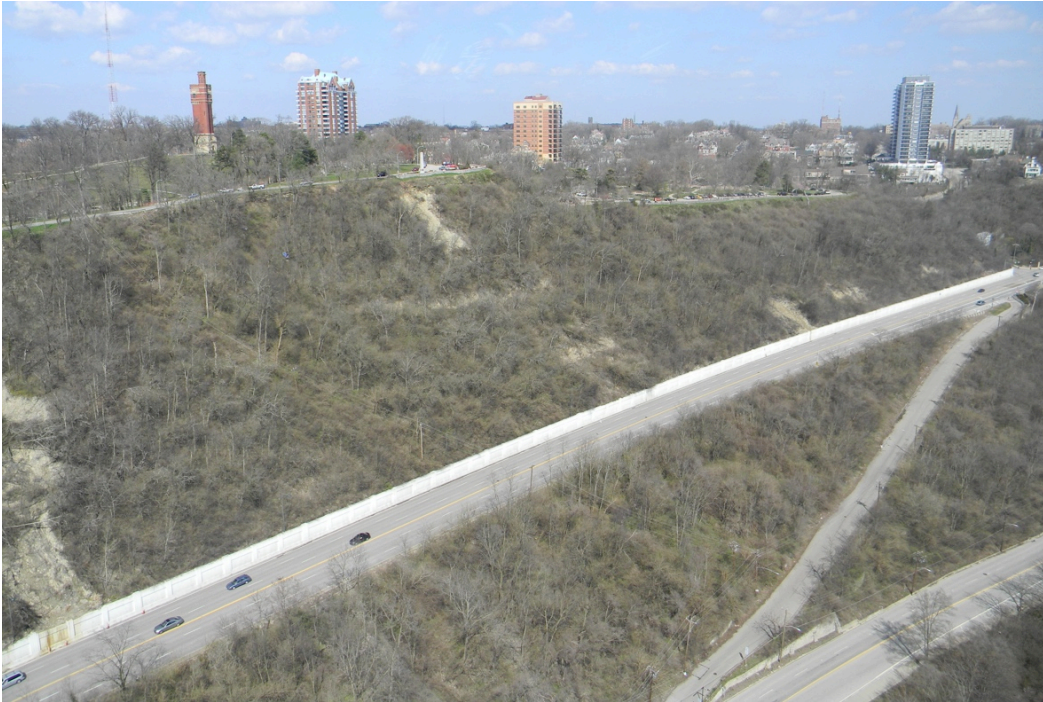
Figure 16: Landslide Areas 1 west, 2 & 3 2012

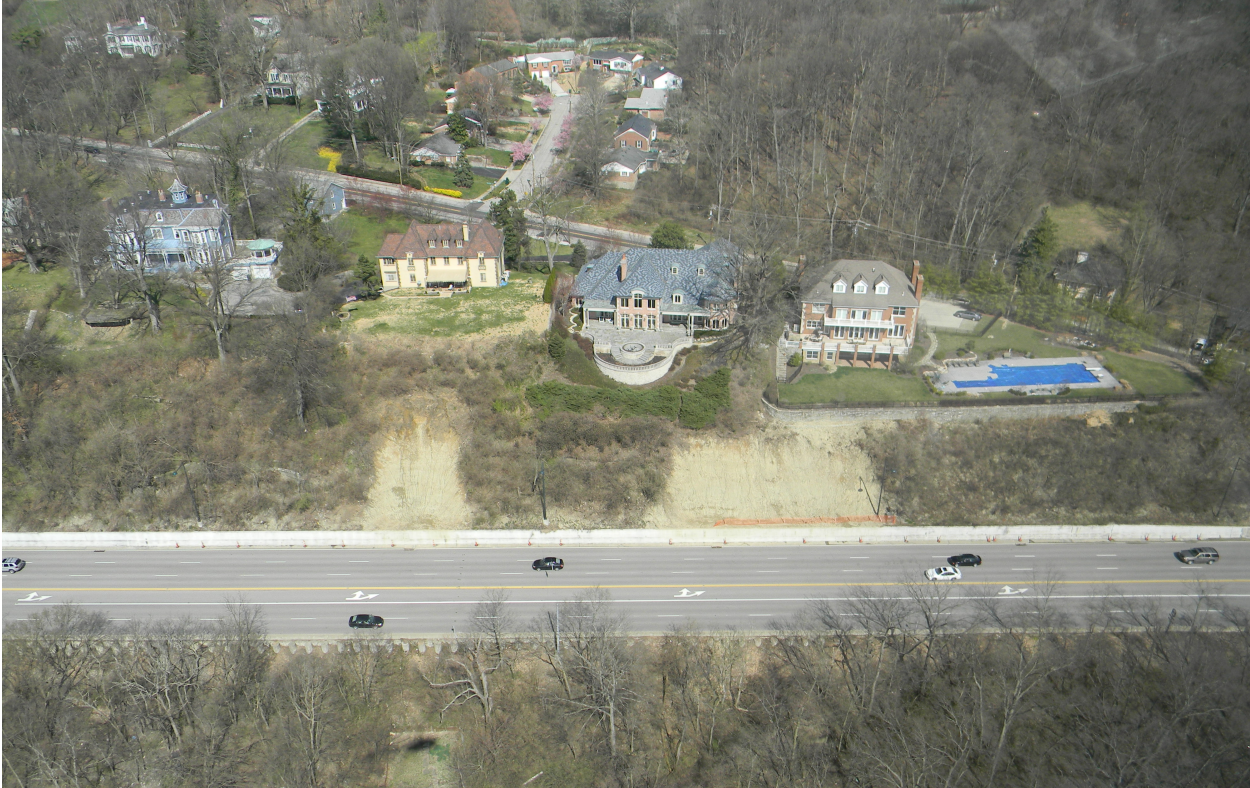
Five landslides have occurred east of Landslide Area 9, between the Collins Road overpass and Taft Road. The landslides occurred between early 1990 and 2017. The slide masses of the landslides were removed by DPS. The upper portion of the slide in the rear yard between 1875 and 1883 William H Taft Rd. although active, has not shown any landslide activity that threatens the Parkway since 2017.

Figure 26: Landslide scars west of Taft 2012
