CINCINNATI

Enhanced Line of Duty Death Report

**Fire Apparatus Operator
Daryl Gordon**

March 26, 2015

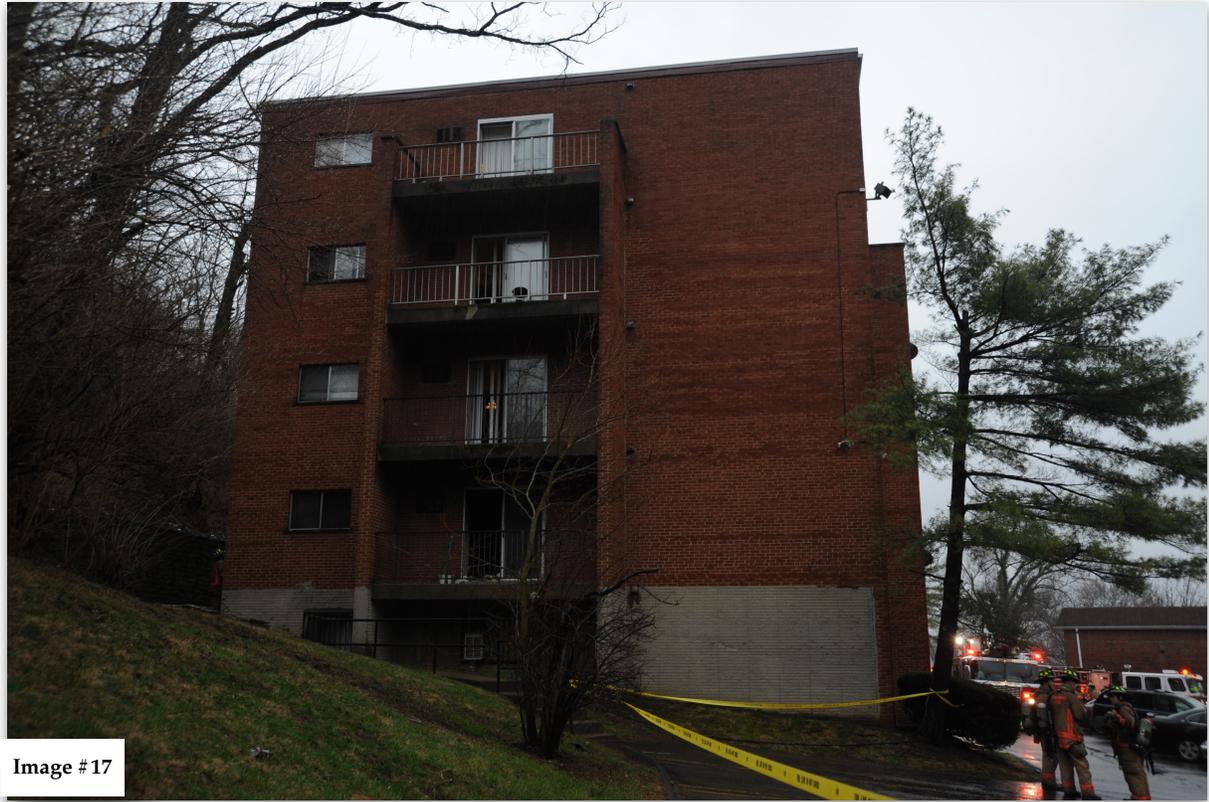
Image #17

“B” Side Notice Grade Difference

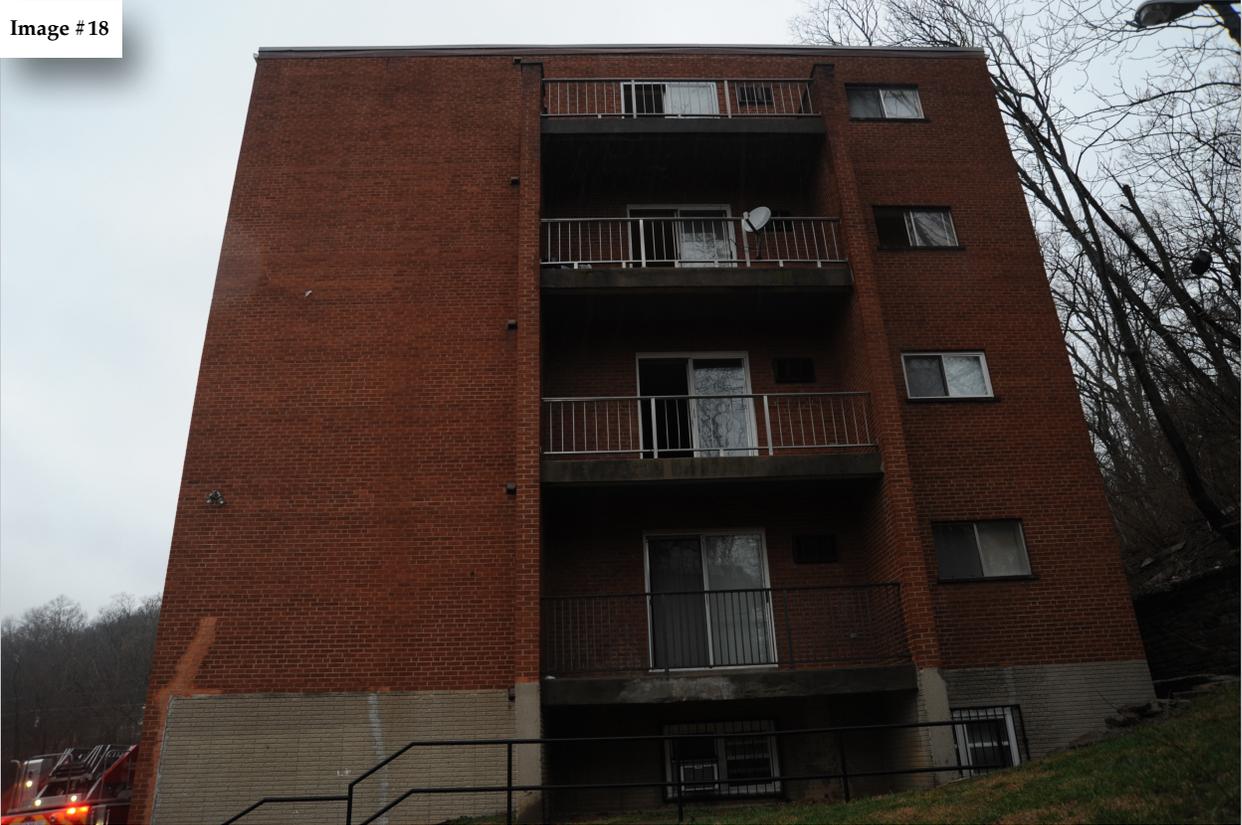
Image #18

“D” Side Notice Grade Difference

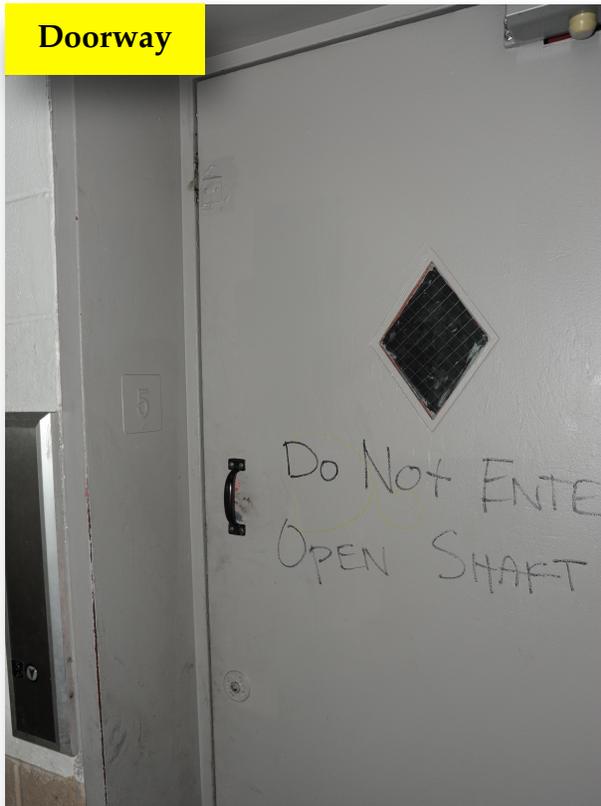
Image #28

**5th Floor Elevator Door
Where FAO Gordon Fell**

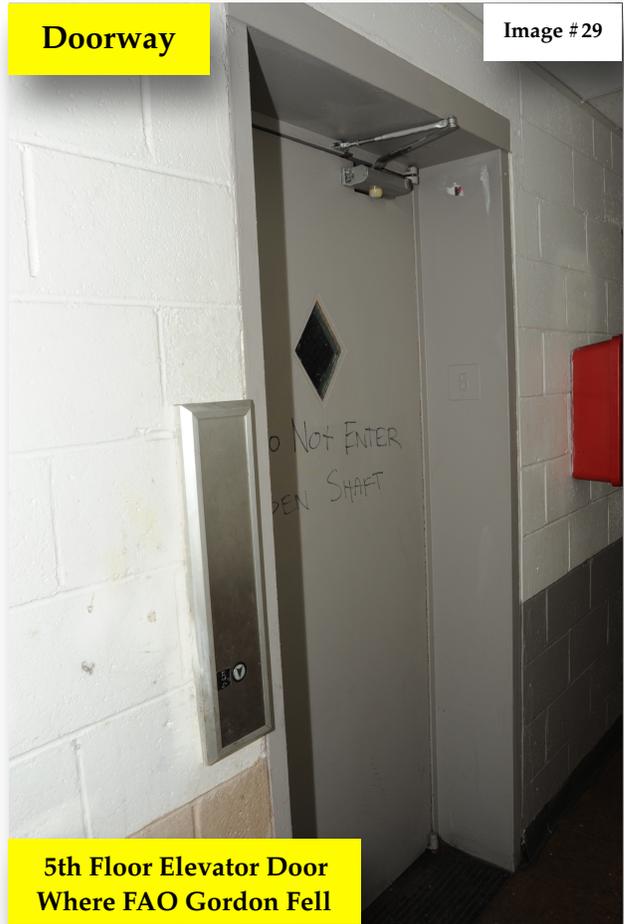
Image #29

**5th Floor Elevator Door
Where FAO Gordon Fell**

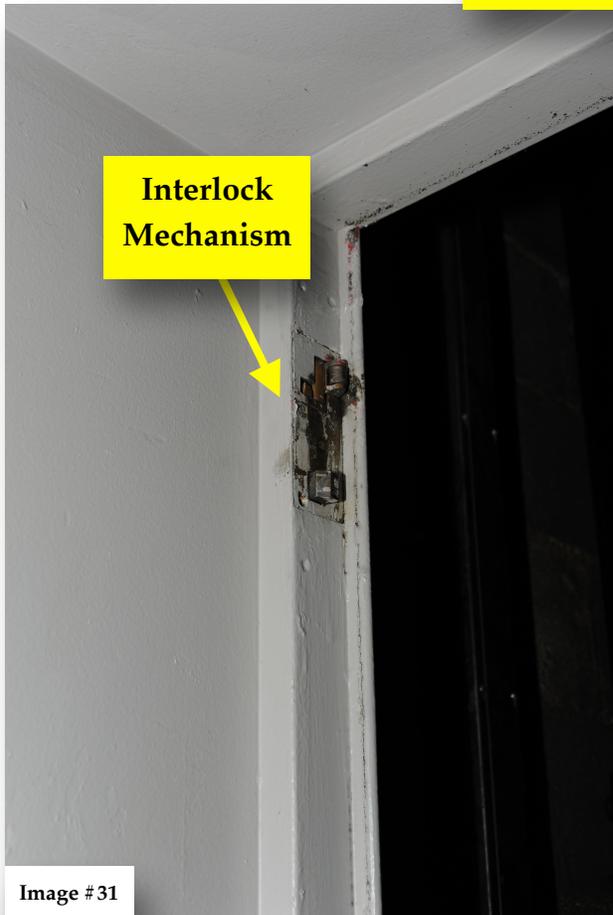
Image #31

**5th Floor Elevator Door
Where FAO Gordon Fell**

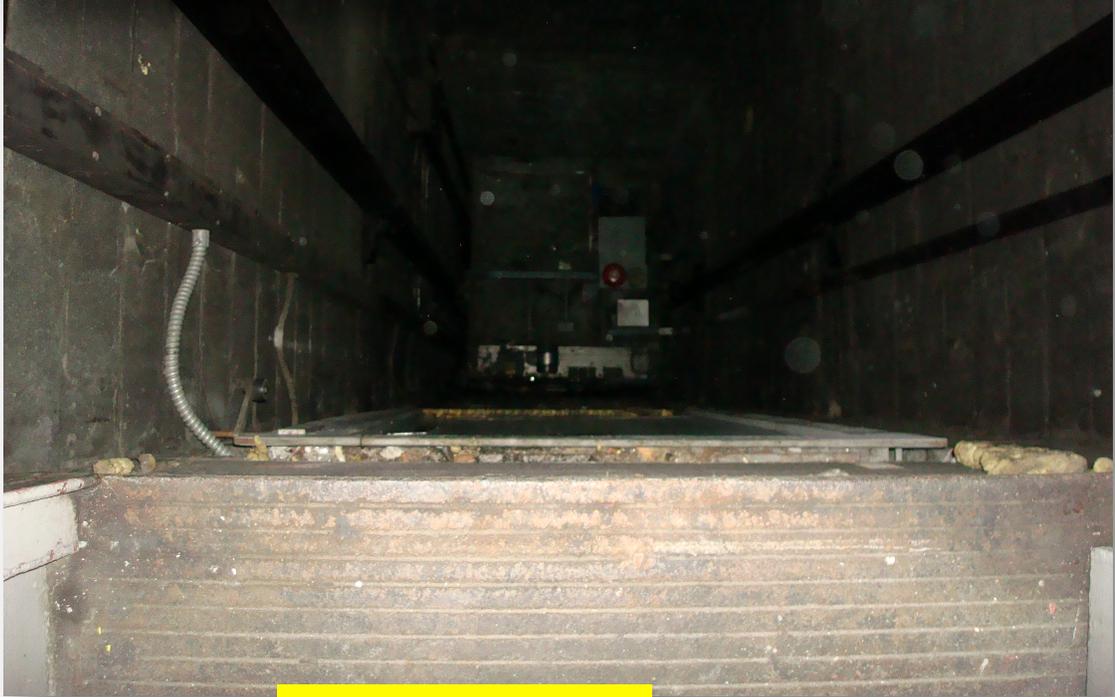
Image #33

**Elevator Shaft - Looking
Down From 5th Floor**

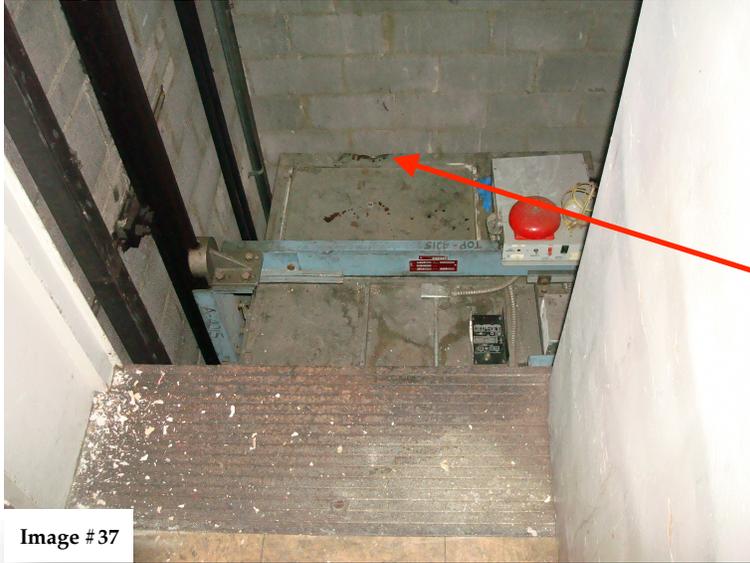
Image #37

Top of Elevator Looking From 3rd Floor
Location Where FAO Gordon Was Wedged

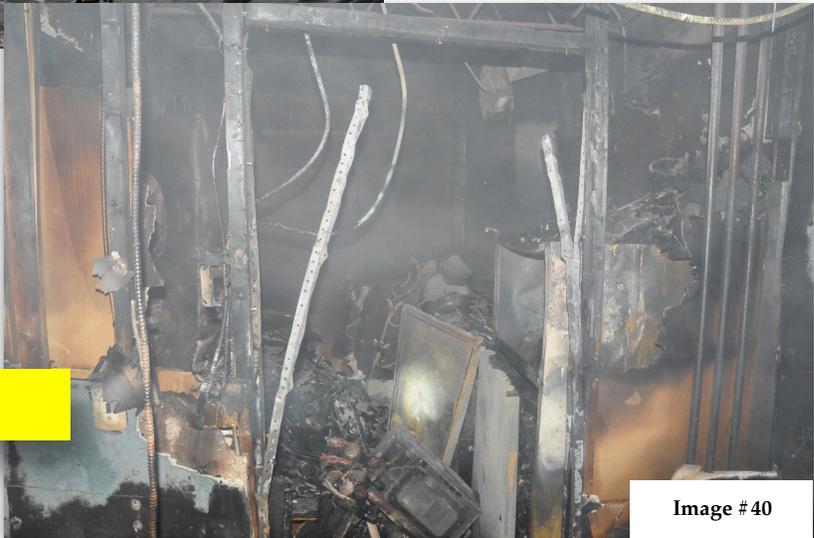
Image #39

Fire Origin

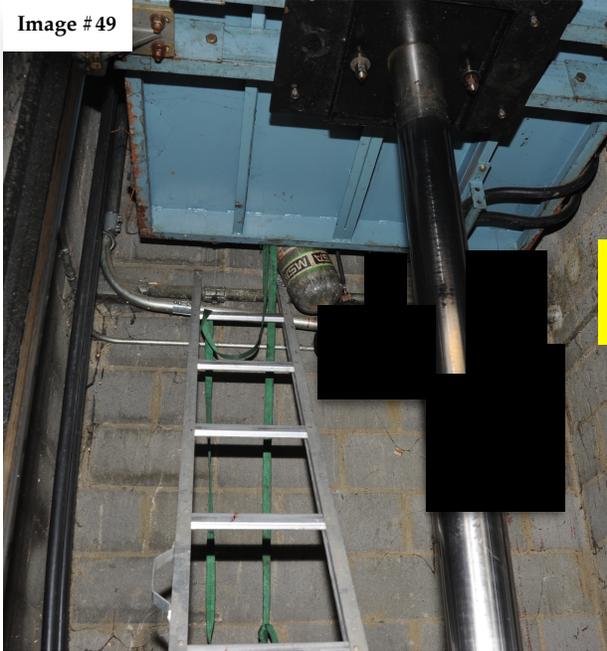
Image # 50

2nd Floor
Elevator
*Note: Wall
Removed to
Remove FAO
Gordon*

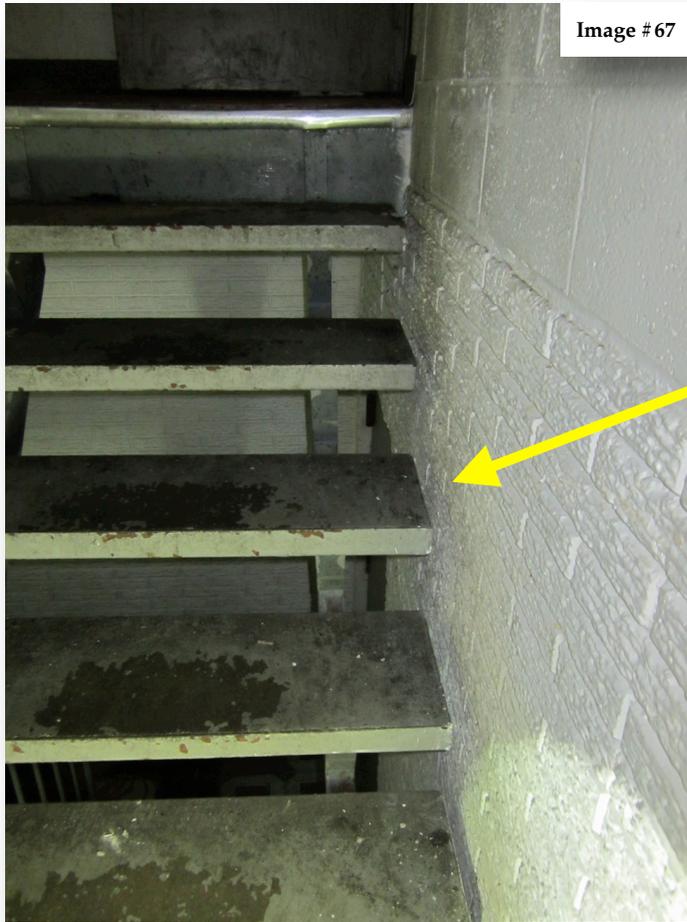
Image #67

At 05:51 hours (00:13:31 after Engine 49’s arrival), Engine 49’s attack line was charged and became wedged in the stairwell between the stair tread and the wall, making it impossible to advance (*See image 67 and 68, page 73*). Additionally, the entrance door to the stairwell wasn’t chocked open until later, further impeding the ability to advance either line. Neither Engine 49 Acting Officer, Engine 31 Acting Officer, nor Engine 31 FF#1 communicated to Command or any other company the inability of the attack lines to reach the fire apartment, the inability to advance either attack line, the need for assistance in deploying the attack lines, or the significant delay in getting first water on the fire.

**Riser from Exterior Door to 2nd Floor Stairwell Door Where Engine 49's line became wedged as it was charged
(NOTE: small gap between tread and wall)**

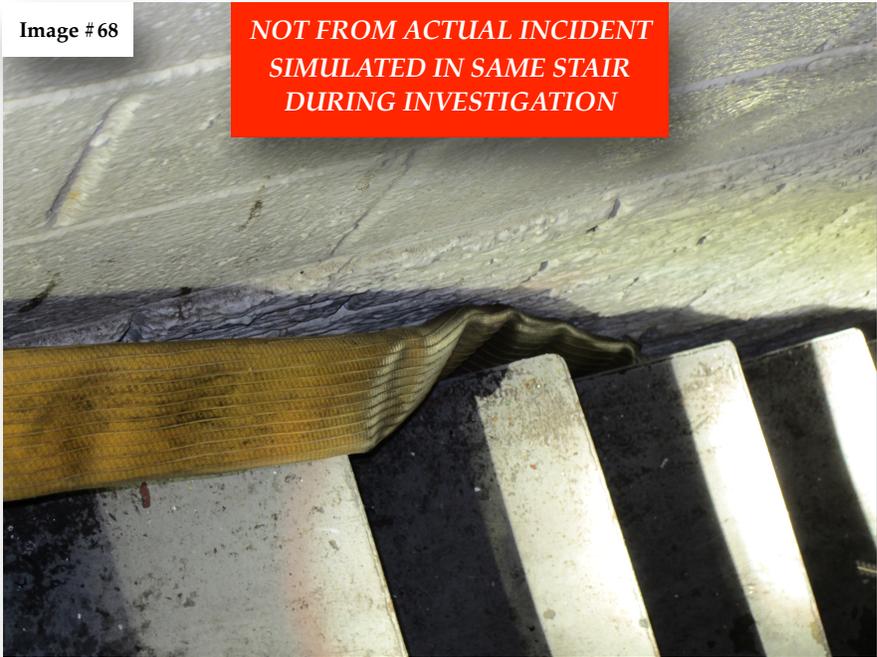
Image #68

**NOT FROM ACTUAL INCIDENT
SIMULATED IN SAME STAIR
DURING INVESTIGATION**

**NOT ACTUAL
PHOTO FROM
INCIDENT
VISUAL OF A
DIFFERENT HOSE PUT
IN THE STAIRS TO
SIMULATE WHAT
HAPPENED TO Engine
49's HOSE LINE**

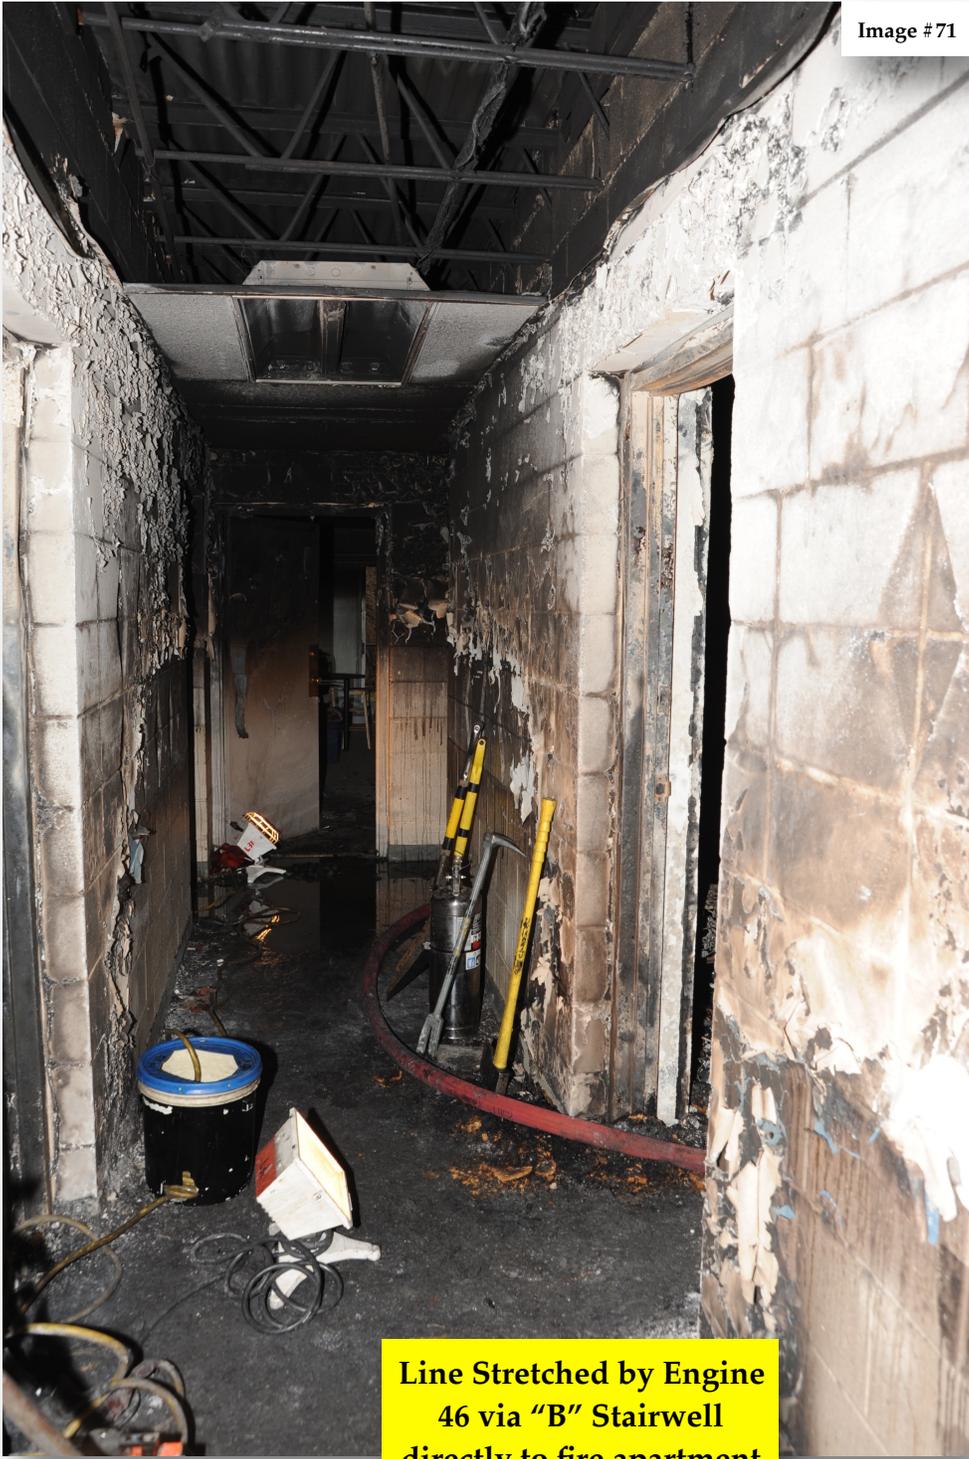
E-31 Line From "D" Stairwell and entering long hallway on 2nd floor (NOTE: Apt 24 in image)

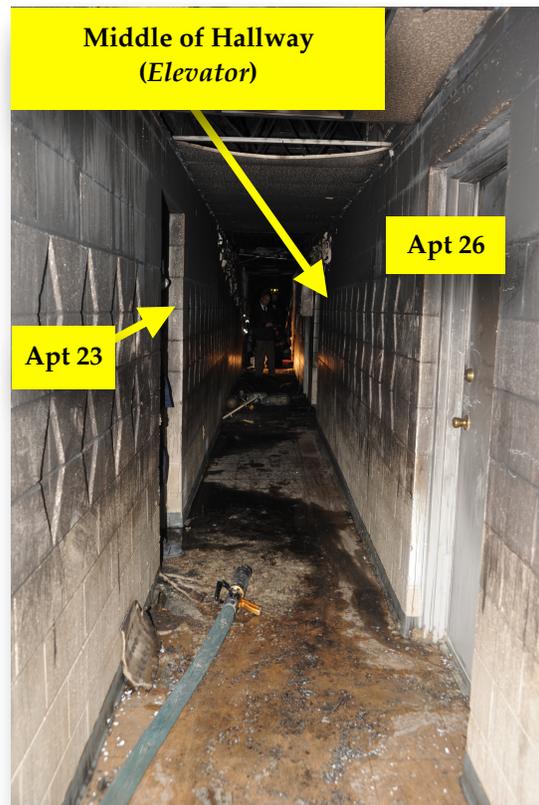
- f. Engine 49's attack line stopped at Apartment 26 and did not reach the fire apartment. The fire continued to burn uncontrolled for over 20 minutes after the fire department's arrival, increasing the spread of heat and smoke to the rest of the building. *(see image to right)*

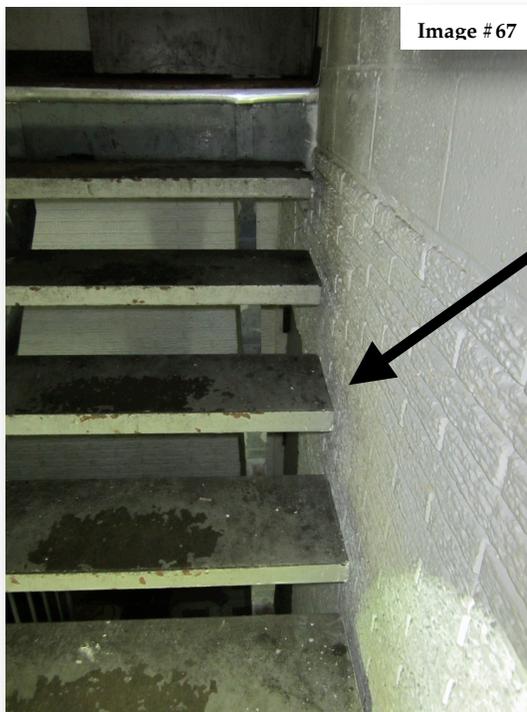
Image #67

**Riser from Exterior Door to 2nd Floor Stairwell Door Where Engine 49's line became wedged as it was charged
(note: small gap between tread and wall)**

- a. Engine 49 Acting Officer was not able to chock the outside entrance door.
- b. Engine 31 did not have door chocks and were looking for items to chock the door open.
- c. Engine 49 FF#2 chocked the door, but this was late in the hose deployment evolution.
- d. Doors in these occupancies should be chocked open to ensure good hose deployment (hose getting stuck beneath a door) and movement (between the door and the door frame).

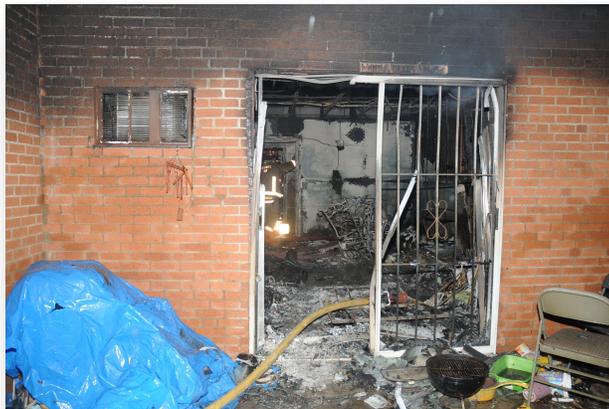
1. Truck 31A ventilated the “C” side sliding glass patio door to the fire apartment very early in the fire operations at the direction of District 4B, causing an increase in fire intensity and a worsening of conditions in the second floor hallway, hampering the ability of Companies to deploy the initial attack line to the seat of the fire and conduct a primary search.

- a. This action occurred without verification that an attack line was in place or that water was ready to be flowed on the fire.
- b. This action was not coordinated with Command or other interior Companies.

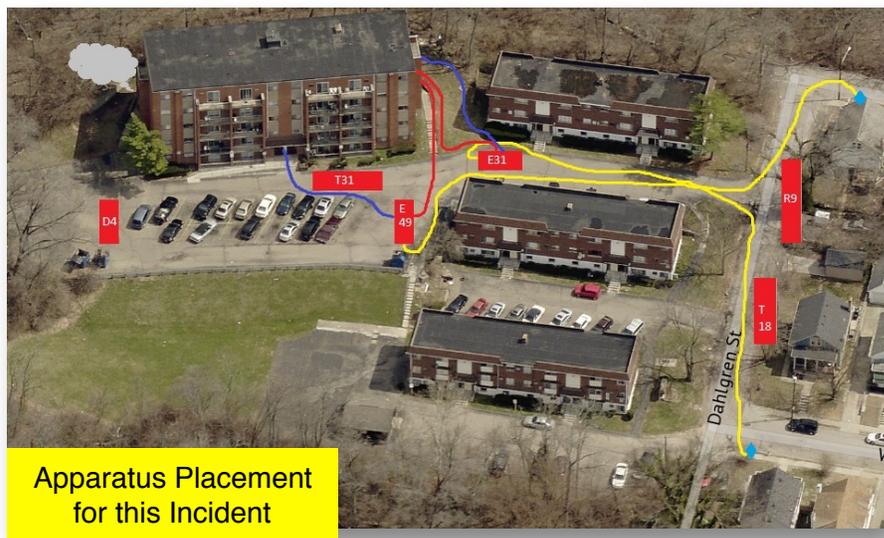
2. **The supply lines laid from Engine 49 and Engine 31 crisscrossed the driveway to the parking lot of the complex, completely sealing off further access to the parking lot for other responding apparatus.**

- c. Engine 31, traveling from the west, could have stayed to the west side of the complex (instead of traveling to the east side), pulled toward the dumpster on the west side (where Engine 49 actually parked), and allowed continued access to the parking lot without crossing the entrance to the parking lot with charged 5” supply line.

- d. Engine Company Officers should consider “positioning” their 5” supply lines into the entrance of a parking lot in a parallel fashion. Crisscrossing 5” supply line should be avoided at all costs. Once a 5” supply line is charged, no apparatus can proceed past – especially if the 5” supply lines crisscross the only entrance to the area.

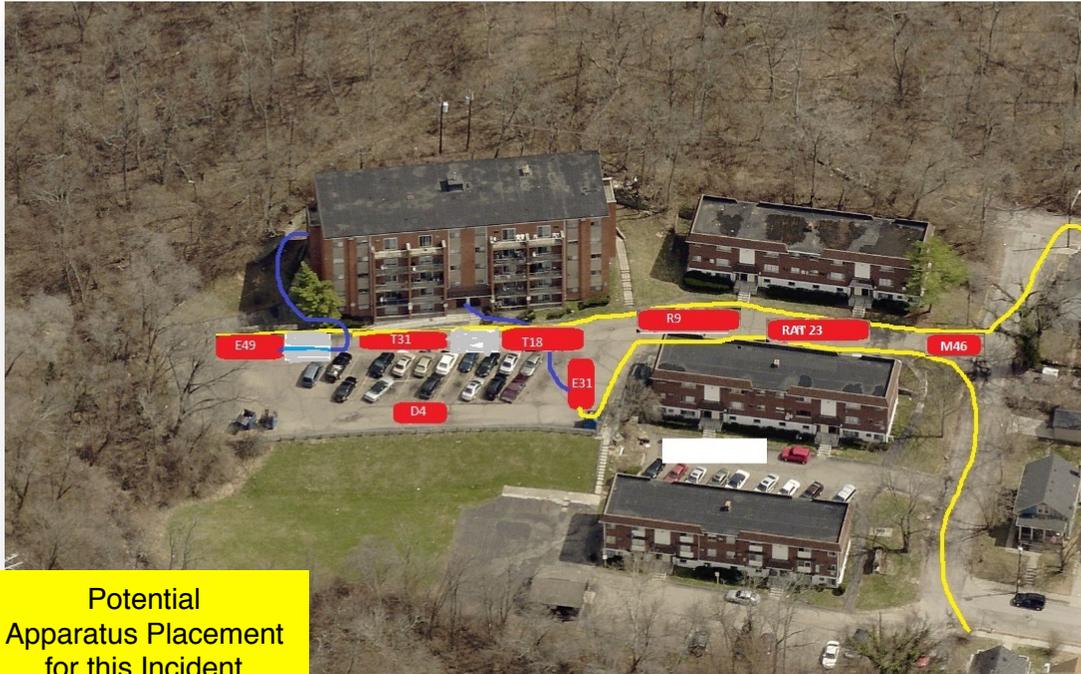
3. **Truck 31 stopped short of the lobby entrance on the “A” side of the building, with their rear mounted aerial closest to the “AD” corner. Truck 31 was the only aerial ladder with access to the building, limiting the ability to conduct exterior rescues via aerial ladders. Access to balconies near the “B” side proved challenging due to their position of the turntable near the “AD” corner.**

- a. Truck 31 could have traveled along the “A” side toward the “A/B” corner, leaving its rear mounted aerial near the lobby at the center of the building to provide easier access to all balconies on the “A” side.

- c. "Channeling" of supply lines may have also allowed Rescue 9 (with specialized tools and equipment), RAT 23 (with RAT equipment) and, potentially, a Medic Unit (for rapid egress path) access to the parking lot.
- d. Positioning in the aforementioned manner would have permitted effective viewing and operation on three sides of this structure.

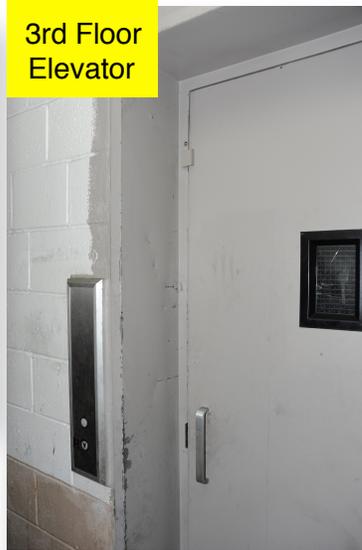
5th Floor
Elevator

3. At this incident, the smoke conditions were reported to be moderate on Floor 5, with visibility of a few feet. Firefighters from Heavy Rescue 14, Engine 8 and Truck 32 were on air as they operated on the 5th floor. It may have been difficult to read the warning marked on the elevator door. When dangerous conditions are found in a limited visibility environment, it is imperative to communicate these hazards to the Incident Commander, post a guard if conditions allow, attempt to render the hazard safe, and await further orders from the Incident Commander.

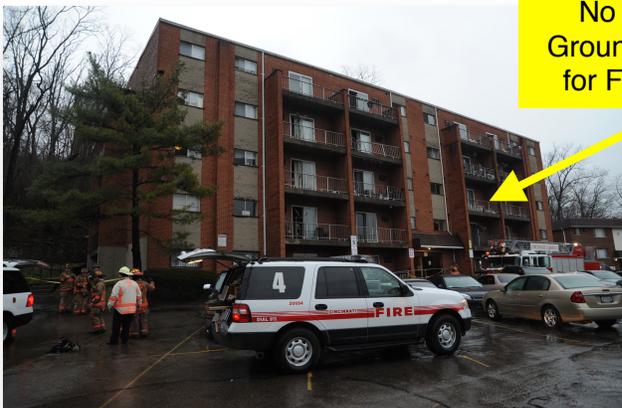
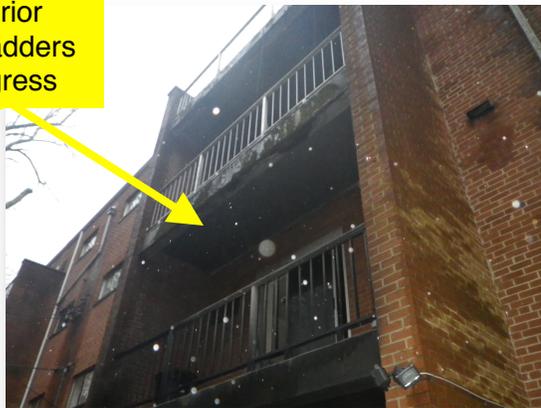
- b. Rescue ladders to the upper floors were never deployed (*see images below*).
- c. A crew was not assembled and available for rescue efforts when the Mayday was transmitted.
- d. No RAT equipment was staged.
- e. No one performed a RAT 360 assessment or “softened” the building.

No Exterior Ground Ladders for FF Egress

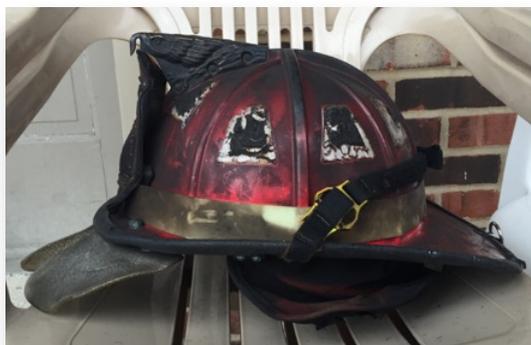
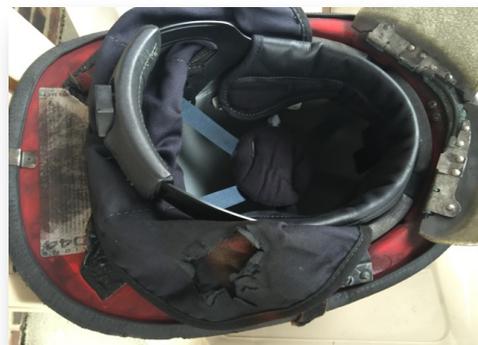
The attached photos show damage to the face piece and helmet of Truck 31 Officer who was initially in the hallway near the fire apartment. No other PPE (with the exception of FAO Gordon's) was inspected or damaged as a result of this fire. Other firefighters received minor burns, but their PPE was not a factor. PPE performed as designed at this incident, limiting injuries to firefighters exposed to high heat on the 2nd Floor hallway.

- a. Truck 31 Officer’s helmet was severely damaged by fire, his ear flaps were burned through, and his SCBA face piece suffered heat damage to the lens.

- b. His PPE was donned and properly worn, thus limiting his exposure to the heat and greatly lessening the thermal injuries he suffered. (NOTE: It was reported in testimony that Truck 31 Officer’s helmet was “on fire” while standing in the hallway off the “B” stairwell. Firefighters should stay low in high heat conditions.)

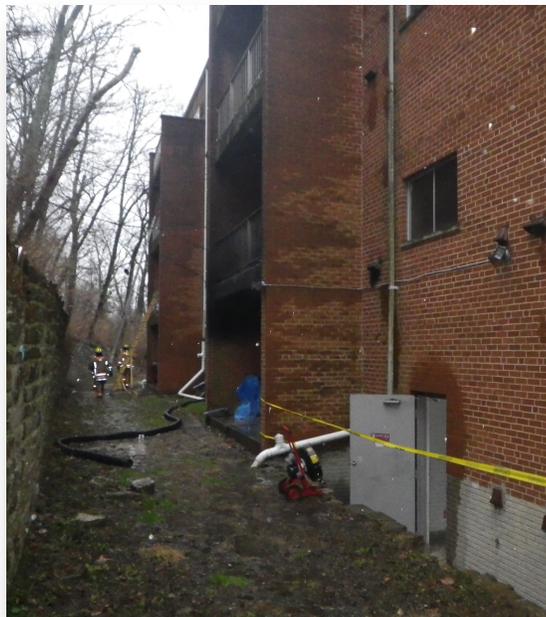
1. The first-arriving truck companies did not set up PPV or pressurize stairwells.
2. First-arriving companies did not designate an attack stairwell or an evacuation stairwell. Attack lines were placed in both the "D" stairwell and the "B" stairwell, causing smoke to spread into both stairwells and throughout the building.
3. PPV at this incident was set up by 3rd Alarm companies, well after the Mayday occurred and extrication efforts were underway.

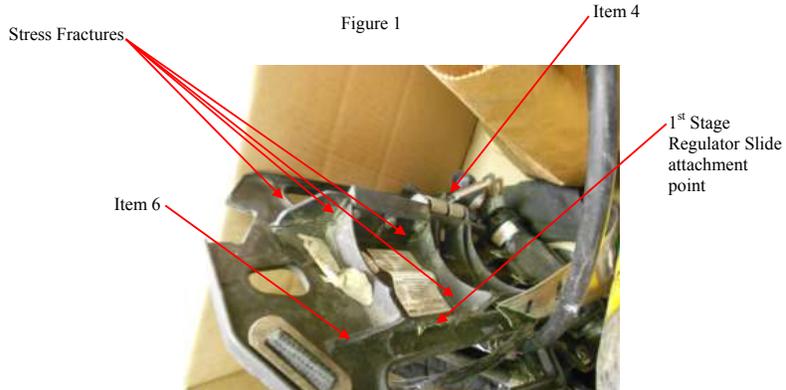
1. Upper right Shoulder strap attachment point fractured and not found in box.
2. There are stress fractures in the structural web just below the missing upper right shoulder attachment point (in multiple places above and below the NIOSH label). See Figure 2
3. Left Grab Handle fractured/missing from SCBA not found in box.
4. Bottle retaining strap deformed on left side and dislodged from spring-loaded attachment point on right side.
5. 1st Stage Regulator Slide is broken off of the Back plate but remains attached to the 1st Stage Regulator.
6. The bottle rest point (top left) is missing a small piece.
7. The outer bottle wrap has separated based on position this would have been on the right rear side of the firefighter. See Figure 4
8. Face Piece removed from box

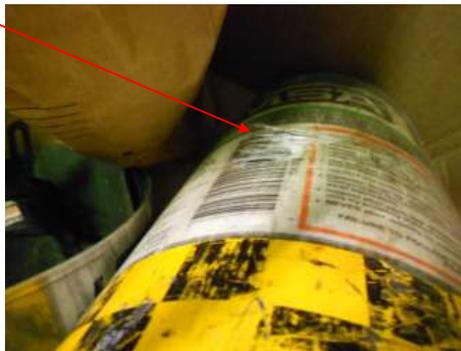
Figure 4

Although the SCBA sustained significant damage as a result of the incident within the elevator shaft at the Dahlgren fire building, it performed well within the parameters of its design and expectation.

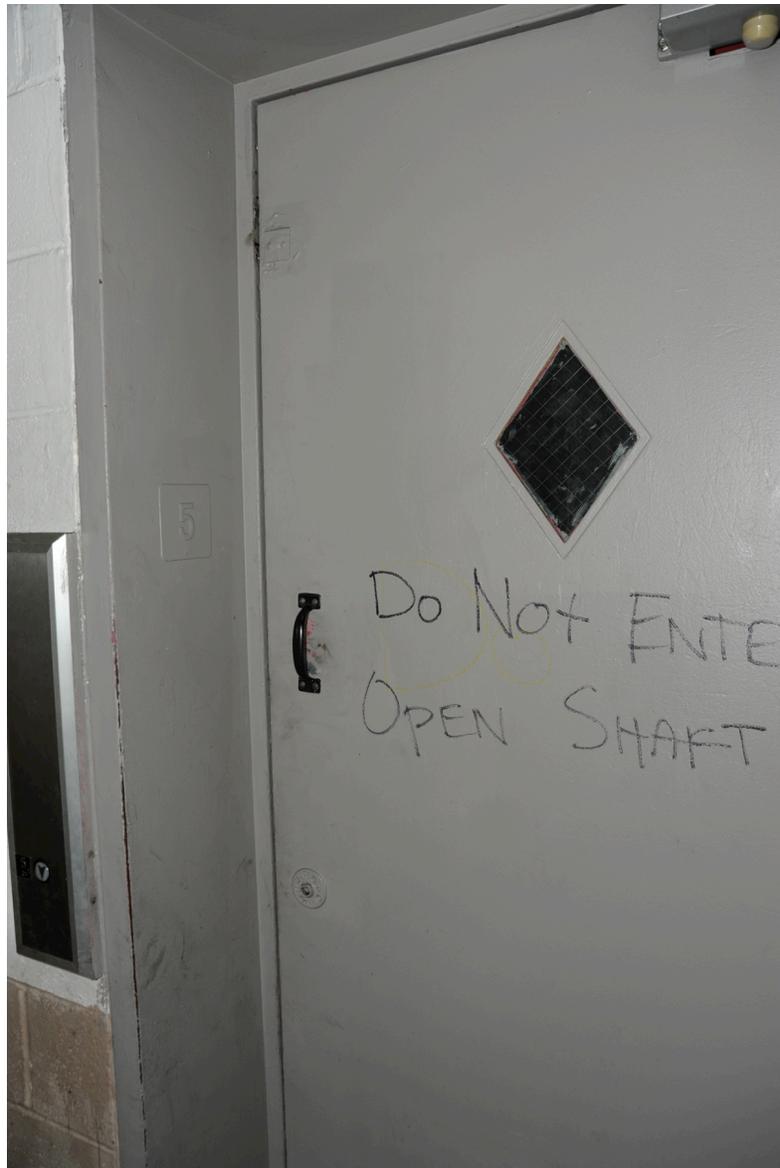
6:11-06:12: While on the fifth floor D-3 encountered HR-14 OIC, FF# 1, and FF#2 at the elevator door. HR-14 showed D-3 the open elevator shaft. HR-14 and D-3 looked into the shaft again at this time and saw nothing. HR-14 FF#2 marked the door with a black permanent marker; **"Do Not Enter Open Shaft"** [Figure 9]. D-3 moved toward the B-C stairwell while HR-14 OIC, FF# 1, and FF#2 searched the laundry room and continued toward the D side of the building. **FAO Gordon's location is unknown.**

Figures 9: Fifth floor elevator door

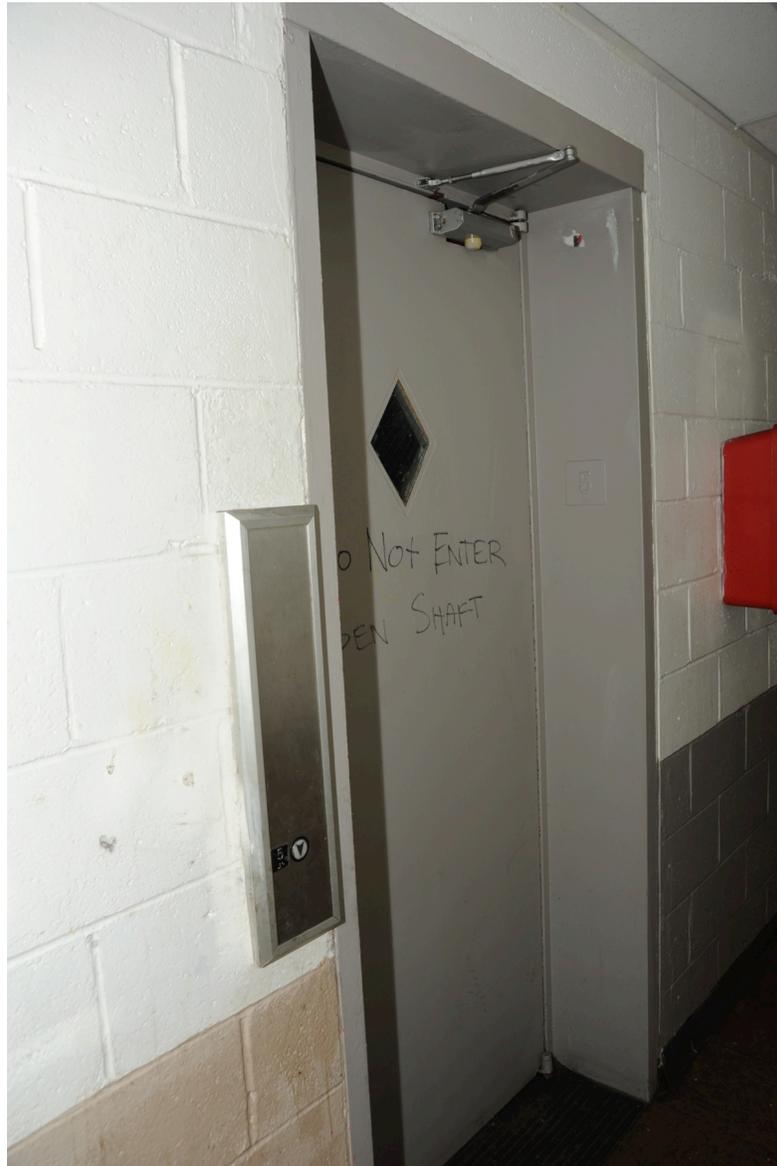
Figure 10: Fifth floor elevator door

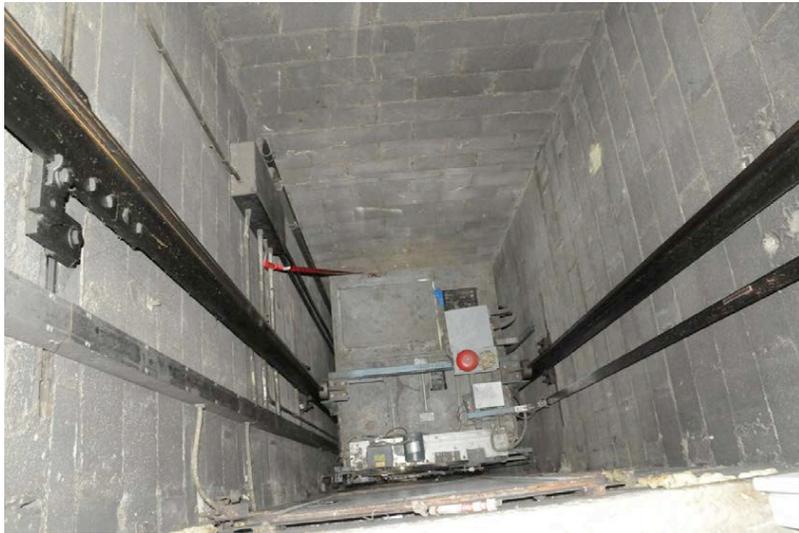
Extrication operations were set up and assigned to the Special Operations Chief (SOC) at 0624 hours. The exact elevator car location was determined to be at the second floor level, with FAO Gordon 'wedged' between the elevator car's exterior C side wall and the C side wall of the elevator shaft [Figure 11]. Available fire companies began to converge on both the second and third floor to begin the extrication process. As HR-9 FF#1, FF#2, and FF#3 exited the structure to obtain specialized extrication equipment from the HR-9 apparatus, members of E-23 forced entry from the second floor hallway into the elevator car and began to remove the elevator car's C side wall using a flat head axe. Members of various fire companies including HR-14 worked both on top of the elevator car and inside of the elevator car to extricate FAO Gordon. The extrication was completed in less than 14 minutes. FAO Gordon was then transported to University Hospital by several medics using Medic 19.

Figure 11: View of elevator shaft and top of elevator car

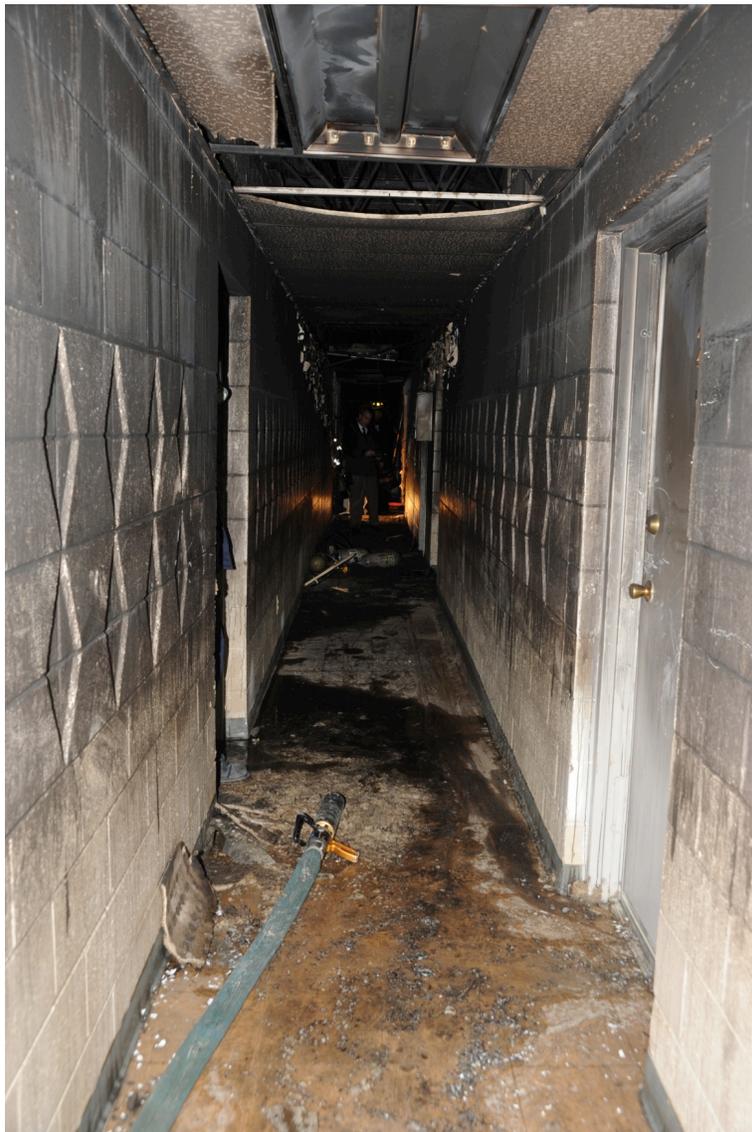
Figure 13: Second floor hallway (viewed from the D side looking toward the B side with the initial attack line)

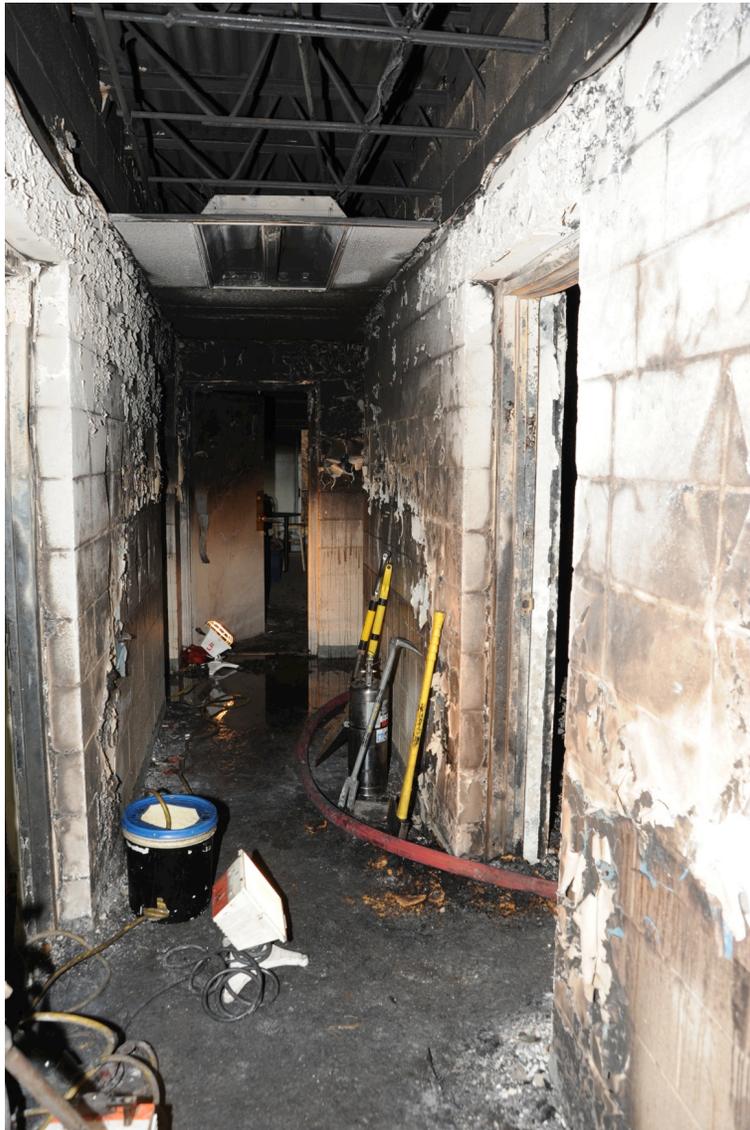
Figure 14: Second floor hallway (the door to the fire apartment (apt 27) is on the right)

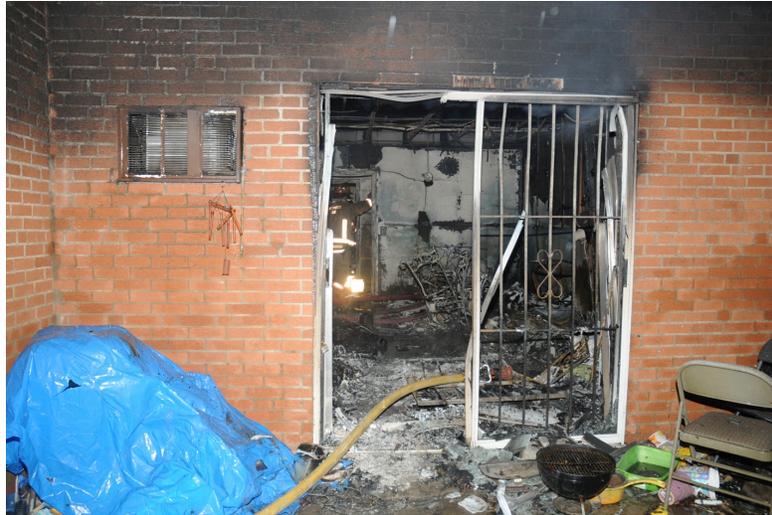
Figure 15: View of fire apartment from C side
